Hands Mill Dam 225.01
Washington

MEMORANDUM

TO: To The File
FROM: Steven Hanna, Dam Safety Engineer
DATE: December 9, 2016
SUBJECT: Inspection of Hands Mill Dam, Washington.

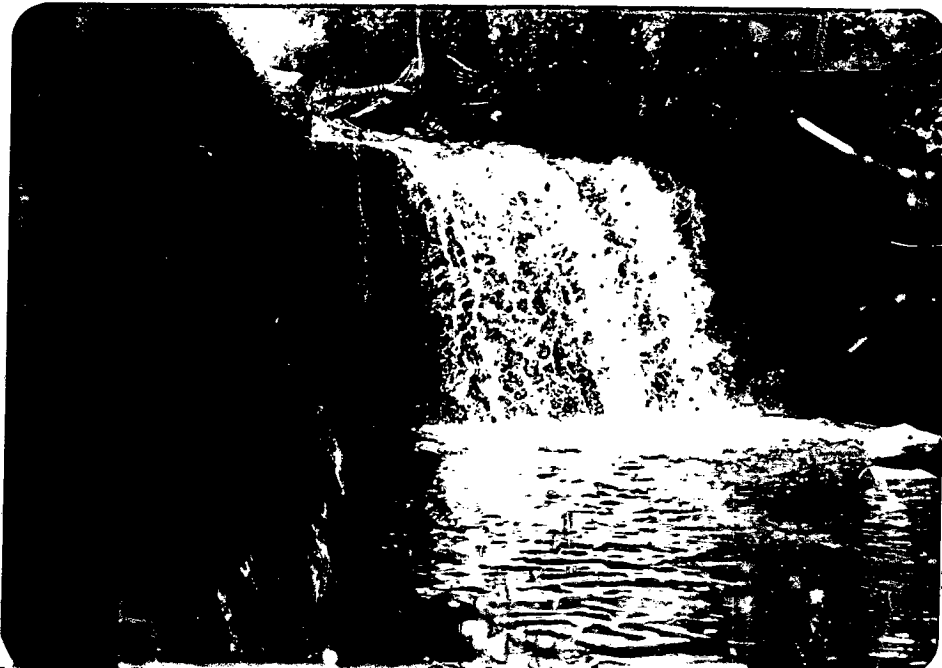
LOOKING DOWN VIS ~~VIEW~~ OF
~~SPILLWAY~~ BREACH TO LEFT OF SPILLWAYS

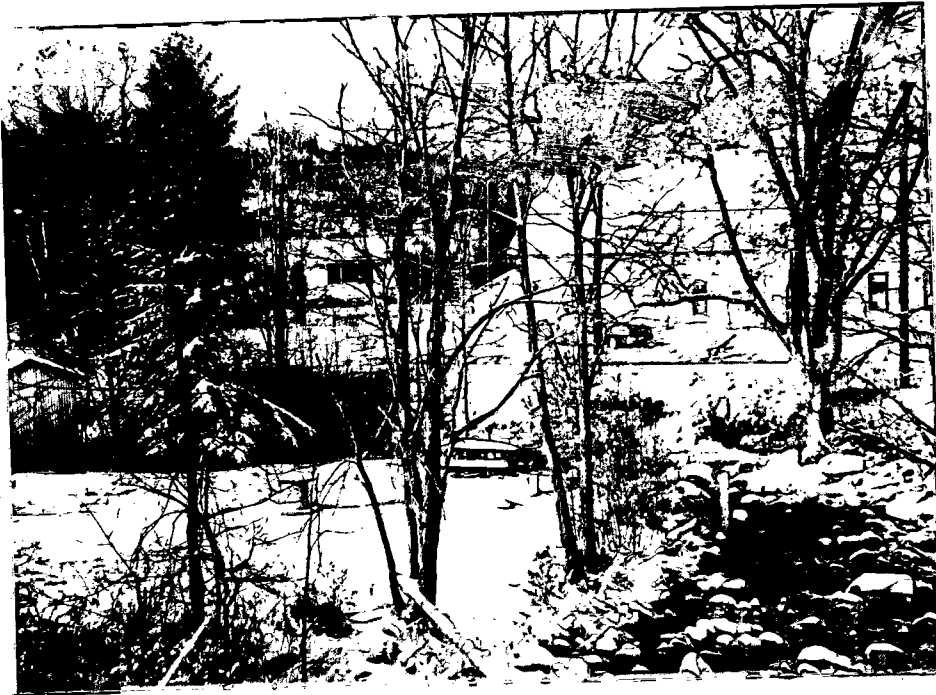
8:51-19

D/S Channel

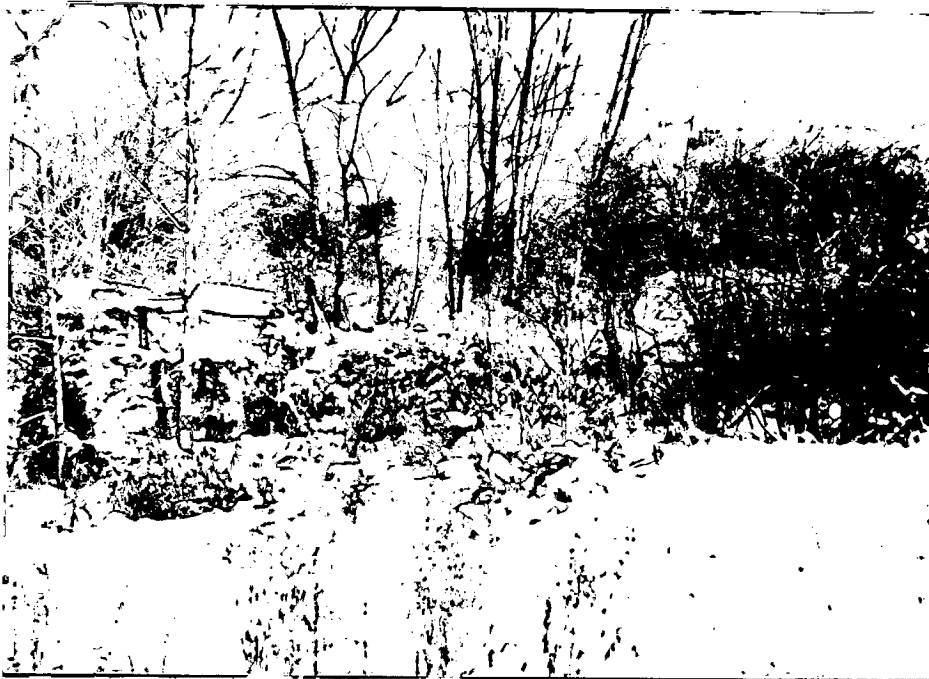
84-S1-35
Left embankment and wheel
chamber(?)

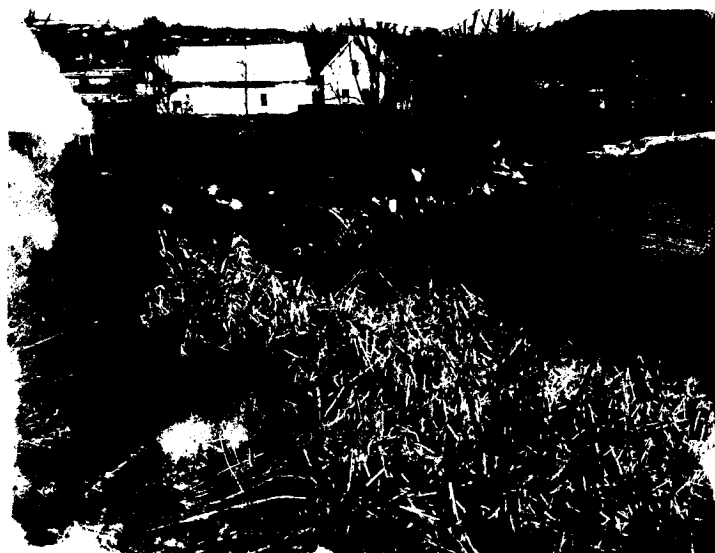
Upstream face of west embankment
