**HISTORIC RESOURCE REVIEW  
AND ARCHAEOLOGICAL RESOURCES ASSESSMENT,  
HANDS MILL DAM (VT STATE ID #225.01) REMOVAL PROJECT  
WASHINGTON, ORANGE COUNTY, VERMONT**

UVM Report No. 1303  
December 8, 2020

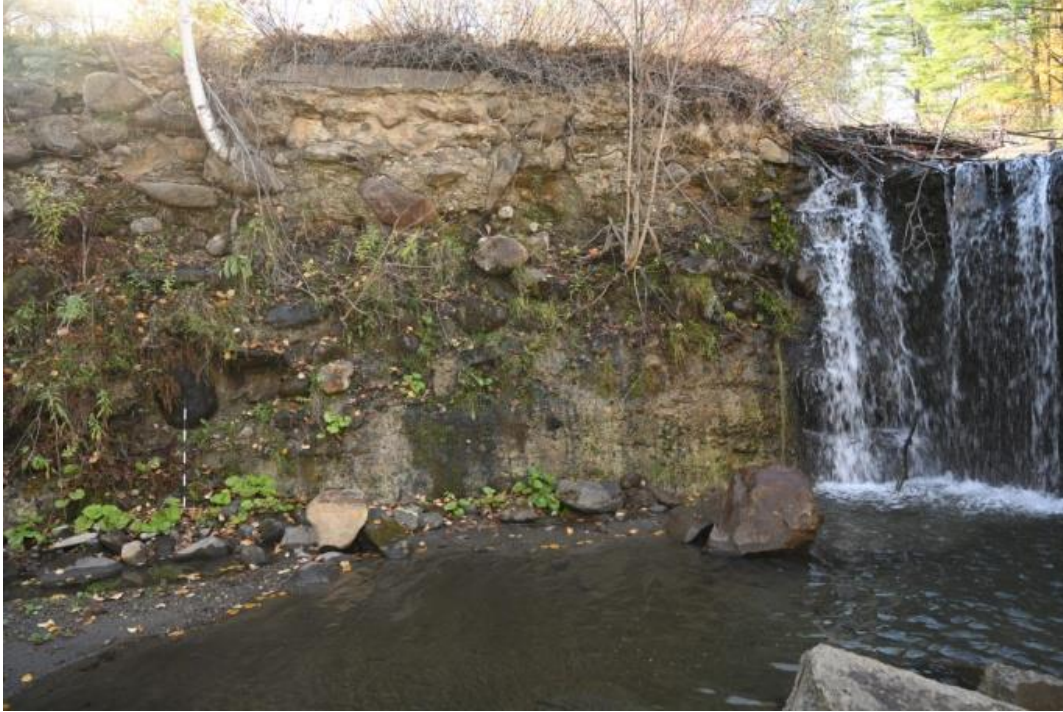
The spillway and low outlet section of the dam is now in poor condition. In 1950, 22 years after construction, this part of the dam was only experiencing “minor surface scaling” (Haybrook 1950:2). Twenty-five years later, or 47 years after construction, the concrete on the downstream face of the spillway was “badly deteriorated” and “severely spalled” (Anonymous 1975a:3). Today, another 45 years on, or 92 years after construction, nearly all of the surface concrete is gone from the air (or downstream) face of the spillway and the concrete core of the structure is crumbling away in small fragments. Water is seeping through the dam and some sizable stones have fallen away (Bushman, Hanna, and Deeing 2016).

Figure 18. View of the left part of the Hands Mill Dam spillway, looking southwest. Note: top section of the spillway appears to be either a different concrete or a different lift, minimal amount of original surface remaining on the downstream face of the structure, and the exposed interior of the rubble / cyclopean concrete.

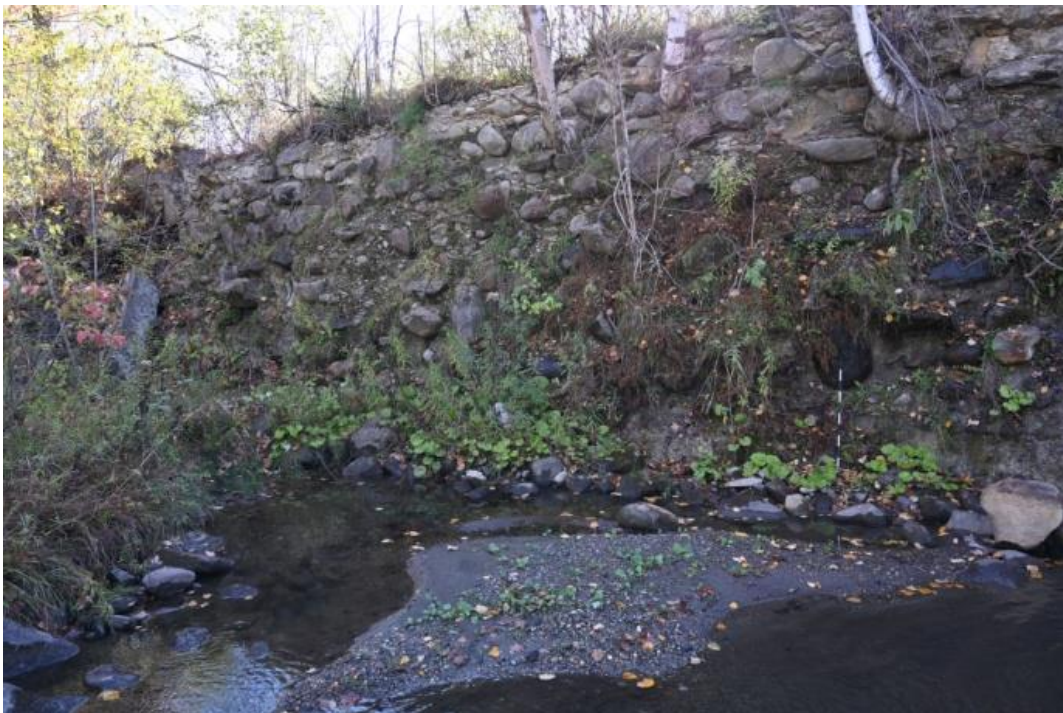
Figure 19. View of the right part of the spillway section of the dam, looking southeast.

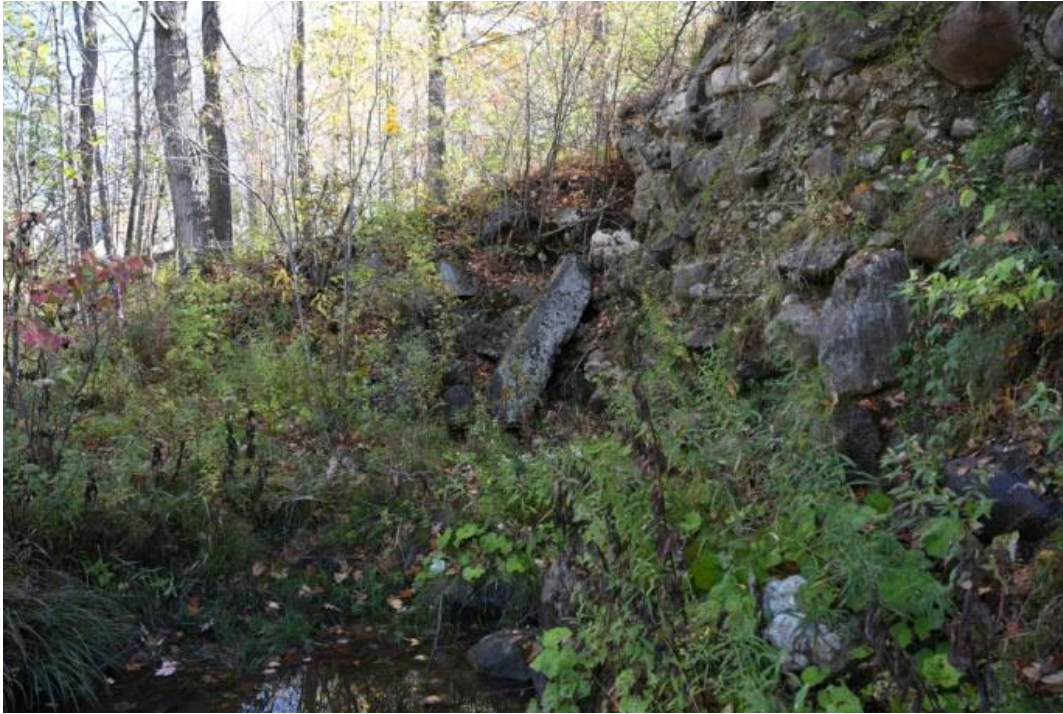
Figure 20. Looking east northeast along the water / downstream face of the spillway section towards the right wing section.

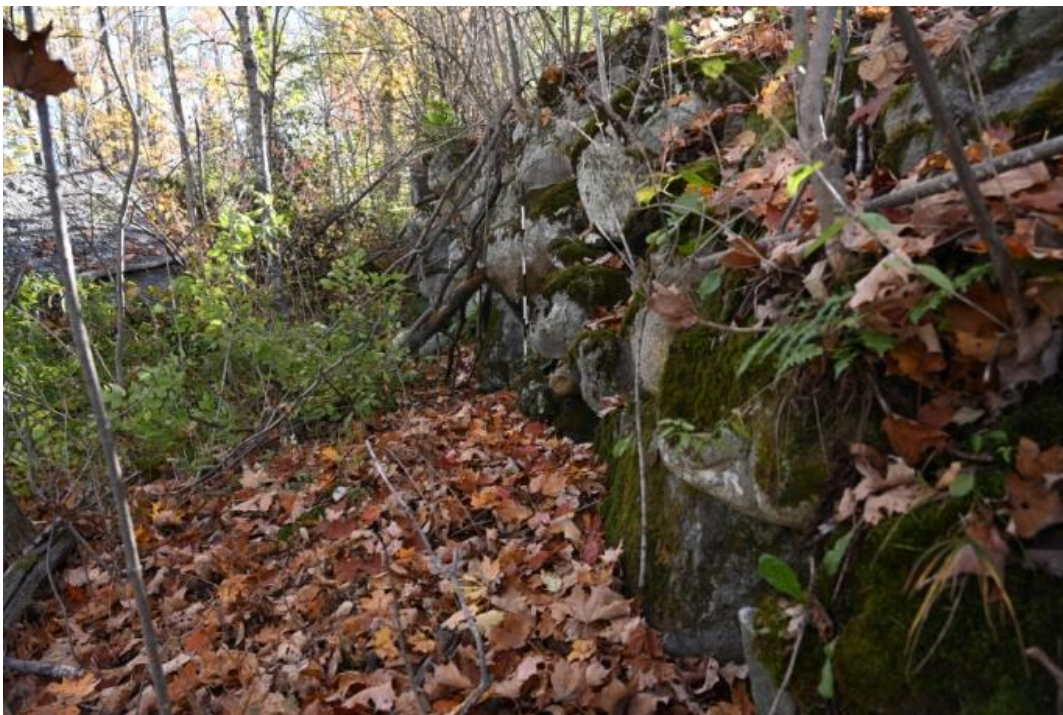
Figure 21. View looking eastwards along the downstream side of the stone faced earth fill section of the dam.

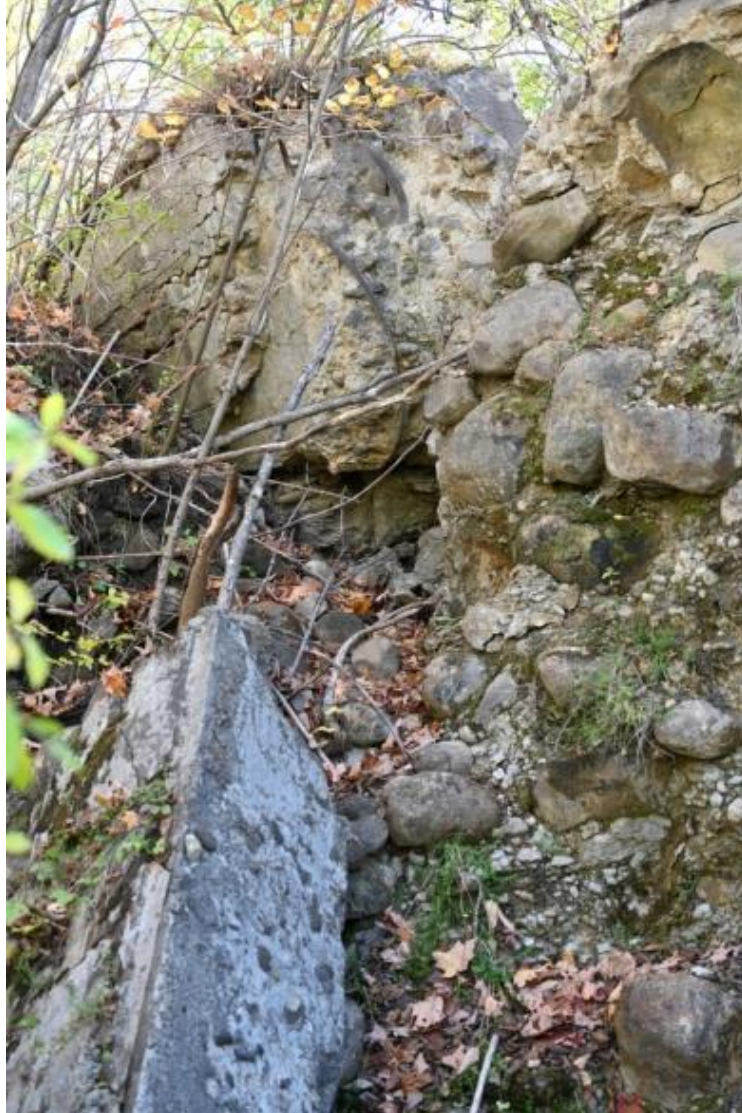
Figure 22. View of the compromised joint section between the spillway (closer) and the right wing sections of the dam, looking east southeast. The right wing structure is formed of rubble concrete and contains some metal reinforcement, possibly plain round bar and flat scrap metal pieces; this part of the structure also appears to have had another layer of concrete (a facing or a veneer) on its downstream side (two board formed surfaces appear to be visible).

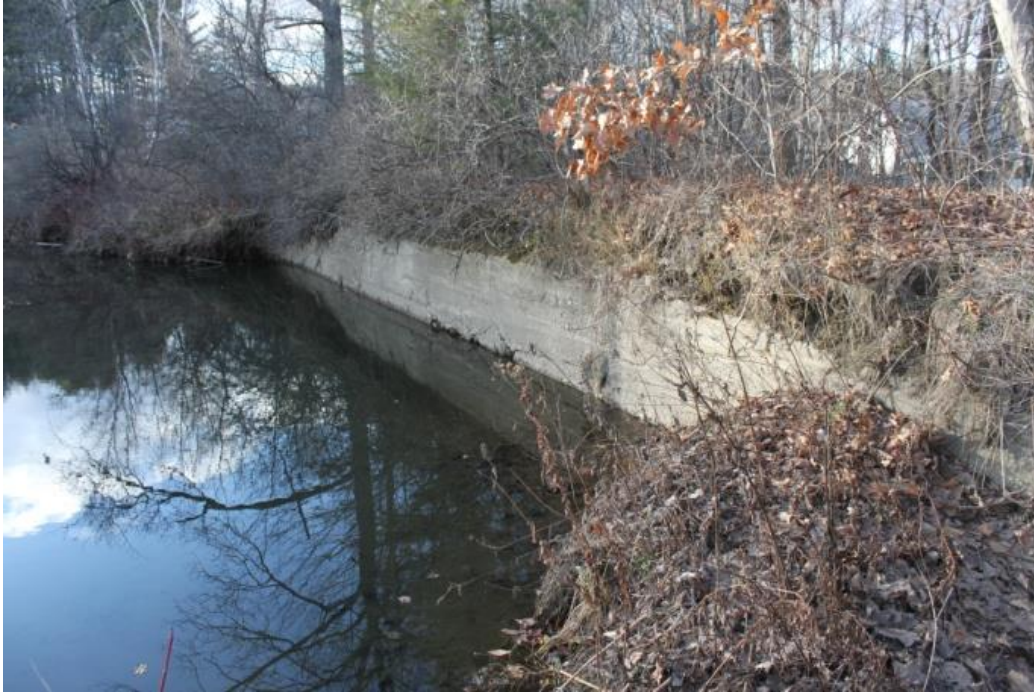
Figure 23. View looking west along the upstream face of the right wing wall / cutoff wall looking towards the spillway section of the dam.

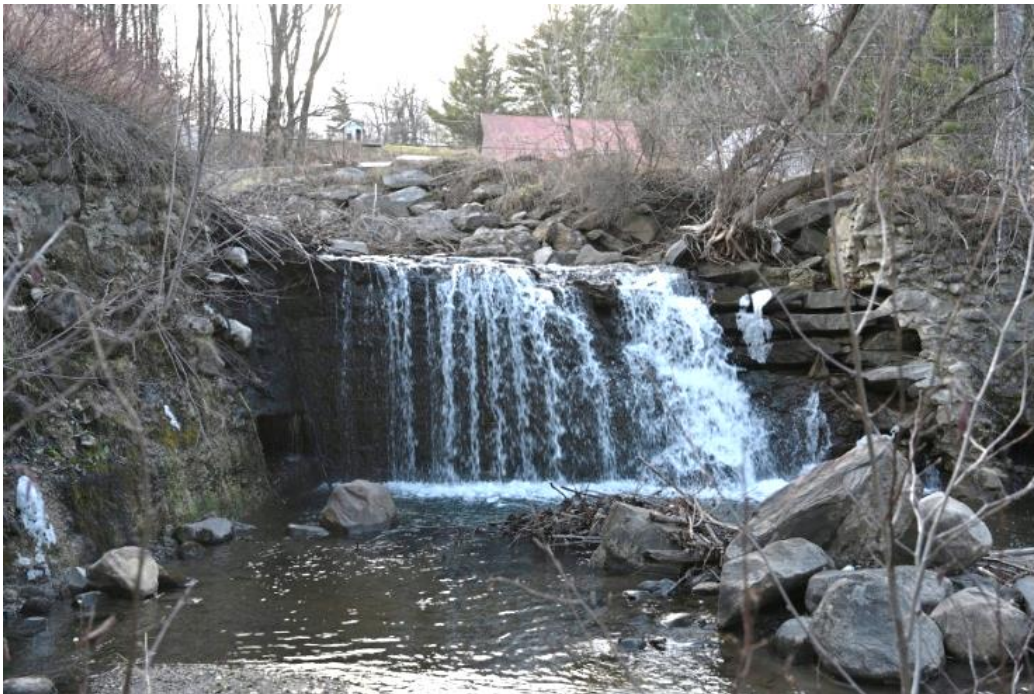
Figure 24. View along the downstream face of the spillway section of the dam (left) at the mill structure (where the water is now flowing), looking west southwest. Note location of the low outlet at the base of the spillway section of the dam, and granite grout fill and parking area visible in the background that covers part of the mill structure as well as the left wing and abutment area of the old dam.

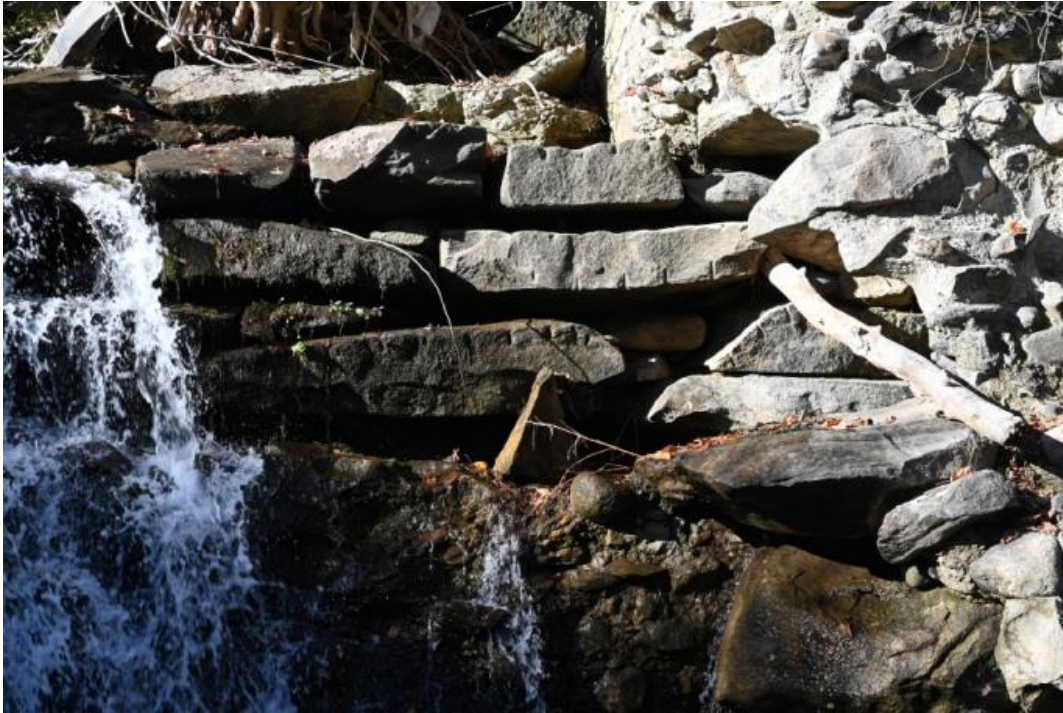
Figure 25. View of quarried stone slabs in the mill structure, looking west southwest.

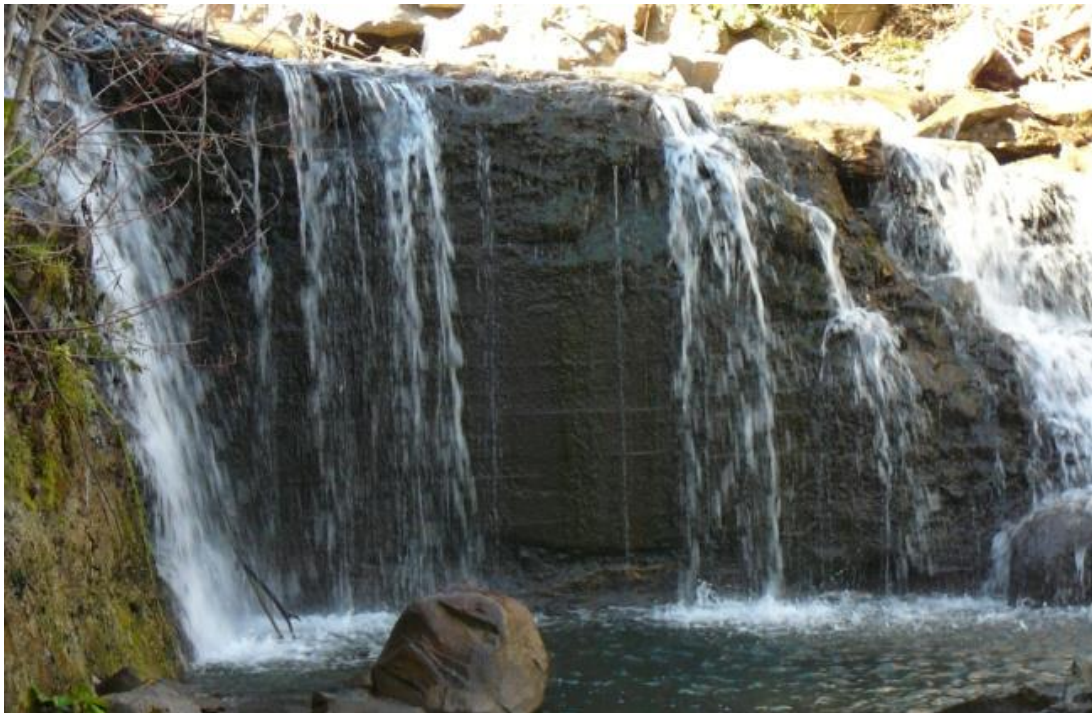
Figure 26. View of the concrete facing on the rough stone wall associated with the east side of the mill, looking west southwest.

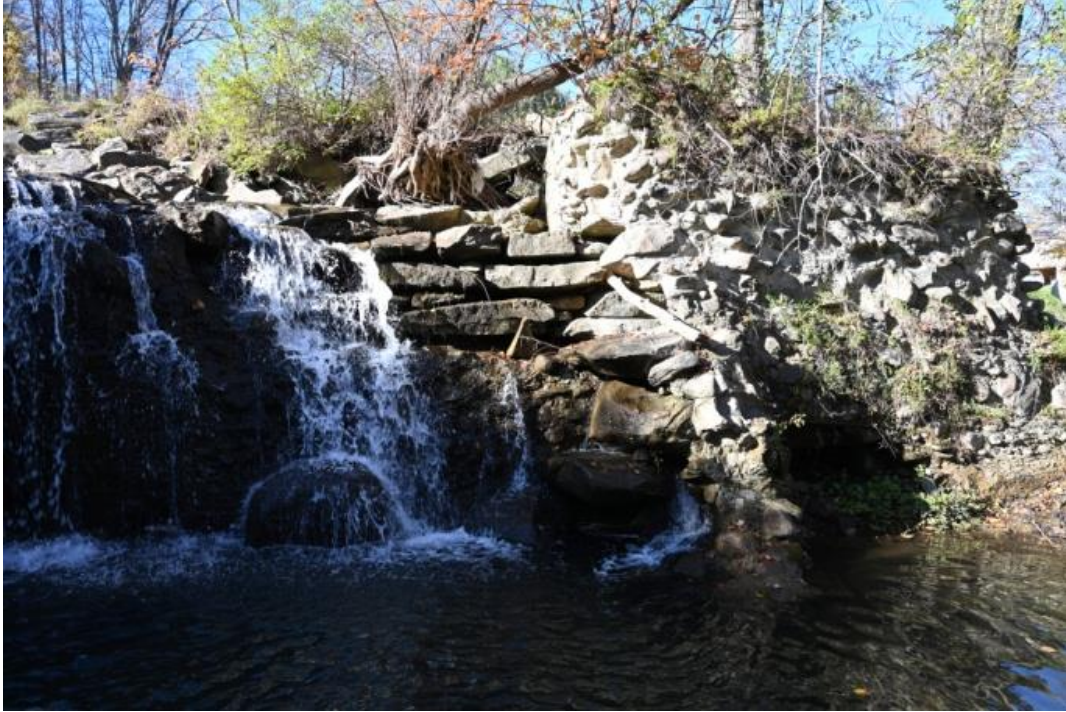
Figure 27. View of a turbine pit structure (at right), looking west northwest.

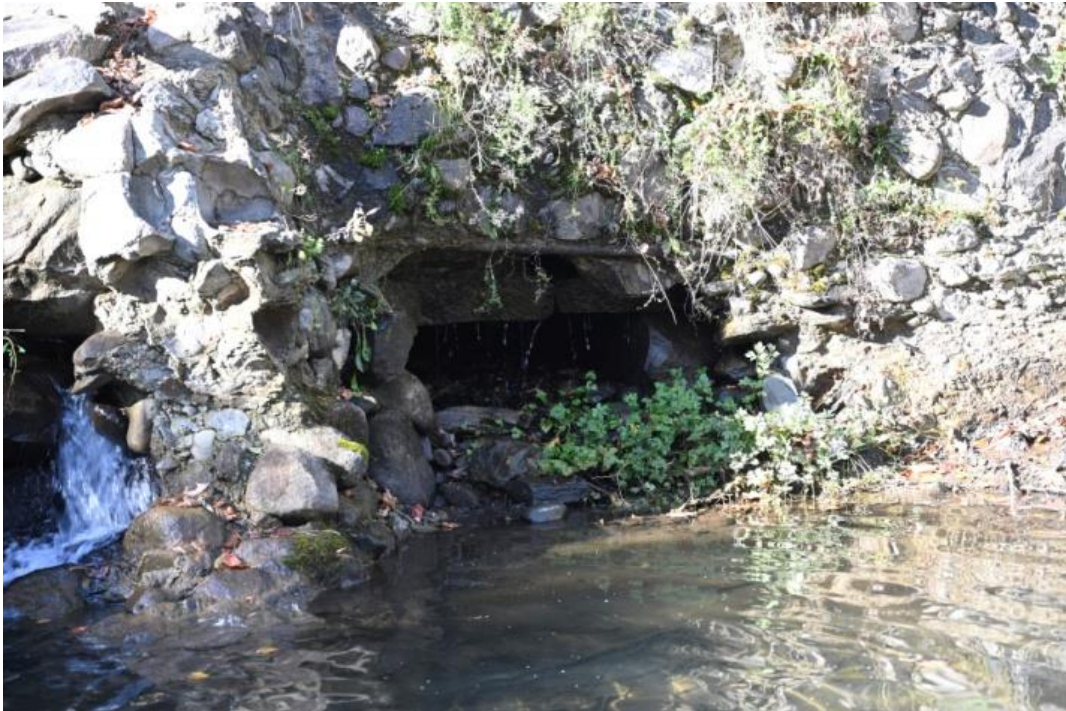
Figure 28. View of the tailrace outlet built into the turbine pit structure, looking west.

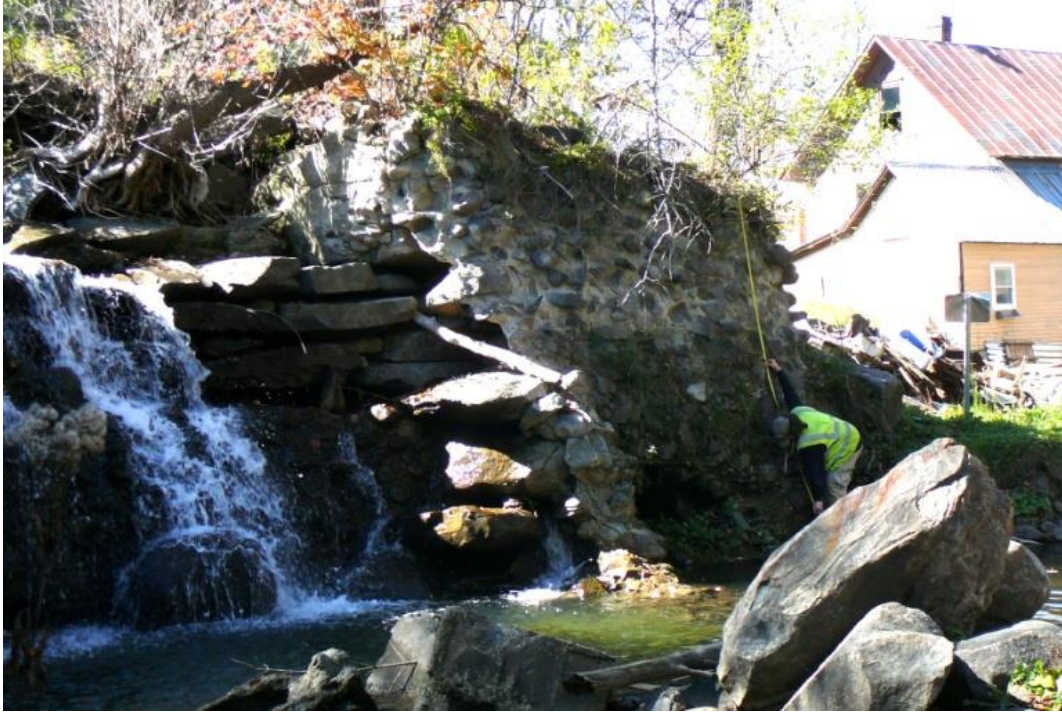
Figure 29. View of the turbine pit structure associated with the mill building, showing the rough stone and concrete ‘shell’ around and above the older structure, looking northwest.

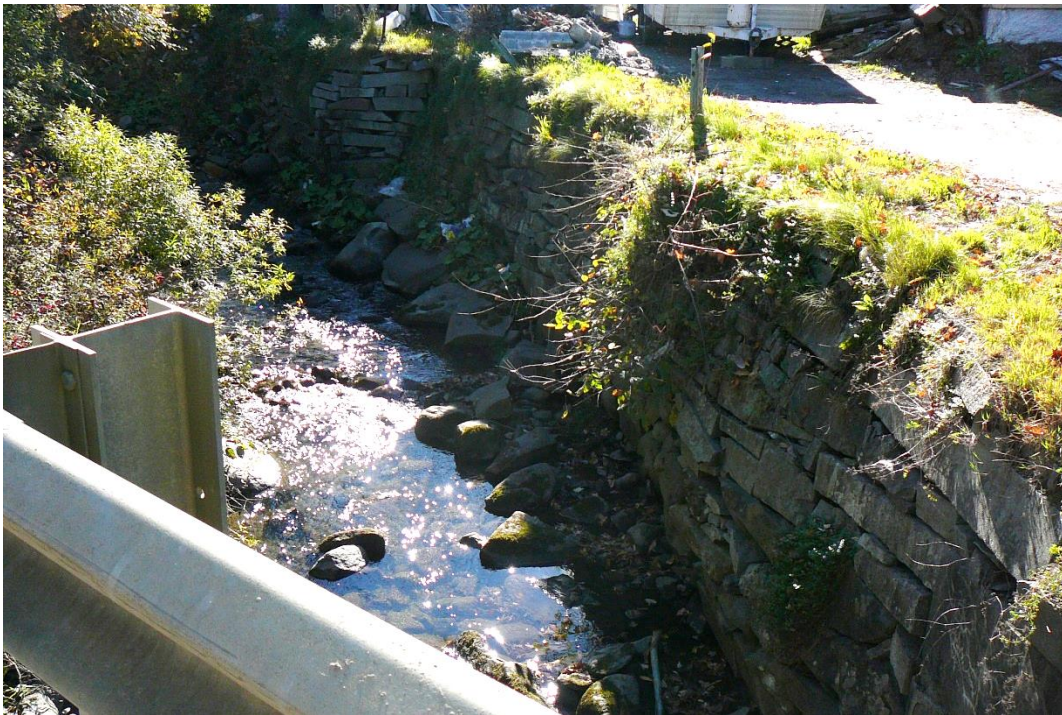
A stone slab wall along the south bank of the Jail Branch, downstream (west) of the dam, may be associated with the dam / mill. It appears to be constructed of quarried stone that is very similar to quarried slabs in the mill structure and is likely a retaining wall to prevent erosion along the river bank. It may also have been constructed to protect the property that the house located northwest of the dam sits upon.

Figure 30. View of quarried stone slab retaining wall along the south bank of the Jail Branch, downstream (west) of the dam, looking southeast.
