30% Design Report: Hands Mill Dam Removal

PROJECT NO.

20-007

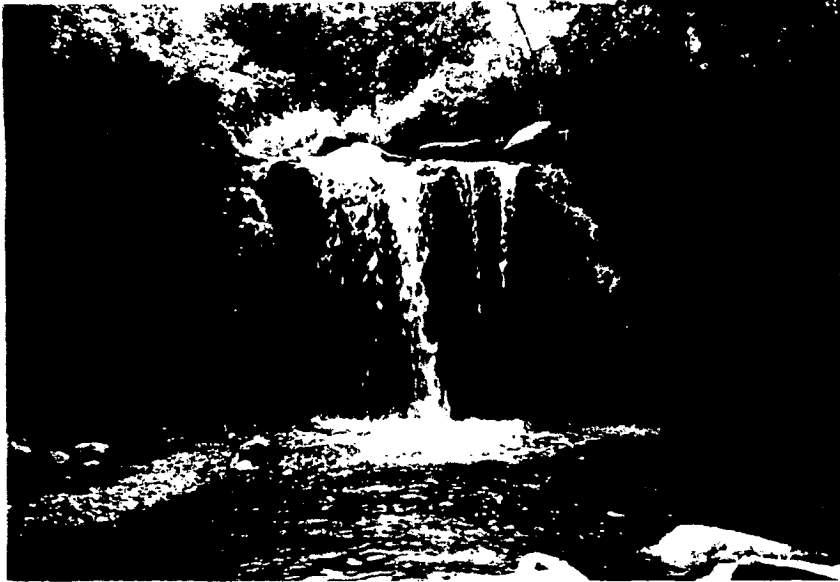
Hands Mill Dam, Washington
2001

Spillway. Note vegetation,
seepage, and concrete
deterioration on walls and
rubble in spillway crest.

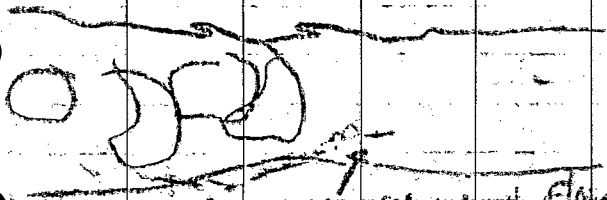
← water flowing
from under rock

right embankment completely
saturated by water (bottom 1/2)

concrete wall flow
broken up

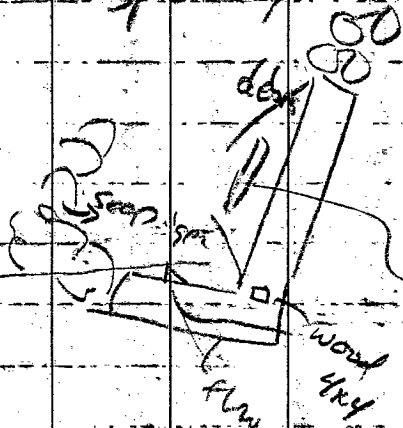
core spalled
up to 12"
deep
sec up
green

end
RT side crest failed
visible d/s wall failed

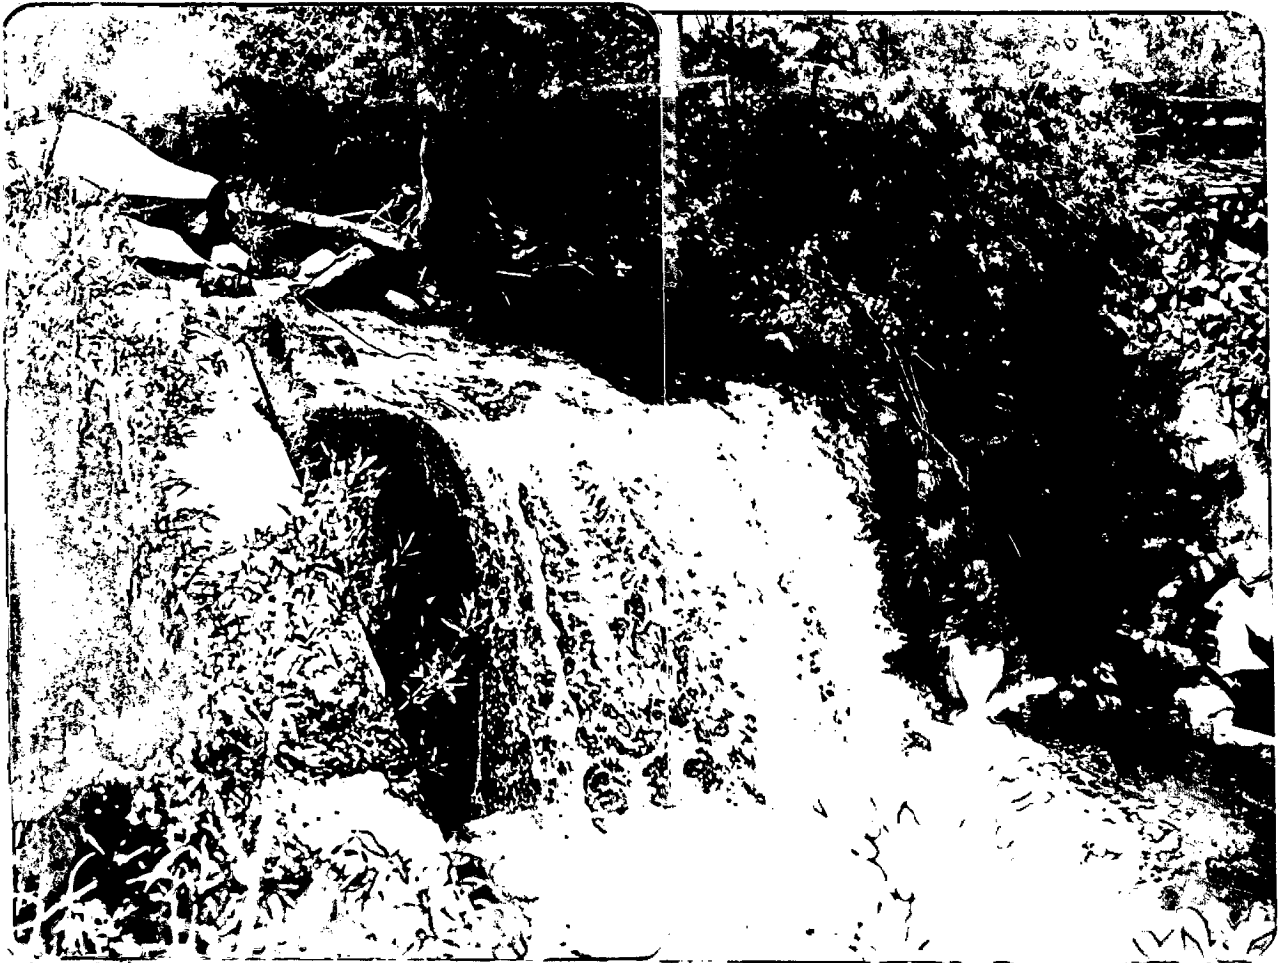
79-15-24 ~~SPILLWAY~~ BREACH

LOOKING DOWN VIS ~~VIEW~~ OF
~~SPILLWAY~~ BREACH TO LEFT OF SPILLWAYS

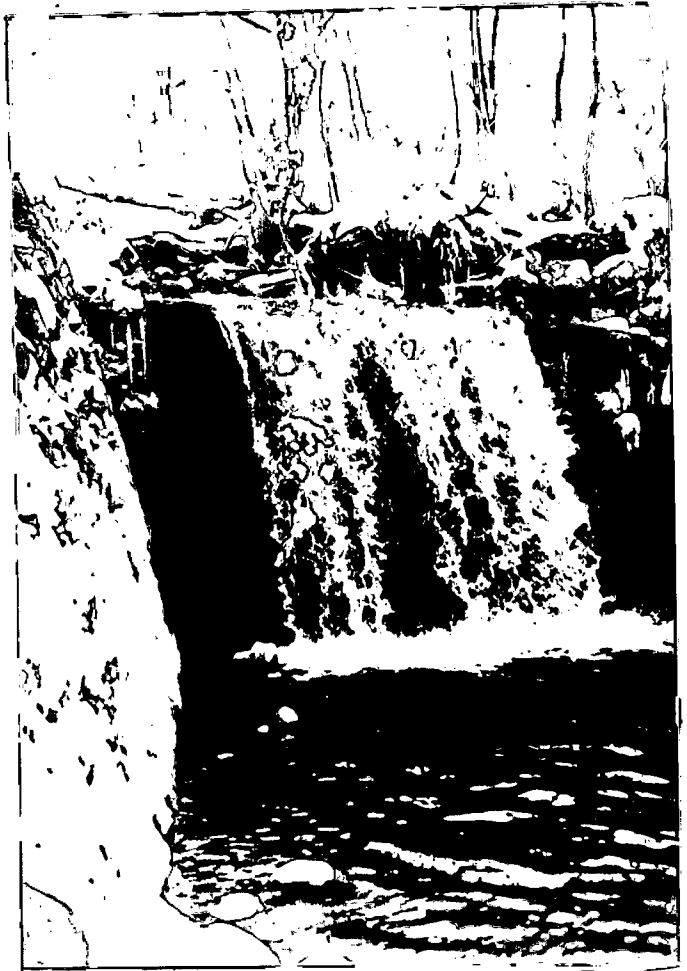
CT-51-30

D/S Face spillway adjacent to breach
