**HISTORIC RESOURCE REVIEW
AND ARCHAEOLOGICAL RESOURCES ASSESSMENT,
HANDS MILL DAM (VT STATE ID #225.01) REMOVAL PROJECT
WASHINGTON, ORANGE COUNTY, VERMONT**

UVM Report No. 1303
December 16, 2020

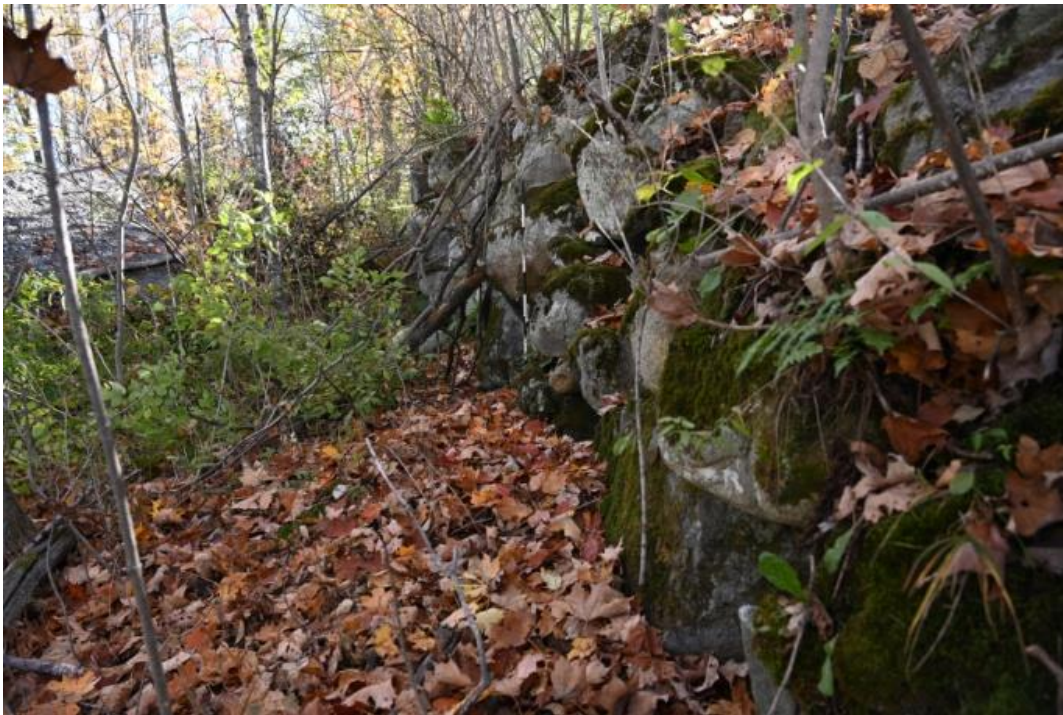
Figure 21. View looking eastwards along the downstream side of the stone faced earth fill section of the dam.

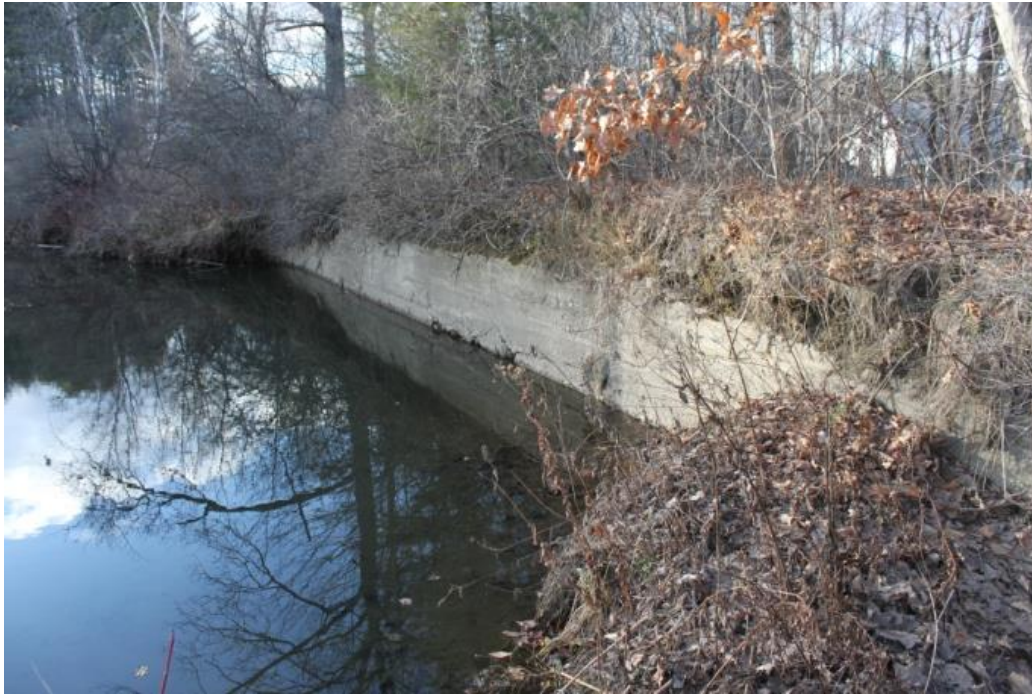
Figure 23. View looking west along the upstream face of the right wing wall / cutoff wall looking towards the spillway section of the dam.

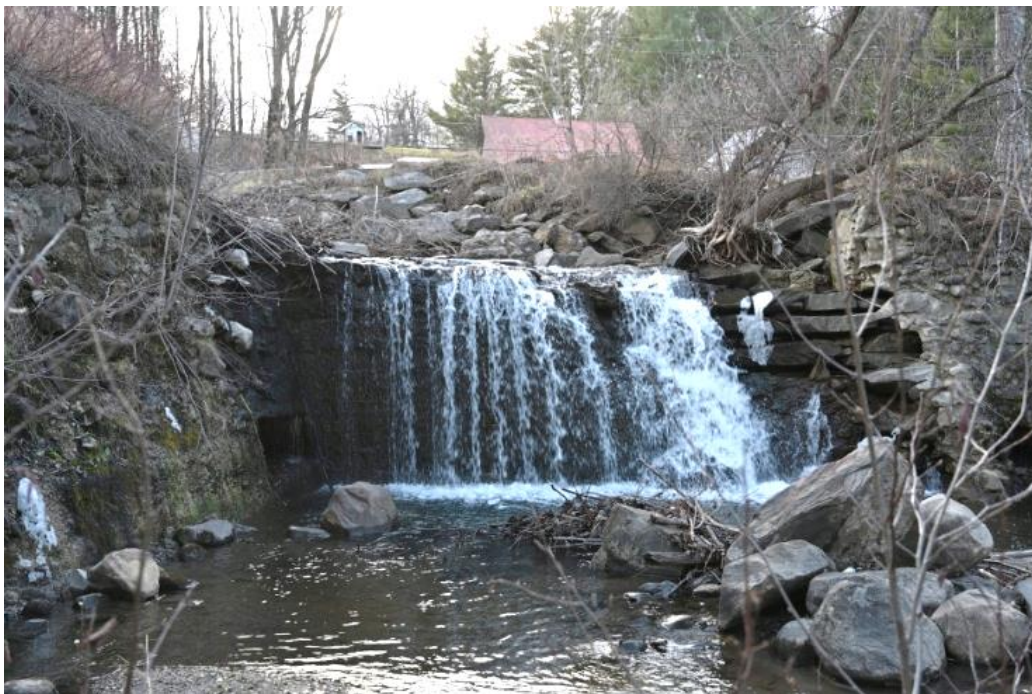
Figure 24. View along the downstream face of the spillway section of the dam (left) at the mill structure (where the water is now flowing), looking west southwest. Note location of the low outlet at the base of the spillway section of the dam, and granite grout fill and parking area visible in the background that covers part of the mill structure as well as the left wing and abutment area of the old dam.
