**HISTORIC RESOURCE REVIEW
AND ARCHAEOLOGICAL RESOURCES ASSESSMENT,
HANDS MILL DAM (VT STATE ID #225.01) REMOVAL PROJECT
WASHINGTON, ORANGE COUNTY, VERMONT**

Kate Kenny
and
Catherine A. Quinn
University of Vermont
Consulting Archaeology Program
111 Delehanty Hall
180 Colchester Avenue
Burlington, VT 05405

UVM Report No. 1303
Revised March 3, 2021

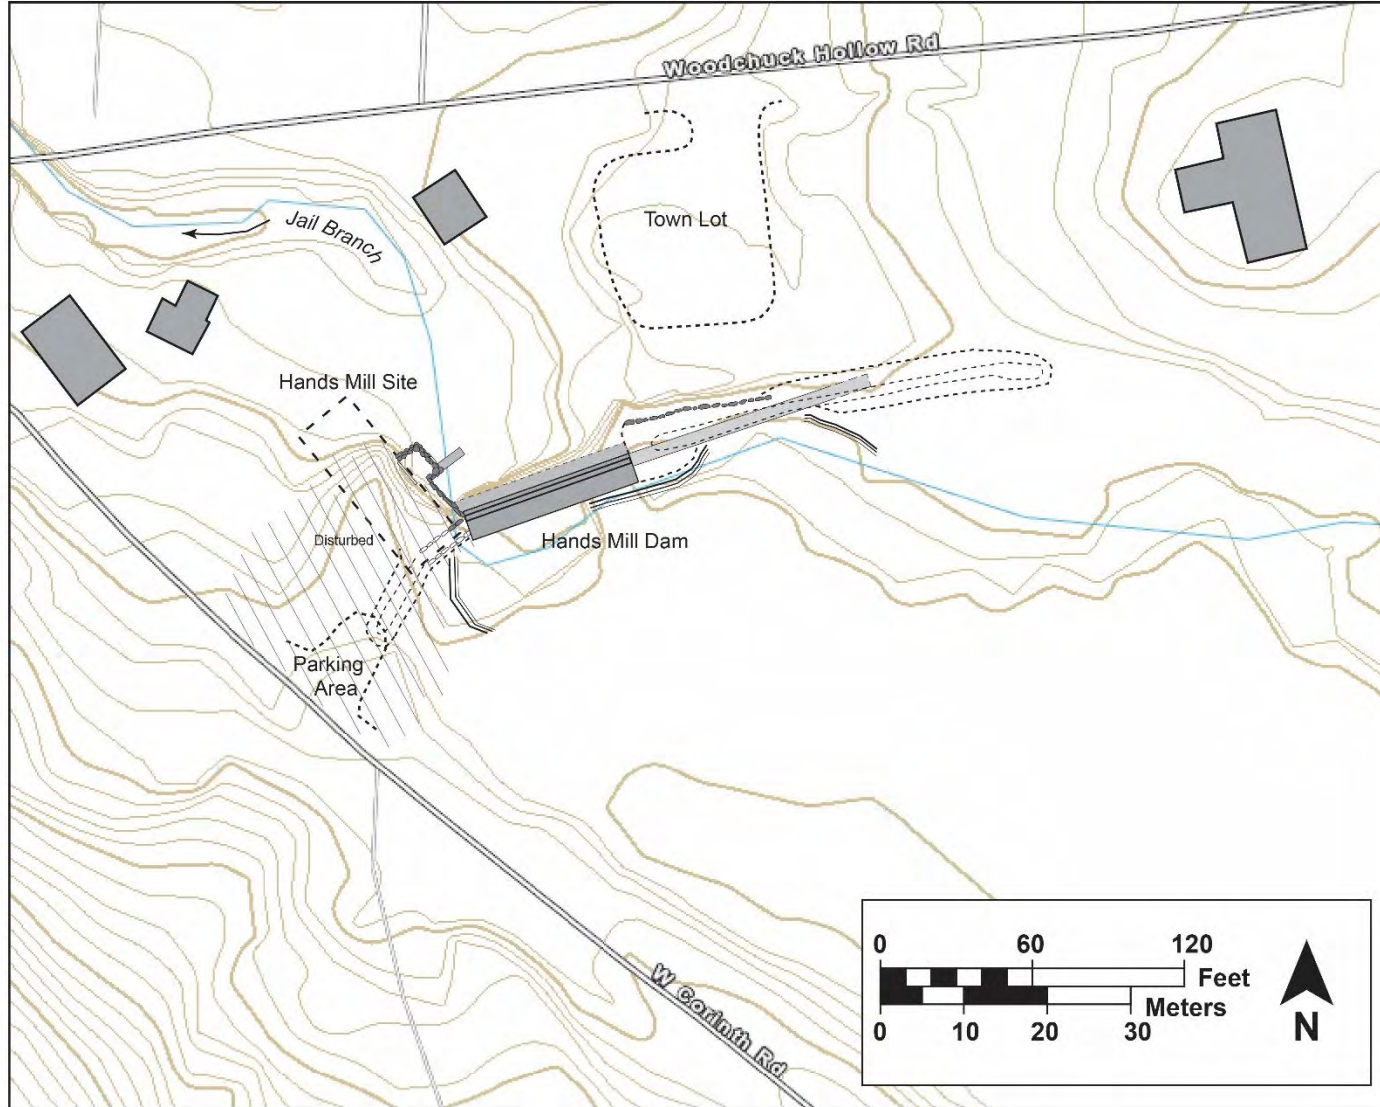
Figure 16. Schematic plan of the Hands Mill Dam site (VT State ID #225.01), Washington, Orange County, Vermont (additional data from <https://vcgi.vermont.gov>).

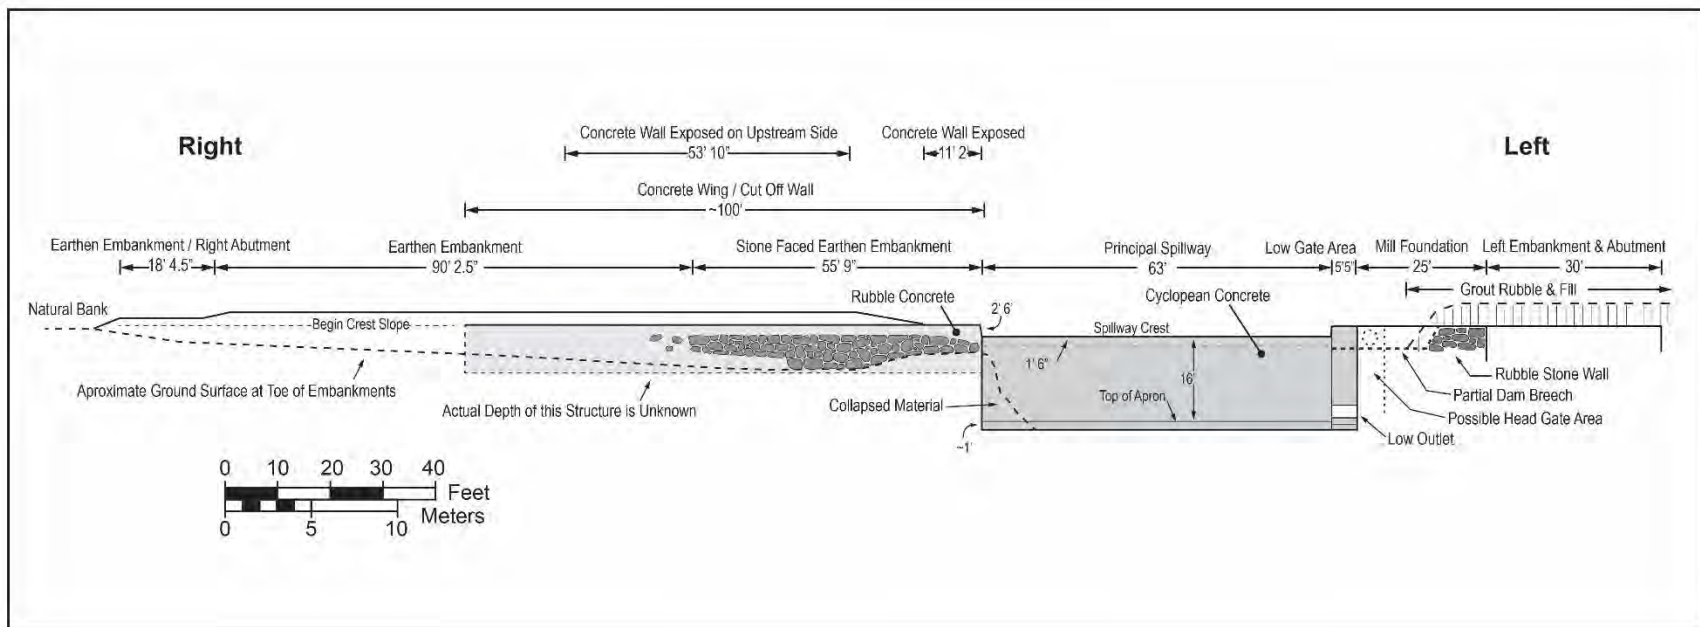
Figure 17. Elevation plan of the Hands Mill Dam (VT State ID #225.01), Washington, Orange County, Vermont (Base map from <https://vcgi.vermont.gov>).

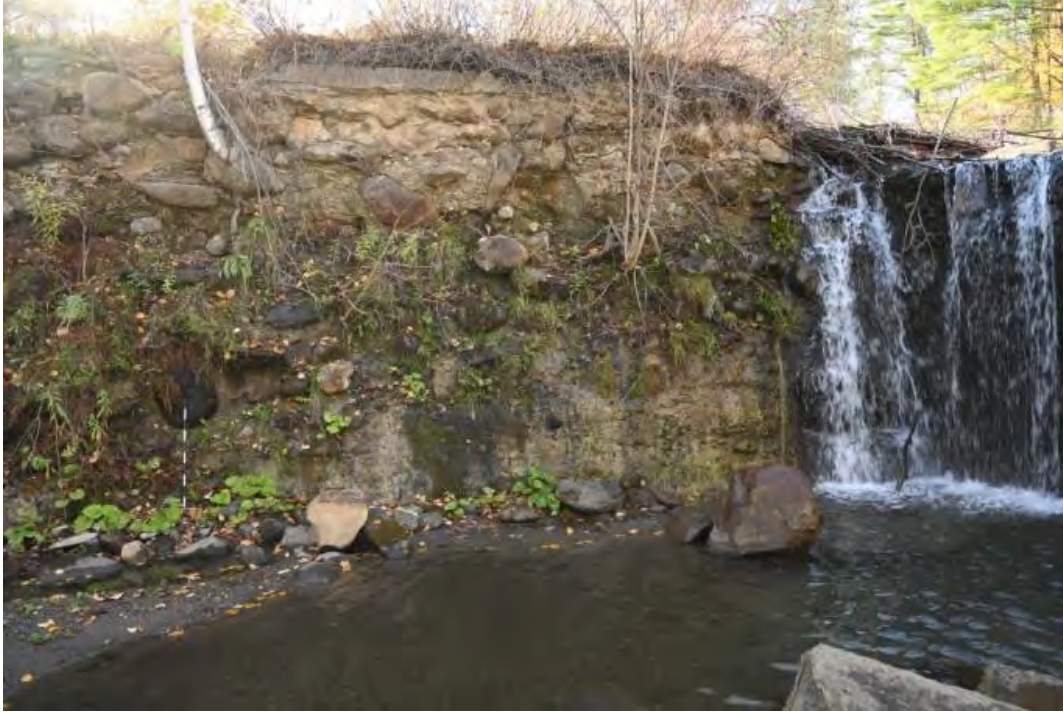
Figure 18. View of the left part of the Hands Mill Dam spillway, looking southwest. Note: top section of the spillway appears to be either a different concrete or a different lift, minimal amount of original surface remaining on the downstream face of the structure, and the exposed interior of the rubble / cyclopean concrete.

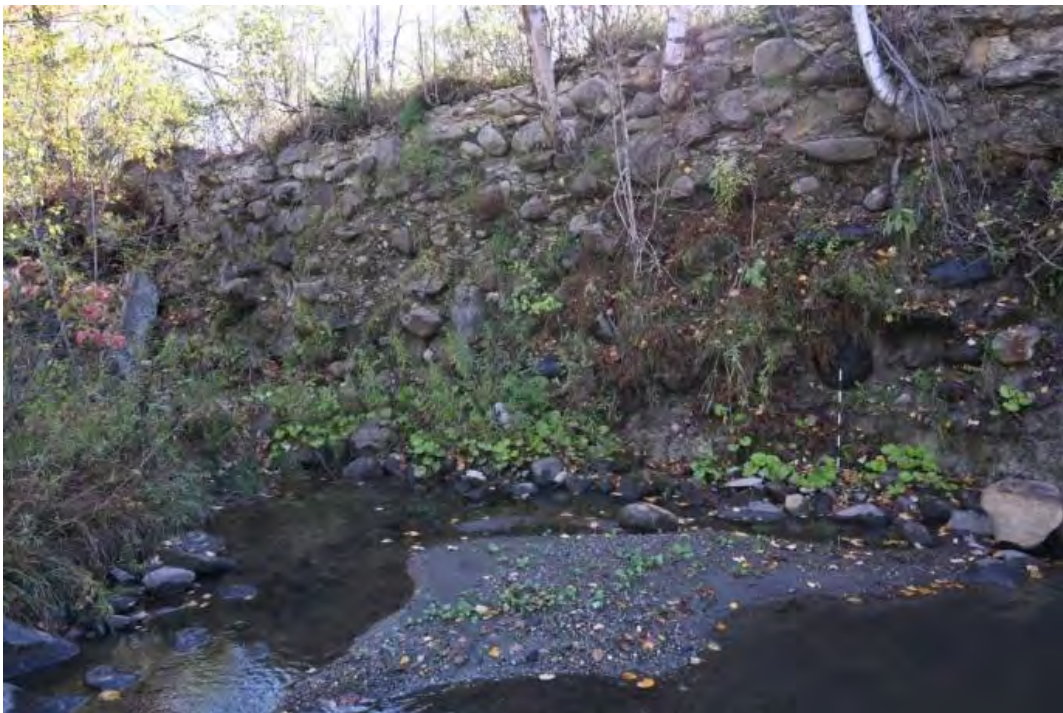
The spillway and low outlet section of the dam is now in poor condition. In 1950, 22 years after construction, this part of the dam was only experiencing “minor surface scaling” (Haybrook 1950:2). Twenty-five years later, or 47 years after construction, the concrete on the downstream face of the spillway was “badly deteriorated” and “severely spalled” (Anonymous 1975a:3). Today, another 45 years on, or 92 years after construction, nearly all of the surface concrete is gone from the air (or downstream) face of the spillway and the concrete core of the structure is crumbling away in small fragments. Water is seeping through the dam and some sizable stones have fallen away (Bushman, Hanna, and Deeing 2016).

Figure 19. View of the right part of the spillway section of the dam, looking southeast.

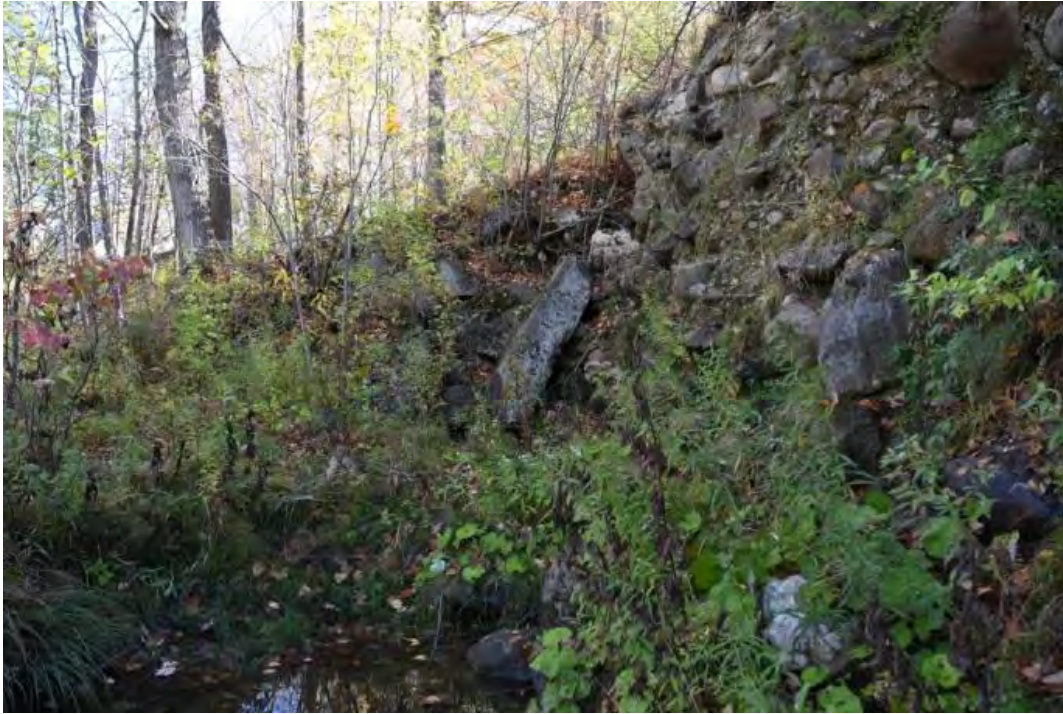
some scour “underneath the apron” (Haybrook 1950:2), and in 1953, Ceretti noted that “although there may be a short apron at the bottom at the spillway the water appears to be quite deep and it is believed some erosion [has] taken place and may be working back under the apron” (Ceretti 1953).

Figure 20. Looking east northeast along the water / downstream face of the spillway section towards the right wing section.

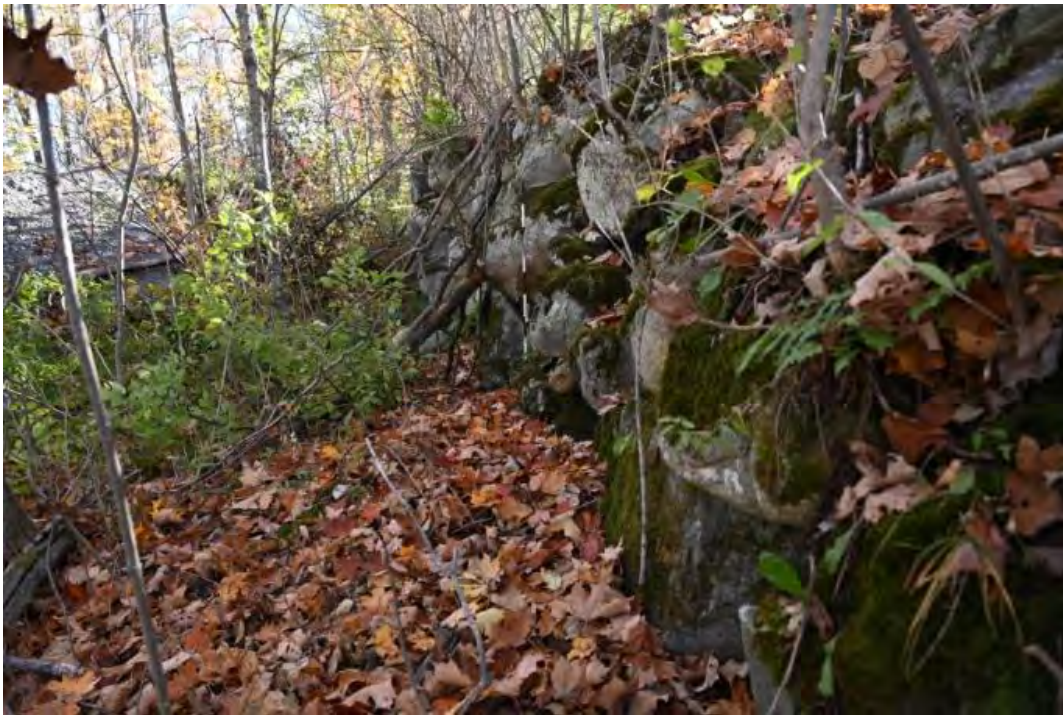
Figure 21. View looking eastwards along the downstream side of the stone faced earth fill section of the dam.

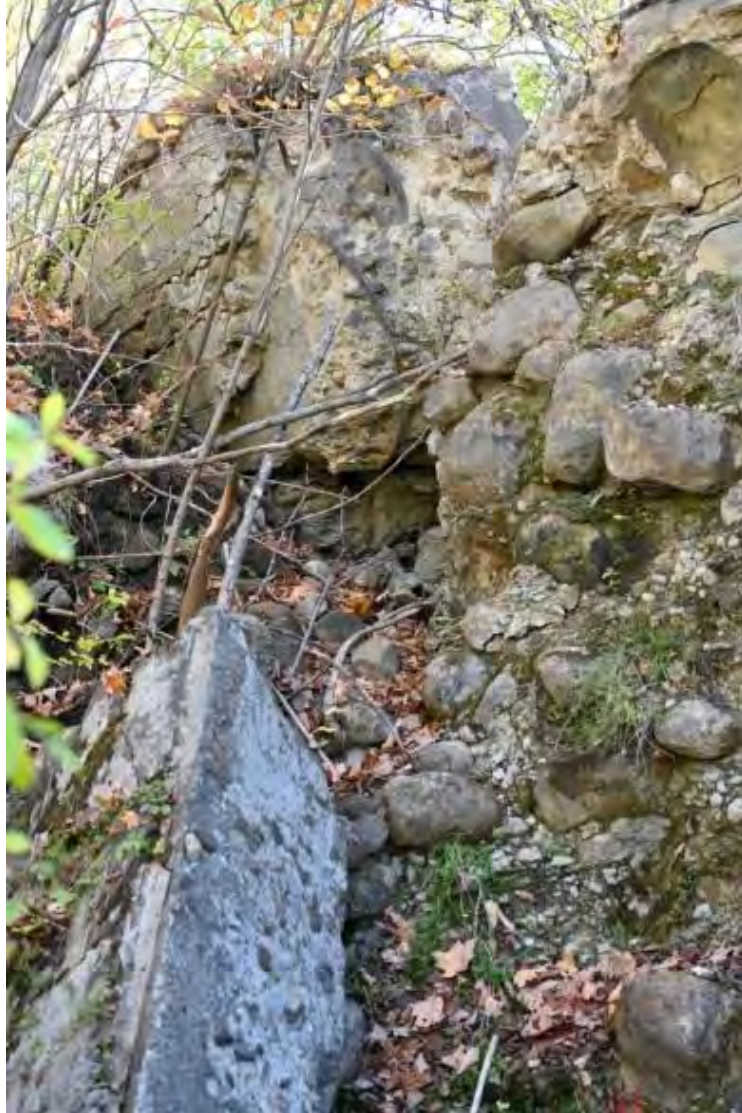
²¹ For example, in 2007, it was reported by state inspectors noted that “there was an exposed concrete cutoff wall near the right end of the dam in a deteriorated condition” (Bushman, Terhhume and Nyebrink 2007). Alternatively, it may simply serve to retain the earthen fill on the upstream side dam and provide a waterproof barrier to protect it.

Figure 22. View of the compromised joint section between the spillway (closer) and the right wing sections of the dam, looking east southeast. The right wing structure is formed of rubble concrete and contains some metal reinforcement, possibly plain round bar and flat scrap metal pieces; this part of the structure also appears to have had another layer of concrete (a facing or a veneer) on its downstream side (two board formed surfaces appear to be visible).

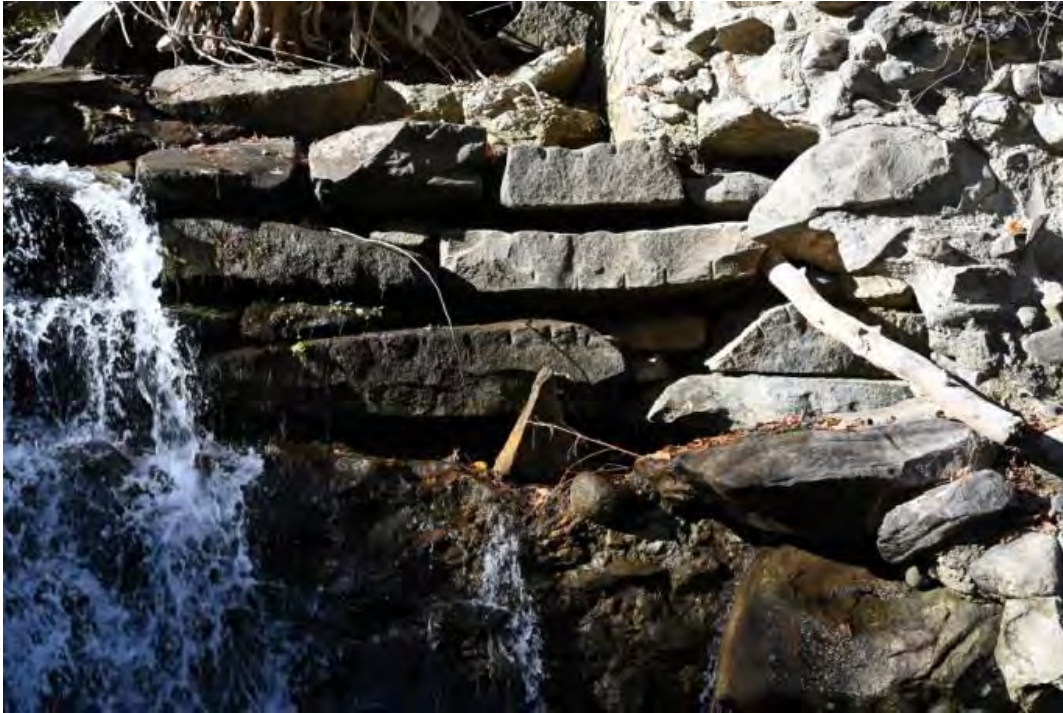
Figure 25. View of quarried stone slabs in the mill structure, looking west southwest.

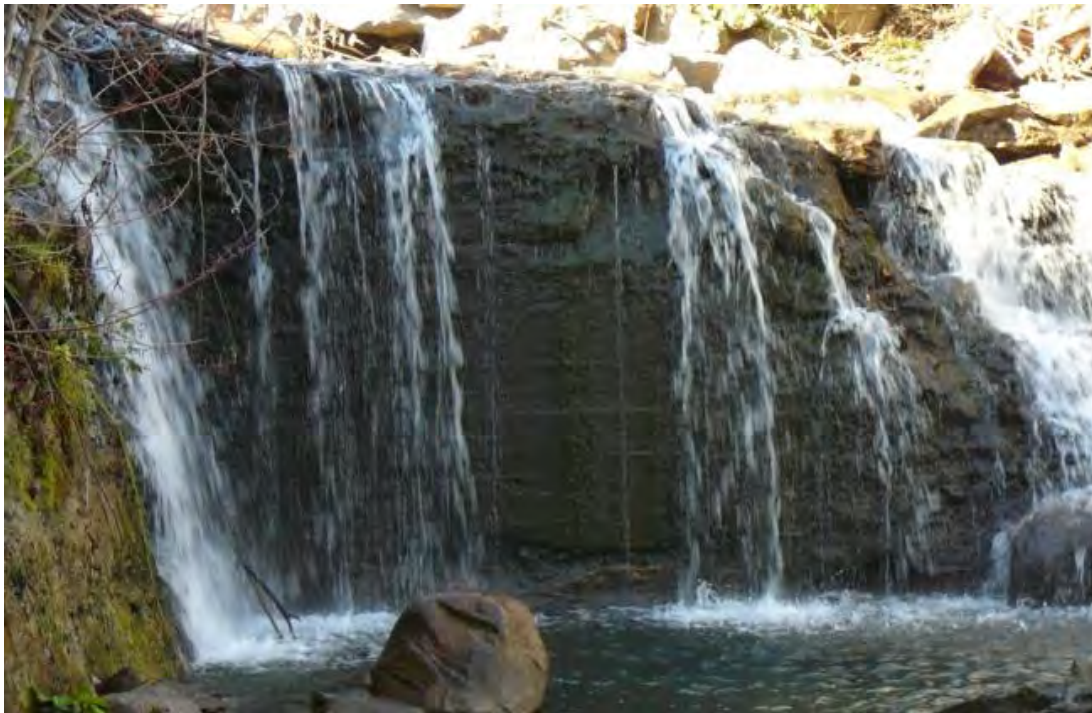
The remaining part of the eastern side of the mill abuts the face of the dam at a point just left of its low outlet and extends north about 21 ft 11 in (6.7 m), a little off the perpendicular from the face of the dam, until it meets the remains of a turbine pit. The eastern section of the mill structure could be a foundation wall and/or a structure related to a flume or penstock. This structure appears to include a stone masonry wall that was subsequently faced by a concrete wall. This concrete facing may have served, in part, as a training wall¹⁶ directing the water flowing below the dam away from the mill structure. Where the concrete has failed, large quarried, but

Figure 26. View of the concrete facing on the rough stone wall associated with the east side of the mill, looking west southwest.

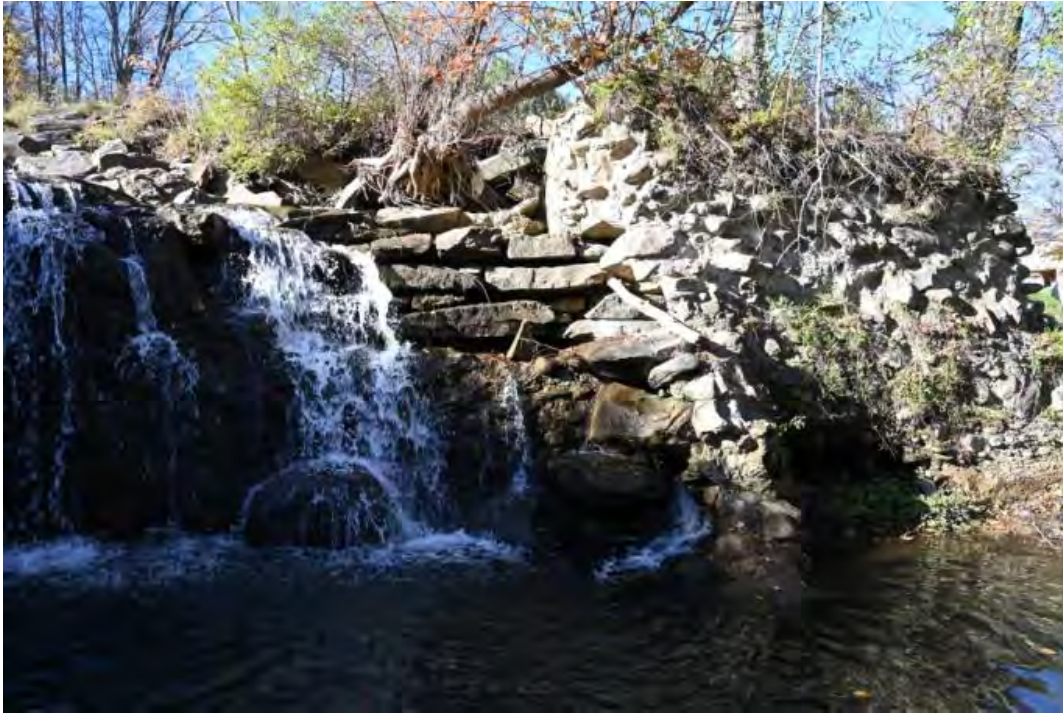
Figure 27. View of a turbine pit structure (at right), looking west northwest.

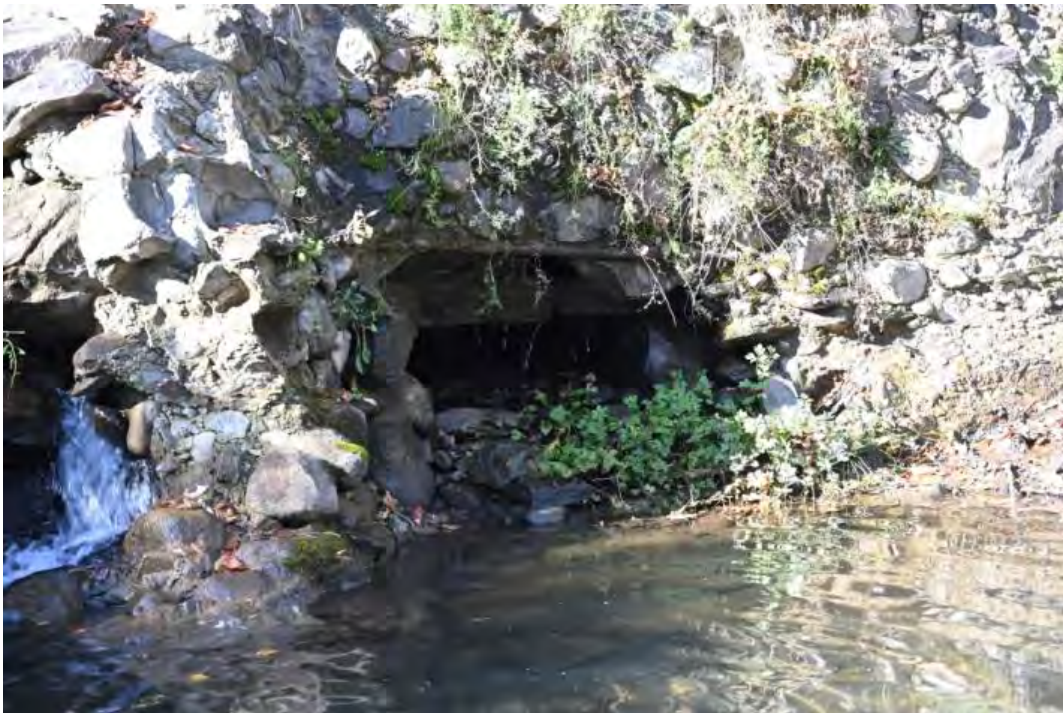
Figure 28. View of the tailrace outlet built into the turbine pit structure, looking west.

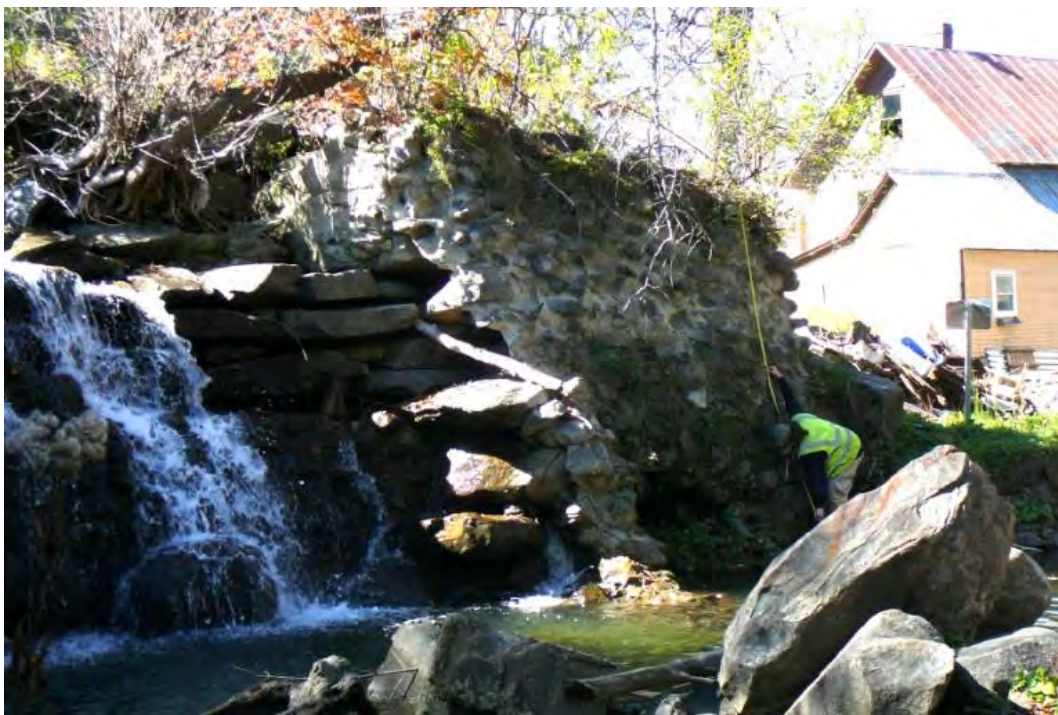
Figure 29. View of the turbine pit structure associated with the mill building, showing the rough stone and concrete 'shell' around and above the older structure, looking northwest.

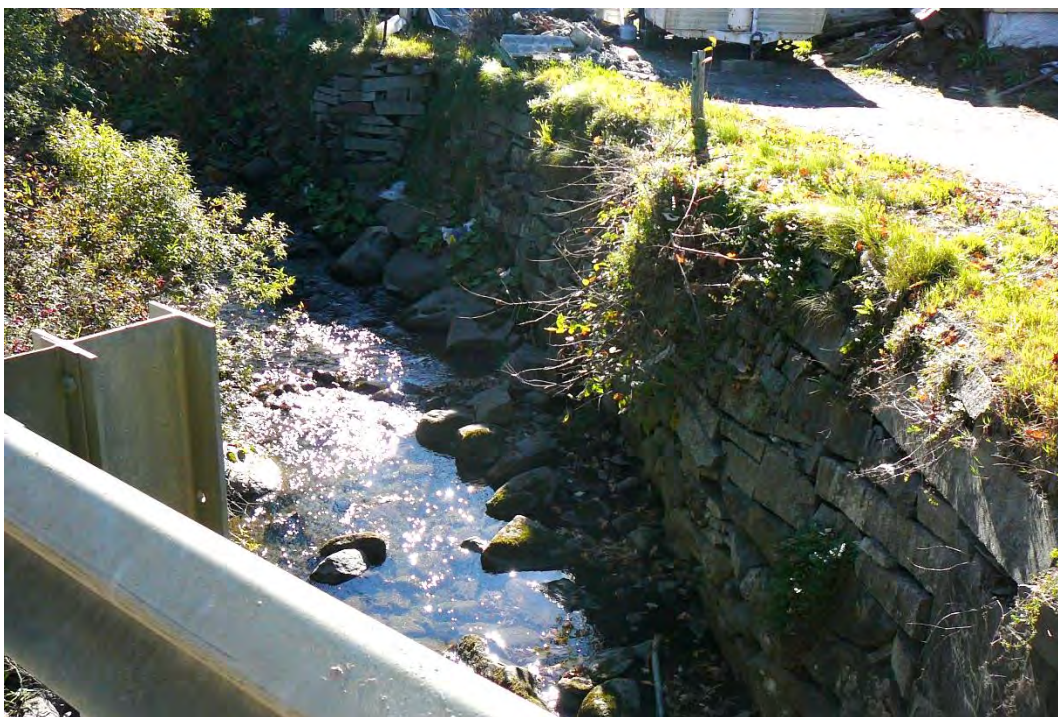
A stone slab wall along the south bank of the Jail Branch, downstream (west) of the dam, may be associated with the dam / mill. It appears to be constructed of quarried stone that is very similar to quarried slabs in the mill structure and is likely a retaining wall to prevent erosion along the river bank. It may also have been constructed to protect the property that the house located northwest of the dam sits upon.

Figure 30. View of quarried stone slab retaining wall along the south bank of the Jail Branch, downstream (west) of the dam, looking southeast.
