To: Gianna Petito, District Manager, Winooski Natural Resources Conservation District

From: Gabe Bolin, PE, Meghan Arpino, Stone Environmental, Inc.

Stone Project No. 20-007 Subject: Hands Mill Dam Removal – Field Investigations and Modeling Summary Memo

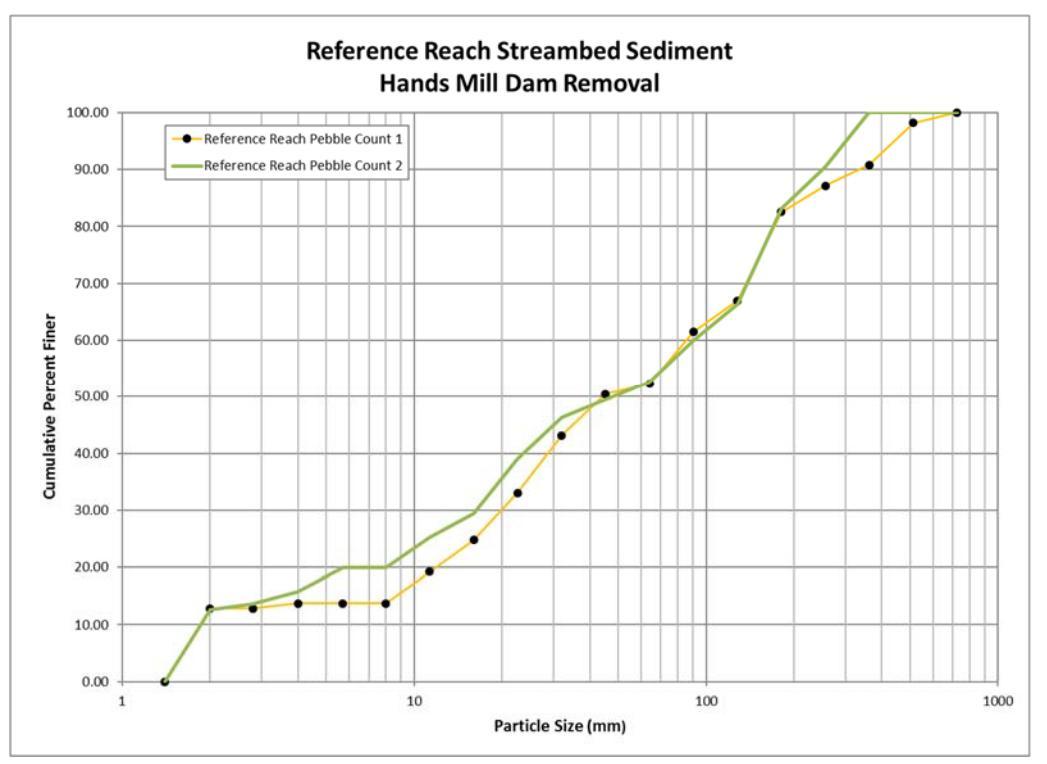
pebble counts were performed in the reference reach as well. The purpose of these counts is to characterize the gradation of the bed material, or distribution of different sized stones within the bed matrix. A plot of the count date as a grain size distribution is provided as Figure 1.

Figure 1. Grain size distribution plots for two pebble counts in the reference reach along Jail Branch.

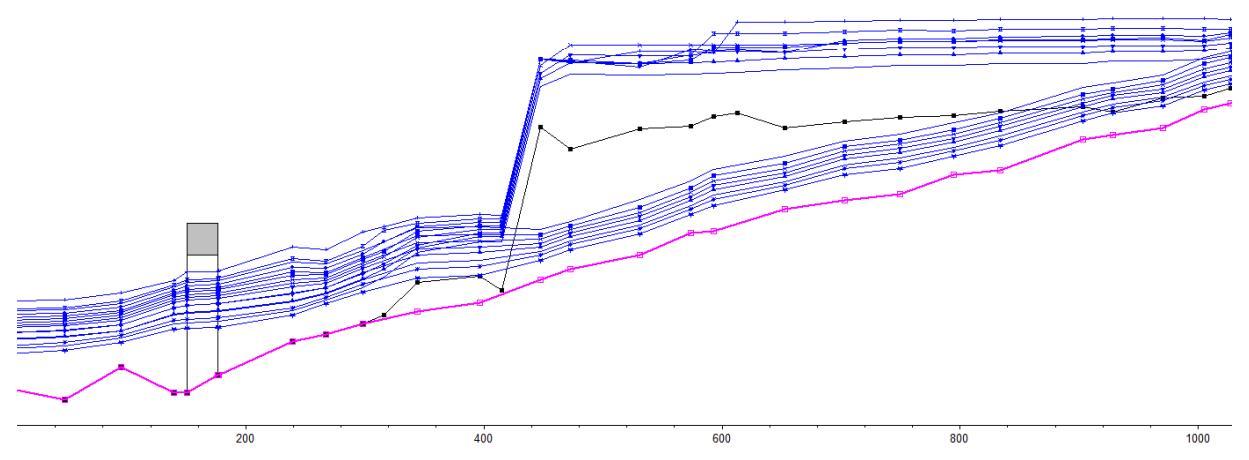
The hydraulic analysis completed for the existing conditions provides insight into the expected water surface elevations, water velocities, flood inundation limits, and barriers to fish passage for the flow scenarios analyzed. A longitudinal profile for existing conditions, including water surface elevations for specific flow scenarios, is provided as Figure 2.

Table 9 below provides a comparison of the 100-year recurrence interval flood water surface elevations at the dam for the existing condition and Alternative A3. Figure 2 provides a plot of water surface elevations for the existing condition and proposed condition, for Alternative A3. Note that the stream thalweg for the existing condition is black, and the thalweg for A3 is pink.

Figure 2. Profile of HEC-RAS output showing water surface elevations for existing and proposed conditions. Water surface elevations (blue lines) that follow pilot channel thalweg (pink line) are storm peak flow water surfaces following dam removal.

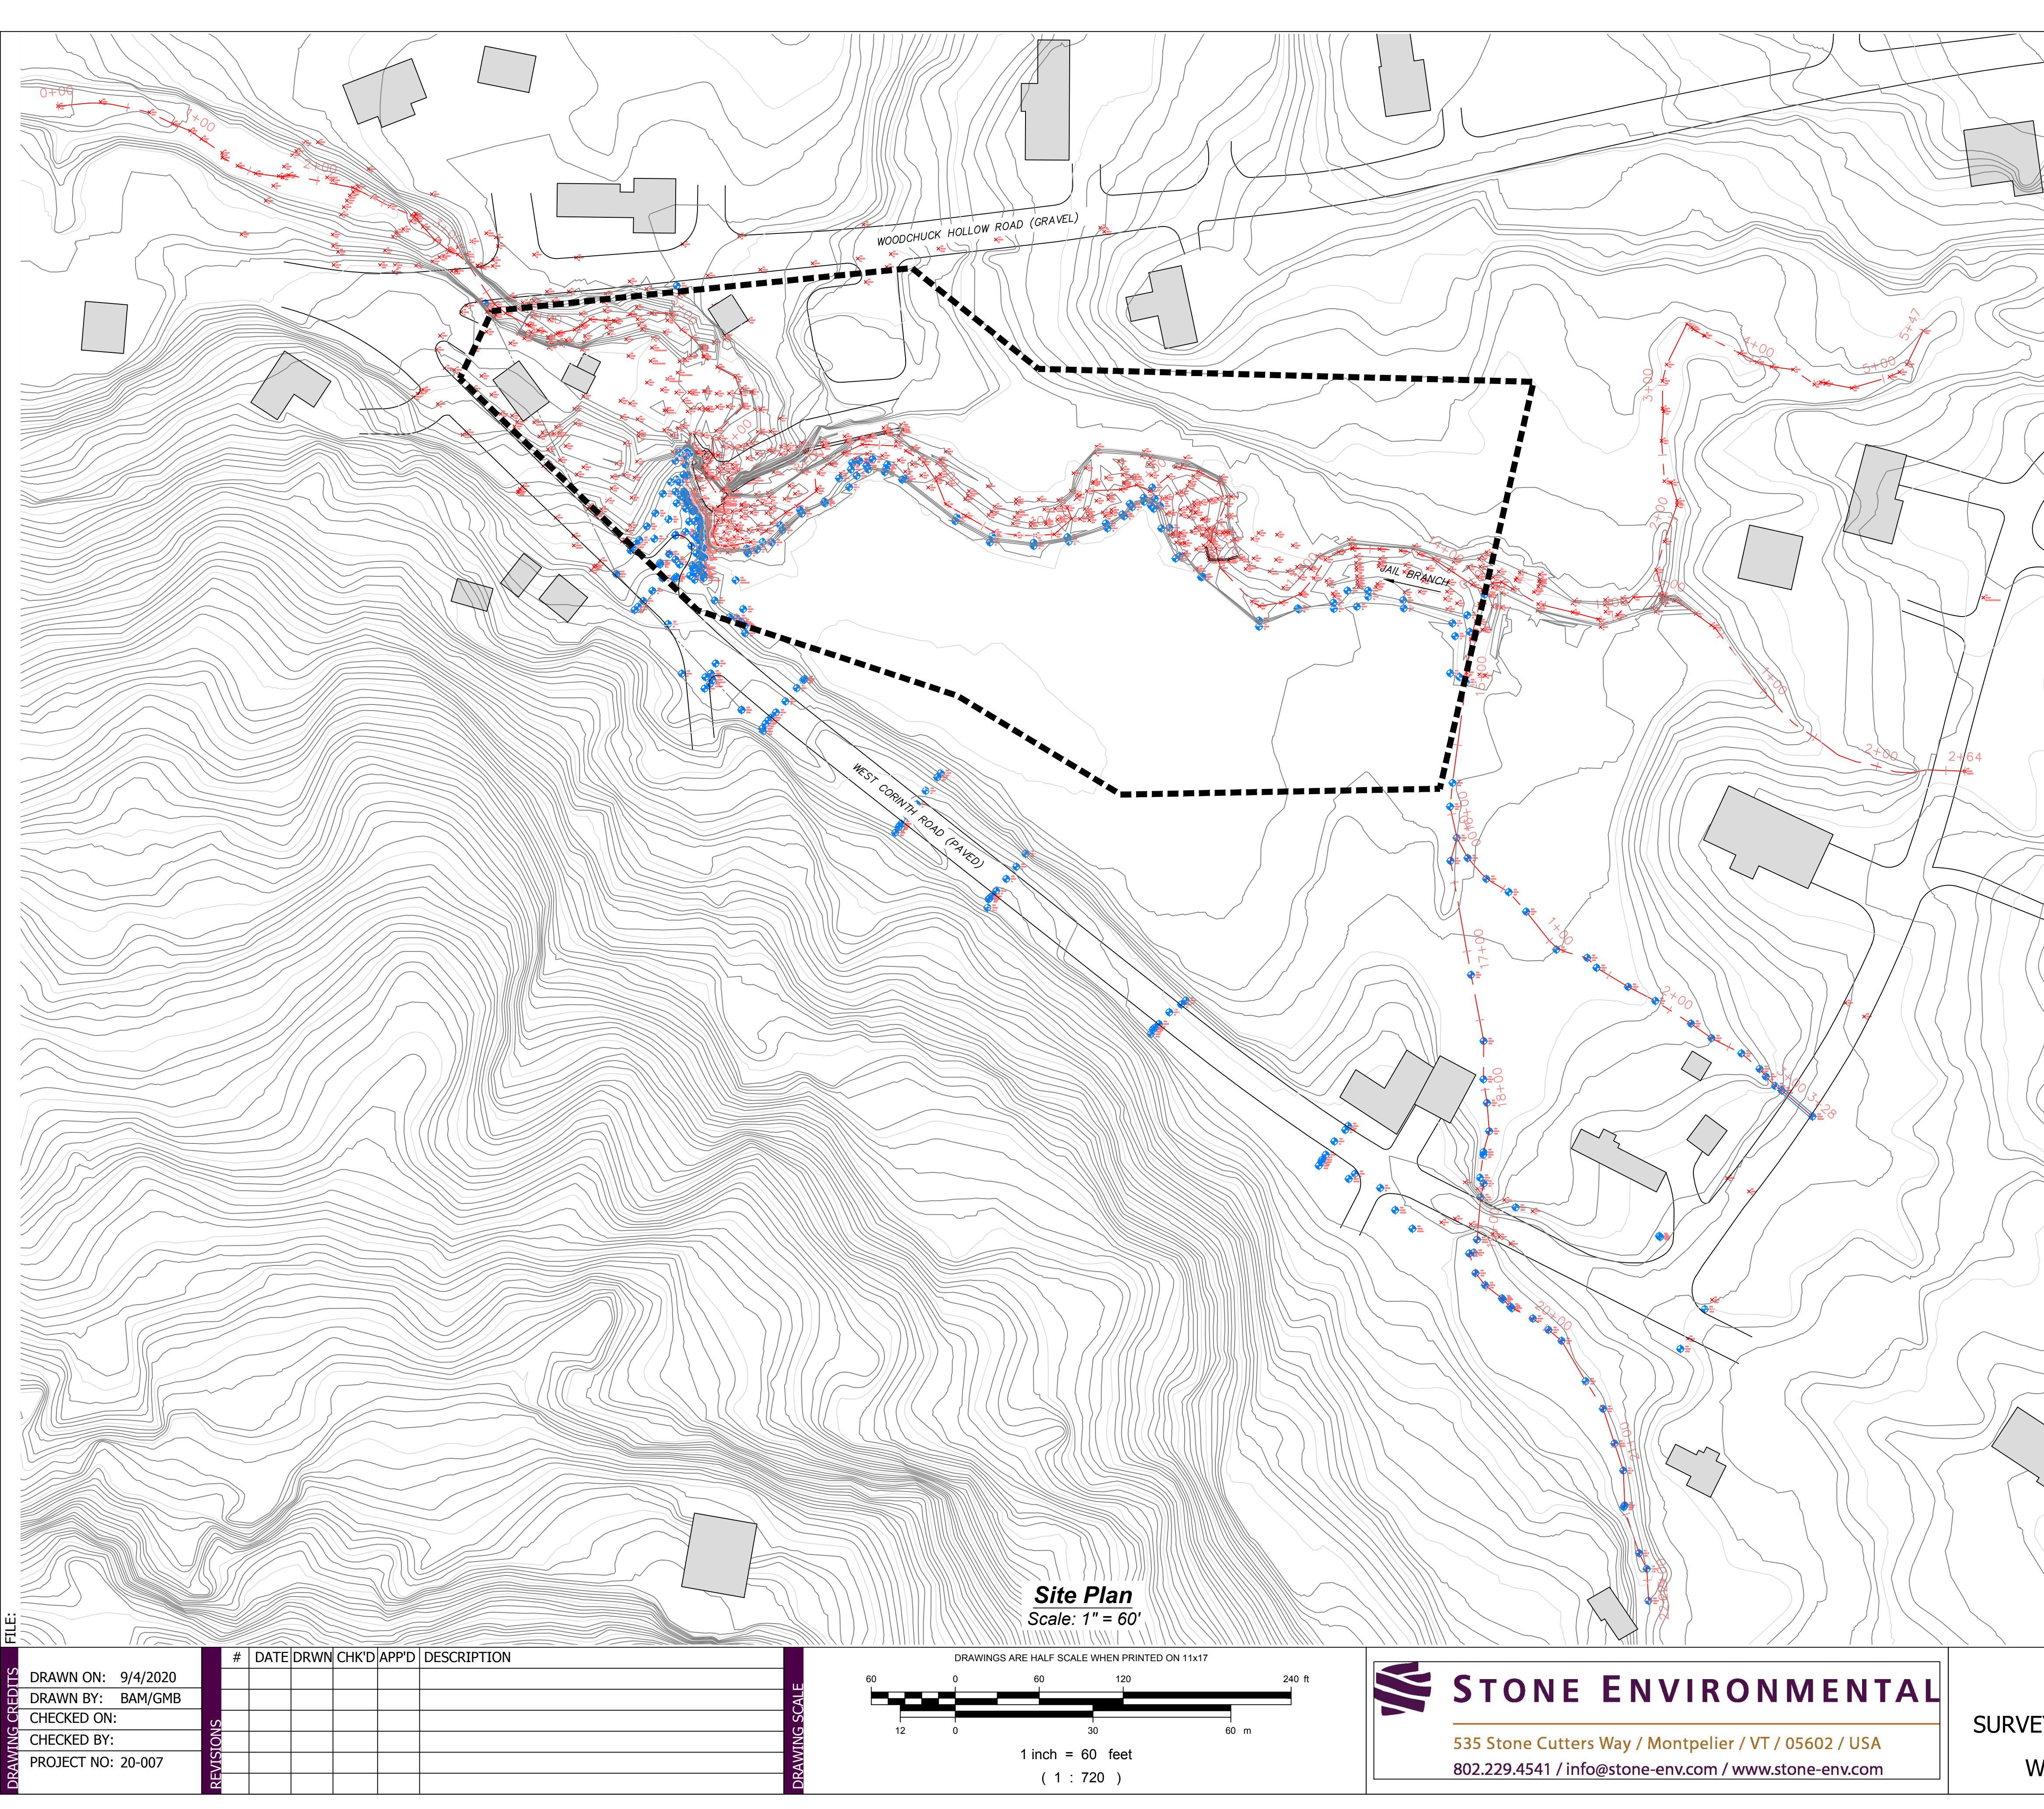
HANDS MILL DAM REMOVAL AT JAIL BRANCH SURVEY EXTENTS PLAN AND LIMITS OF DISTURBANCE

The extent of the survey data is shown on Sheet 1. Approximately 2,200 feet of longitudinal profile was collected along Jail Branch, including reference reaches upstream of the site, down to a few hundred feet beyond the bridge at Woodchuck Hollow Road. Approximately 500 feet of longitudinal profile of the unnamed tributary to Jail Branch, conveying flow from the northeast was surveyed, along with two additional tributaries conveying flow from the west up to Vermette Road. Typical features collected as part of the longitudinal profiles specific to fish habitat included top and bottom of steps, pool head and tail crest, maximum pool depth, riffle head and tail, etc. Longitudinal profile data is used to define reach slopes, which is a primary dataset in designing the pilot channel; therefore a large amount of this data was collected as part of the survey.

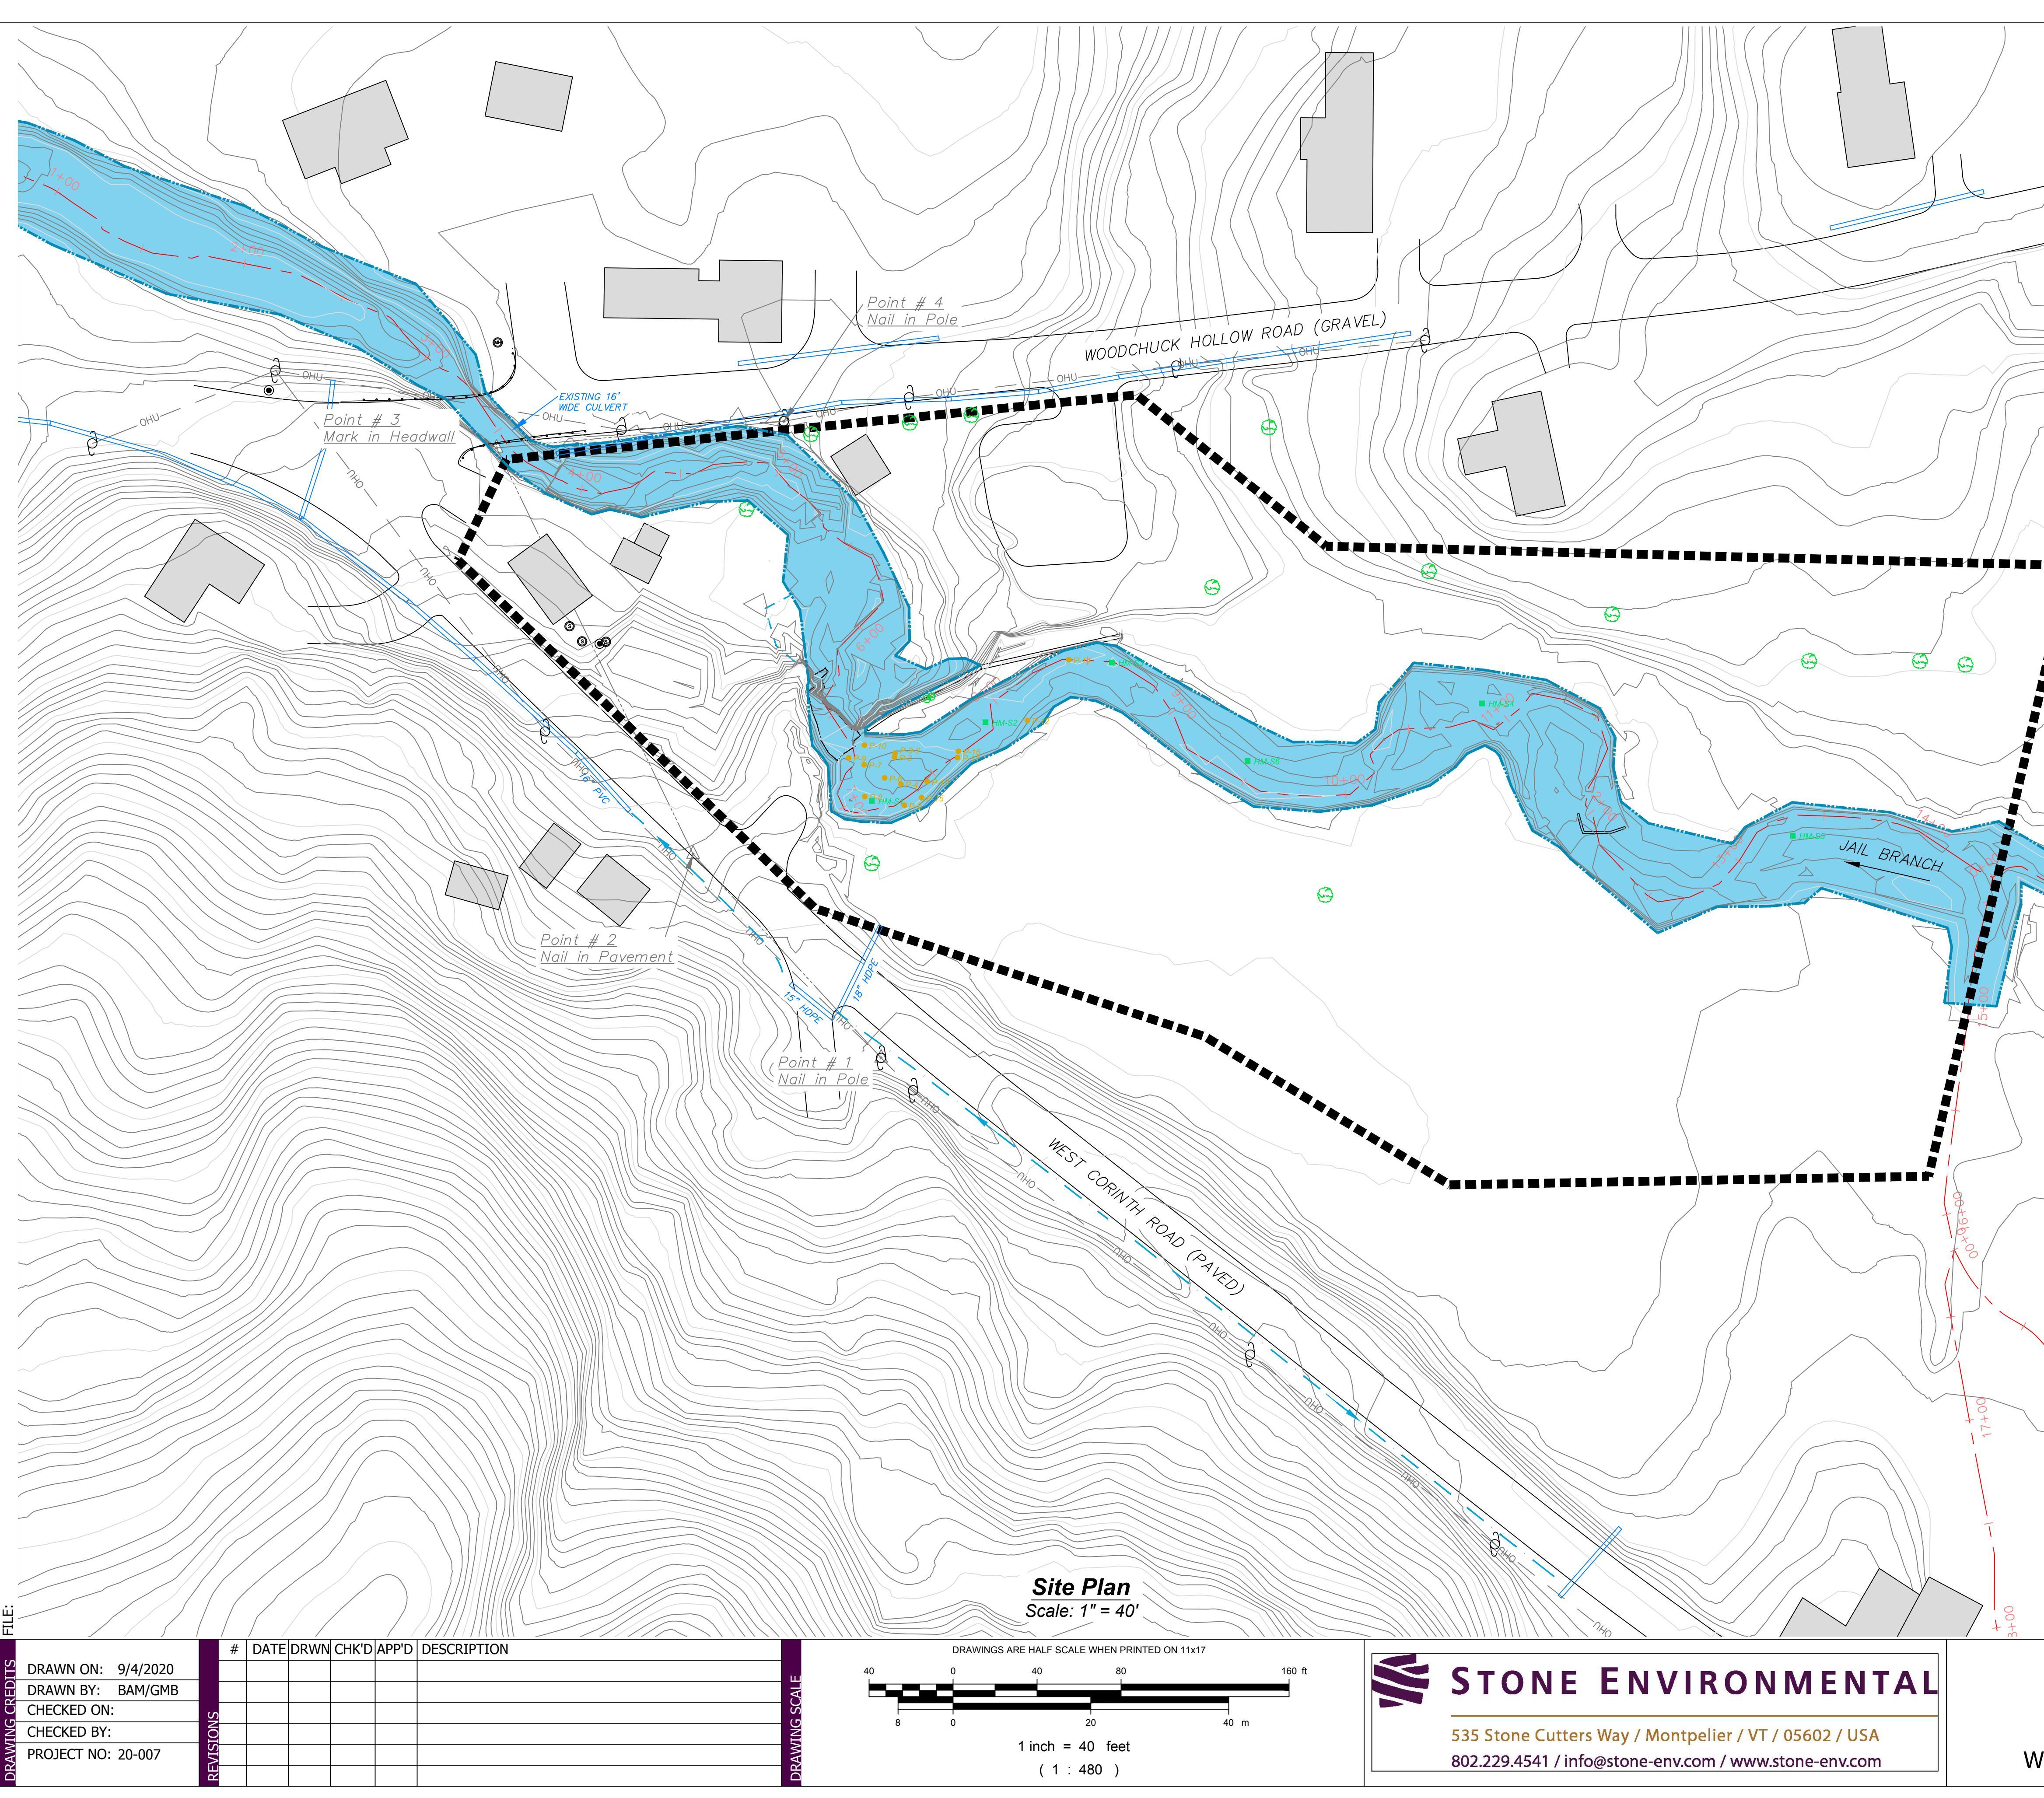
HANDS MILL DAM REMOVAL AT JAIL BRANCH EXISTING CONDITIONS

Approximate locations of these trees are provided on Sheet 2. Some of the details in Table 2 above require refinements. Due to limited time during the topographic survey and other field work, and due to difficulty in accessing some of these trees due to dense floodplain vegetation, some of the information in this table is an estimate (i.e. dbh, species, etc.) and/or has been acquired by remote surveys. Refinements will take place prior to completion of 30% designs.

Stone established four control points throughout the site, all of which were established in the vicinity of the dam and downstream bridge. Locations and descriptions of control points are provided on Sheet 2 and were set in road pavement, at utility poles and at the downstream bridge headwall. As a quality control measure, Stone regularly checked back to control points to assess equipment precision and data accuracy. Any discrepancies found to be over 0.1 feet resulted in resurveying of relevant data.
