MEMO

Stone Project No. 20-007
Subject: Hands Mill Dam Removal – BCA Analysis Memo

TO: Town of Washington, Care of Carol Davis, Town Clerk, Dam Owner
FROM: Benjamin Green, PE, Dam Safety Program (DSP), Engineer
Katherine King, DSP, Assistant
DATE: November 18, 2020
SUBJECT: DSS-Wise Lite Dam Failure Analysis and Flood Inundation Maps
Hands Mill Dam, Washington, Vermont
State ID No: 225.01 | National ID No: VT00308

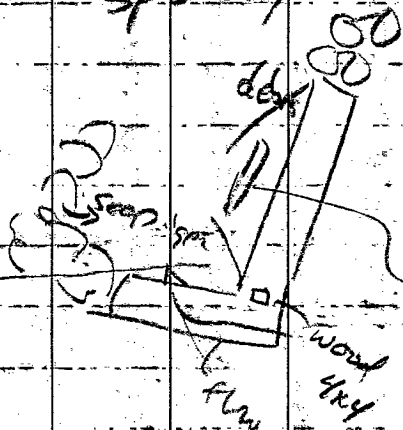
core spalled
up to 12"
deep
sec up
generally

end
RT side crest failed
visible d/s wall failed

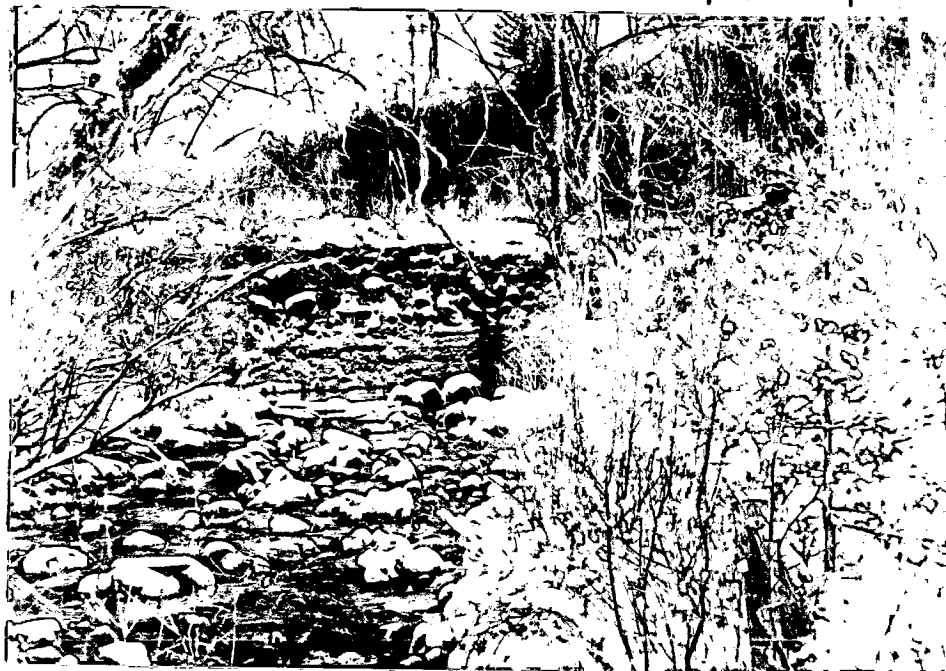
84-51-36 Breach at left end of spillway.
