Shady Rill Picnic Area Floodplain Restoration Design

Middlesex, Vermont

Final Report
July 13, 2018

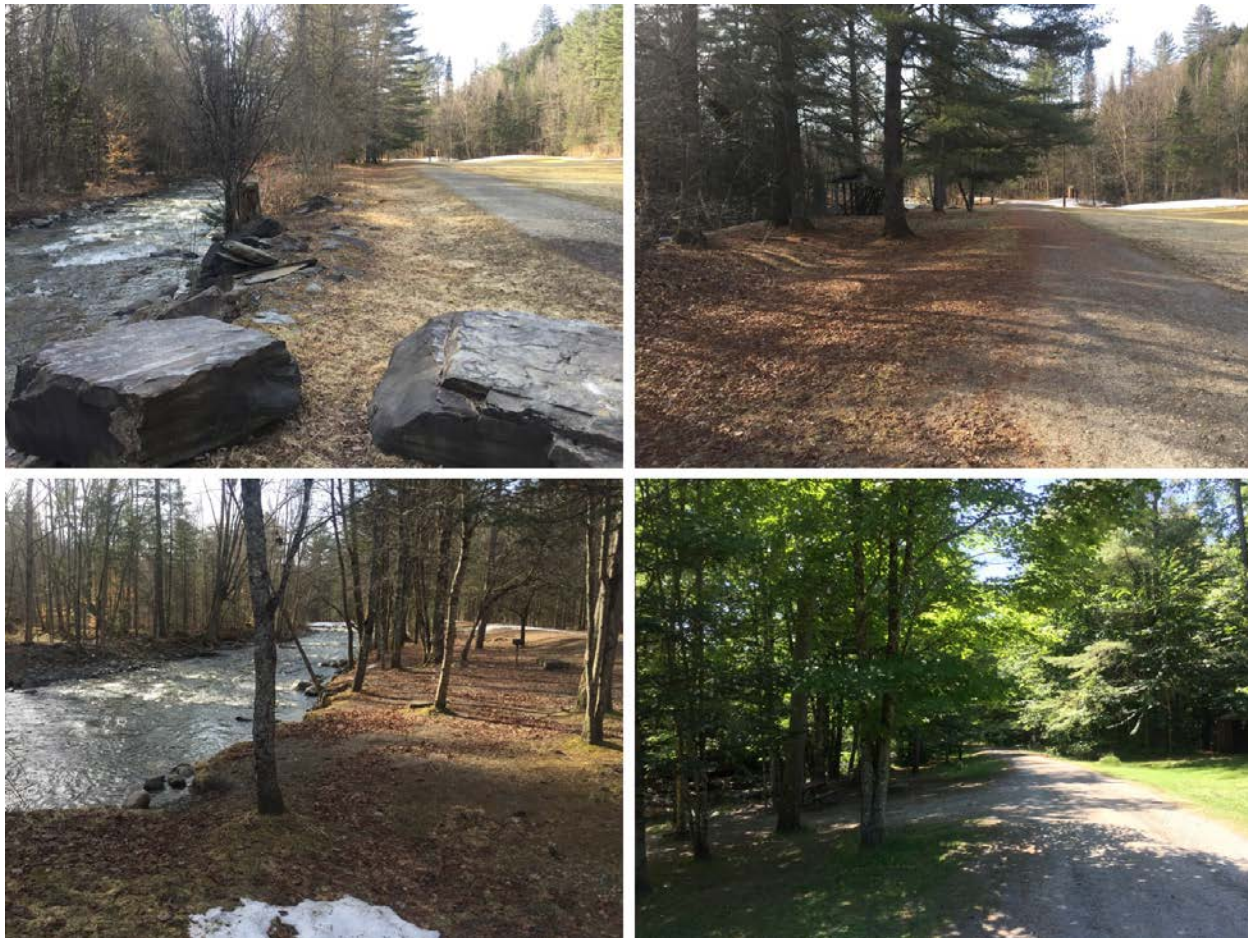
The majority of the Shady Rill Picnic Area lies within the mapped river corridor and is within the Federal Emergency Management (FEMA) flood hazard area with a 1% annual chance of flooding (see Appendix A-1 for a map showing these boundaries). As such, the riparian area along this section of Martins Brook should be well vegetated with a robust riparian buffer. However, the site lacks an adequate buffer and is very compacted along the river's banks due to unrestricted access to the river's riparian zone and heavy use of the picnic areas along the river bank (Figure 2).

Figure 2. Unrestrained access to the river and well-used picnic sites along the stream bank have led to soil compaction.

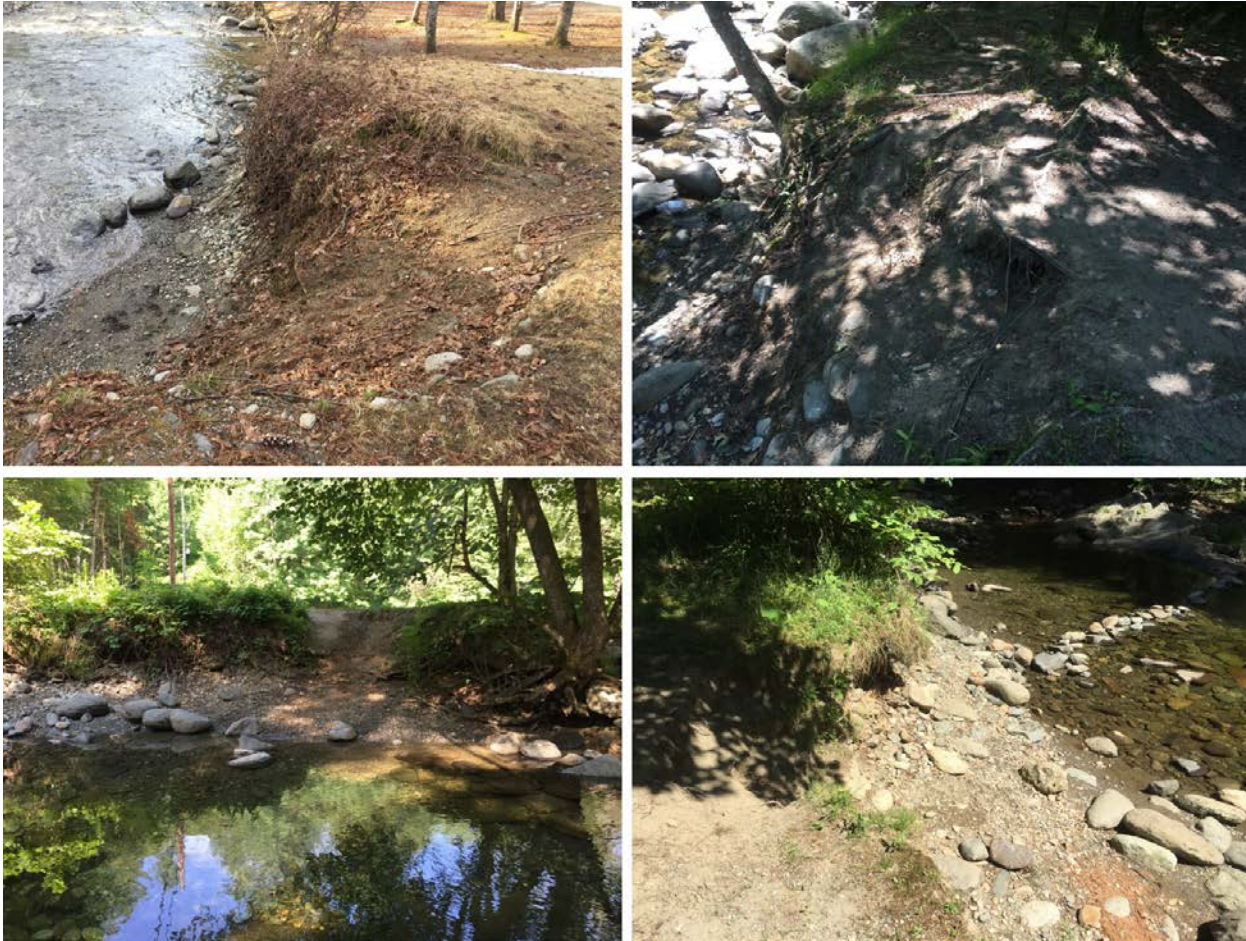
Shady Rill Picnic Area is a popular recreational area and as such visitors to the park want access to Martins Brook. Currently, there are no designated access points to the river, so park visitors climb down the banks to the river along the length of the park. This has resulted in several areas where erosion is occurring because of this access or is worsened by the access (Figure 3).

Figure 3. The river is accessed along the length of the site, exacerbating erosion.

Two strategies are recommended in the proposed site restoration plan to address these issues. The first is to install four hardened access points along the length of the site. These access points will restrict foot traffic to these locations and will limit additional stream bank erosion associated with foot traffic. The access point closest to the entrance to the park will be handicap accessible while the remaining three access points will consist of a path with hardened stairs leading down to the stream bed (Figure 8). It is recommended that a sign be installed at each of these access points to inform visitors of the need to remain on the paths. An example of a possible sign design can be found in Figure 9.

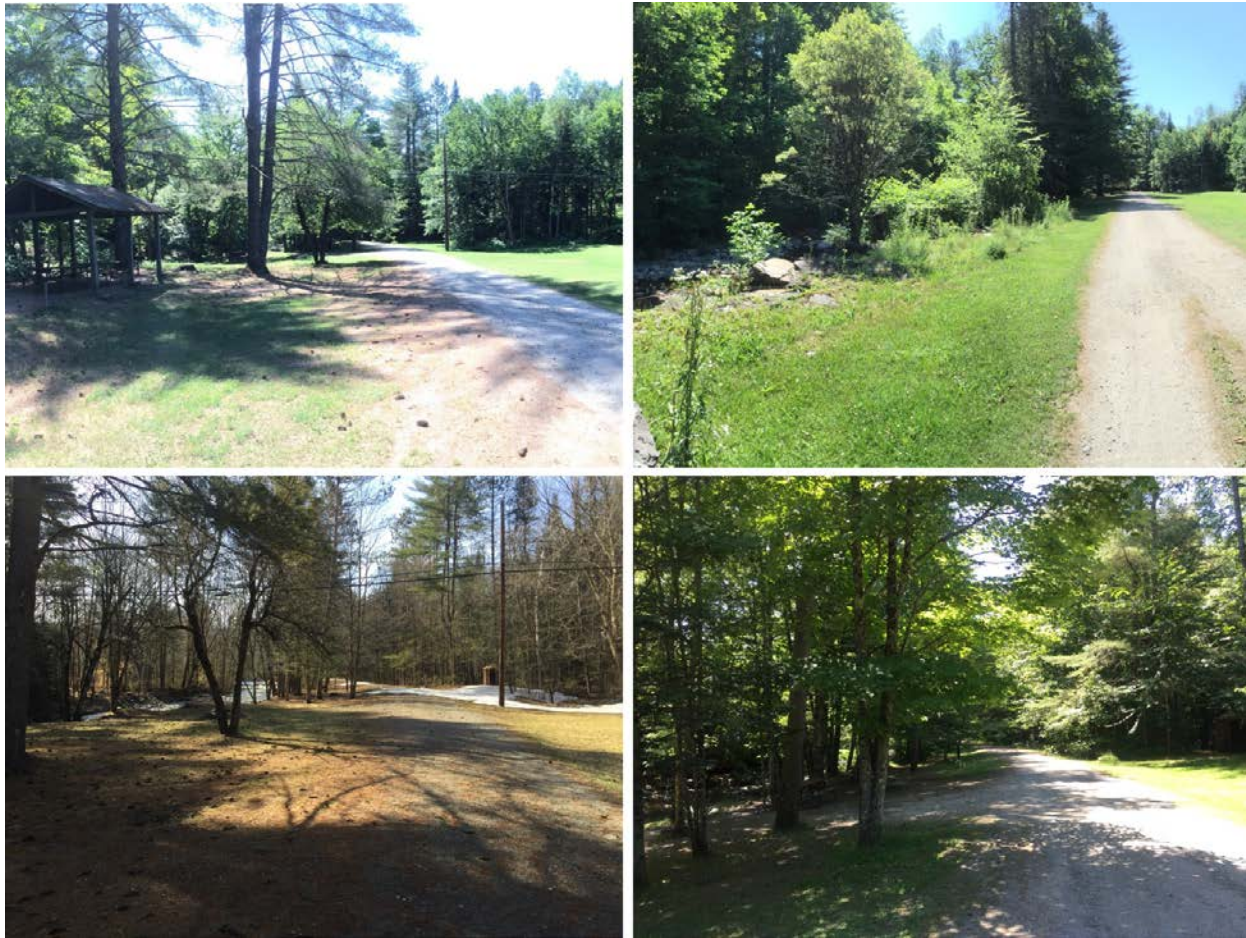
The road used to access the park from Shady Rill Road runs the length of the park and closely parallels Martins Brook. The road passes within the river corridor and would limit the extent of the proposed buffer restoration. This access drive is elevated above the surrounding ground surface, and acts as a barrier to floodplain access in high flows when the river is accessing its floodplain to the east of the access drive. Additionally, stormwater running off the road surface makes its way to the brook via overland flow, and this increased stormwater flow over the non-cohesive banks has increased bank erosion (Figure 4).

Figure 4. The access drive is elevated and preventing floodplain access to the west of the road.

Currently, the access drive to the picnic area runs closely alongside the stream and is raised above the surrounding ground surface. This raised drive infringes upon the stream's riparian buffer zone and prevents floodplain access at high flows due to its elevated position. Additionally, vehicles that access this site often park to the east of the access drive along the stream banks. It is recommended that the access drive be relocated along the western edge of the open field area. In addition to allowing better floodplain access and more complete restoration of the riparian buffer, it will also prevent additional compaction from vehicles driving along the road and parking along the stream bank.

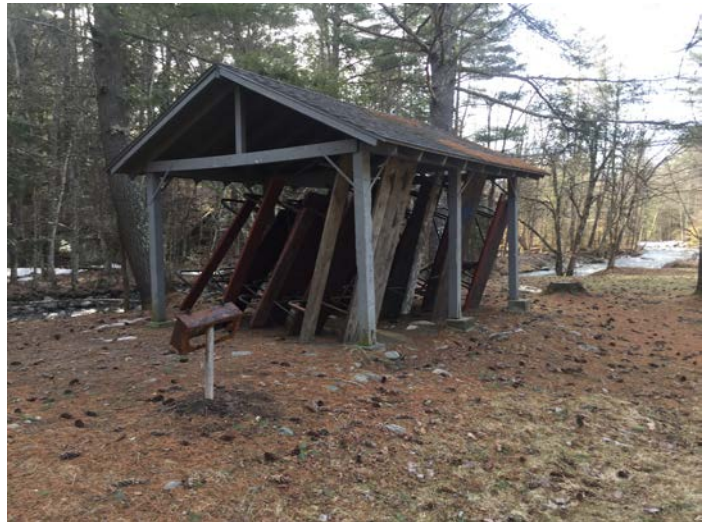
A pavilion that provides shelter to park visitors and stores picnic tables in the off season is located within 30 ft of the stream bank (Figure 5). The stream buffer restoration area extends a minimum of 50 feet from the stream (except where the access drive prevents this at the park entrance), and the area where the pavilion is currently located is well within that riparian restoration area (see section 4.2 for details on the buffer restoration). It is recommended that this pavilion be relocated away from the stream. The recommended location for the pavilion, as shown on the 30% design plans (Appendix A-9), is located far enough away from the stream as to not infringe on the 50 ft buffer and is placed in a location that least impacts the field area for recreational use and where picnicking should be encouraged.

Figure 5. Pavilion that will be relocated and exposed soil that will be revegetated as a part of the project.

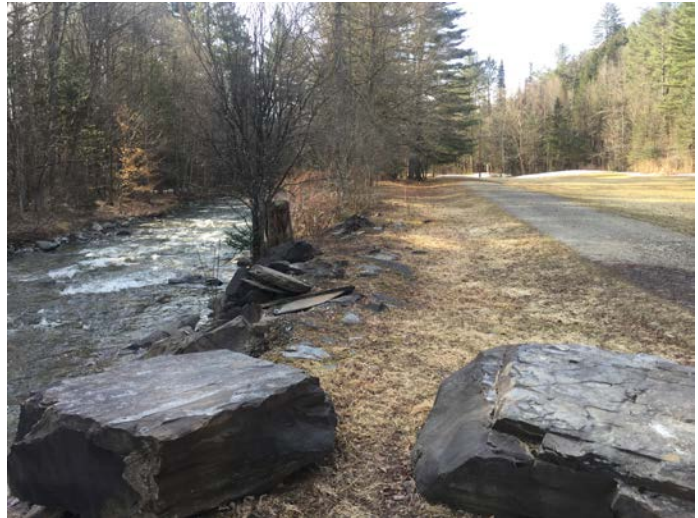
Figure 6. A section of the area abutting Martins Brook where the buffer restoration plantings will be implemented.

Riparian buffer plantings are recommended for the area along Martins Brook (Figure 6). The access drive will be relocated to allow for a minimum 50-foot buffer from the stream except at the entryway to the picnic area. The entrance will remain in the same location due to the high cost and topographic challenges of relocating the entryway. A mix of native trees, shrubs, and wildflower and low-mow grass mix are recommended for the site (see Table 1 for a list of species). A full list of the recommended species, photos of the plants, a description of their benefits, planting information, and a rendering of what the site would look like after the restoration is complete can be found in Appendix A-10. The design calls for larger sized stock as past experience has shown that there is often long-term cost savings when more mature plants are used due to the high die-off of smaller plants and the need for replanting to maintain adequate vegetated cover.

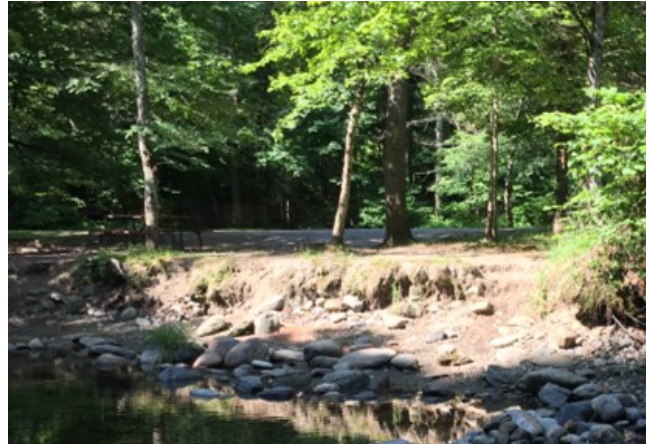
Currently, Martins Brook can be accessed along the length of the Shady Rill Picnic Area. The banks are susceptible to erosion, and the foot traffic from park visitors climbing down the stream banks along the length of the site increases the bank erosion. During site visits it was observed that the stream banks consist of primarily non-cohesive boulder and cobble materials (Figure 7). Additionally, the use of the site above the streambanks has resulted in significant compaction and areas with bare soils. The sources of the compaction are foot traffic as well as vehicular traffic. In addition to driving into the site along the access drive that closely parallels the stream, visitors to the area regularly park vehicles to the east of the access drive within a few feet of the stream banks. This compaction and lack of adequate vegetation allows for little to no natural infiltration along the length of the site to the east of the access drive. As such, stormwater inputs to the stream via overland flow can further undermine bank stability. Erosion was noted along more than 100 feet of the banks on this side of the stream. Erosion was limited to that stretch primarily because much of the remainder of the banks along this side are armored with riprap.

Figure 7. The non-cohesive stream banks are highly susceptible to erosion.
