**HISTORIC RESOURCE REVIEW
AND ARCHAEOLOGICAL RESOURCES ASSESSMENT,
HANDS MILL DAM (VT STATE ID #225.01) REMOVAL PROJECT
WASHINGTON, ORANGE COUNTY, VERMONT**

UVM Report No. 1303
December 16, 2020

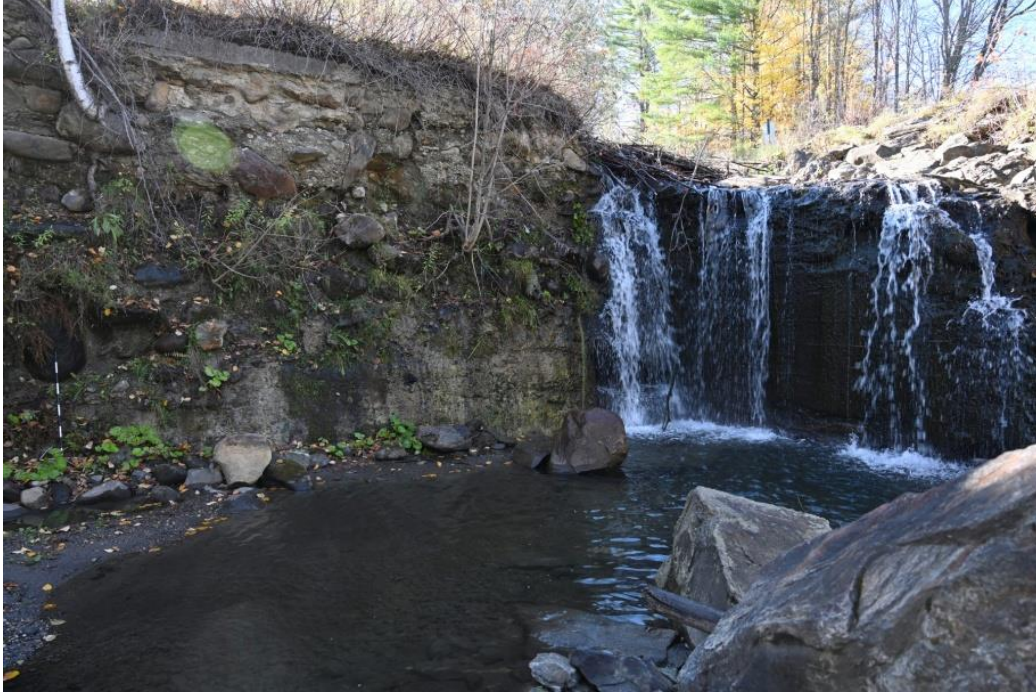
Figure 2. View of the Hands Mill Dam and associated mill structure, Washington, Orange County, Vermont, looking southwest.

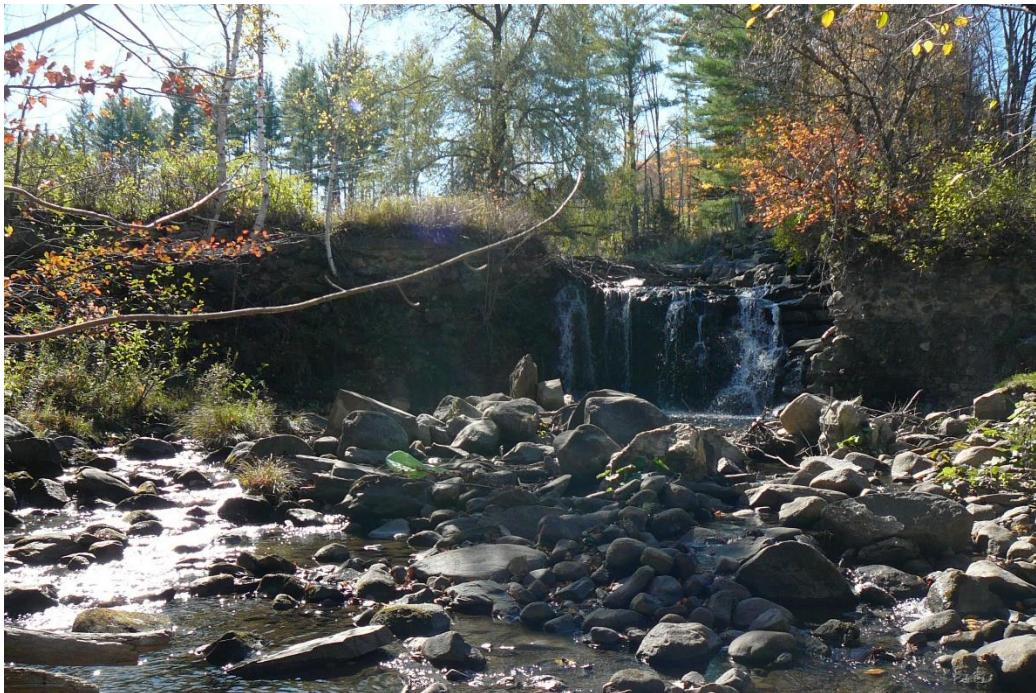
Figure 3. View of the Hands Mill Dam and associated mill structure, Washington, Orange County, Vermont, looking southeast.

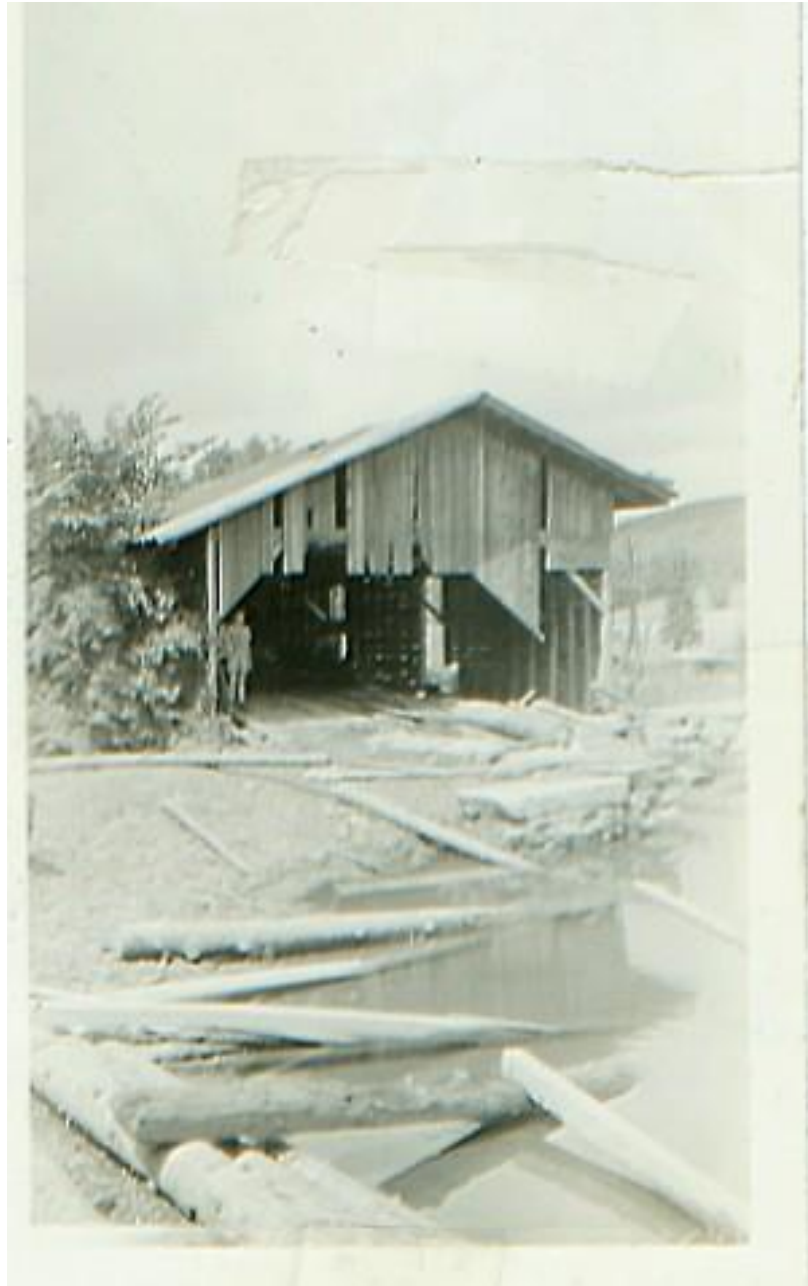
Figure 11. View of the saw mill ca. 1942 (Courtesy of Mary A. and James Driscoll), looking north northeast, with the mill pond in the foreground (note log storage). Masonry dam elements are visible at right and a section of earthen embankment is visible at left foreground; by this time, the head gate's hoist had probably been removed.

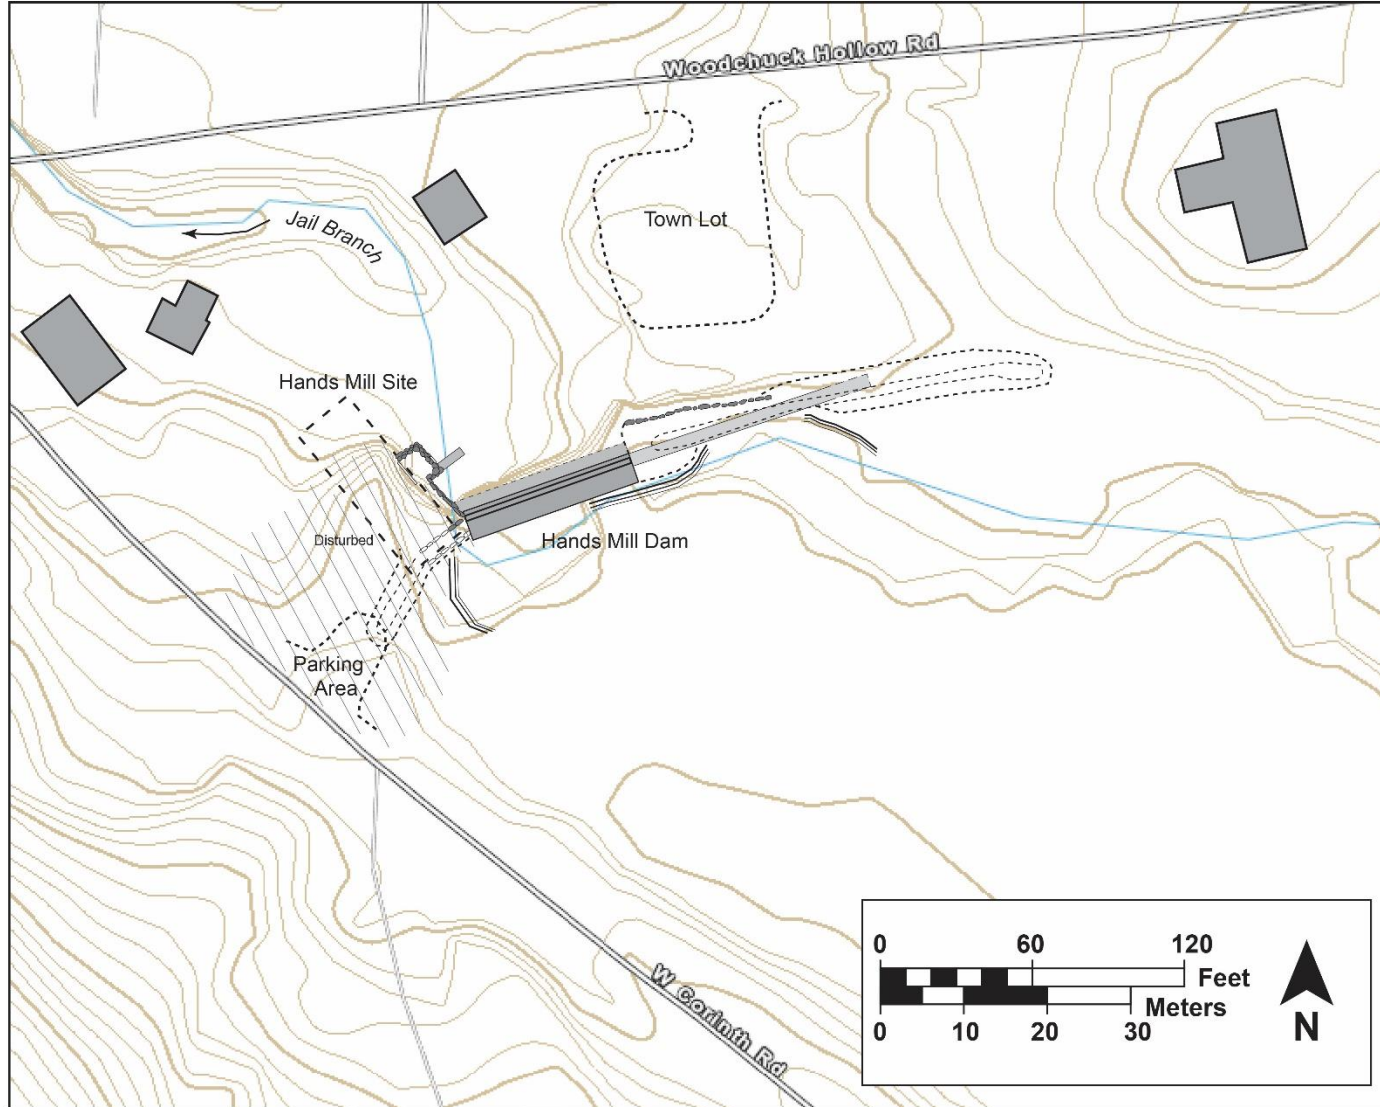
Figure 16. Schematic plan of the Hands Mill Dam site (VT State ID #225.01), Washington, Orange County, Vermont (additional data from <https://vcgi.vermont.gov>).

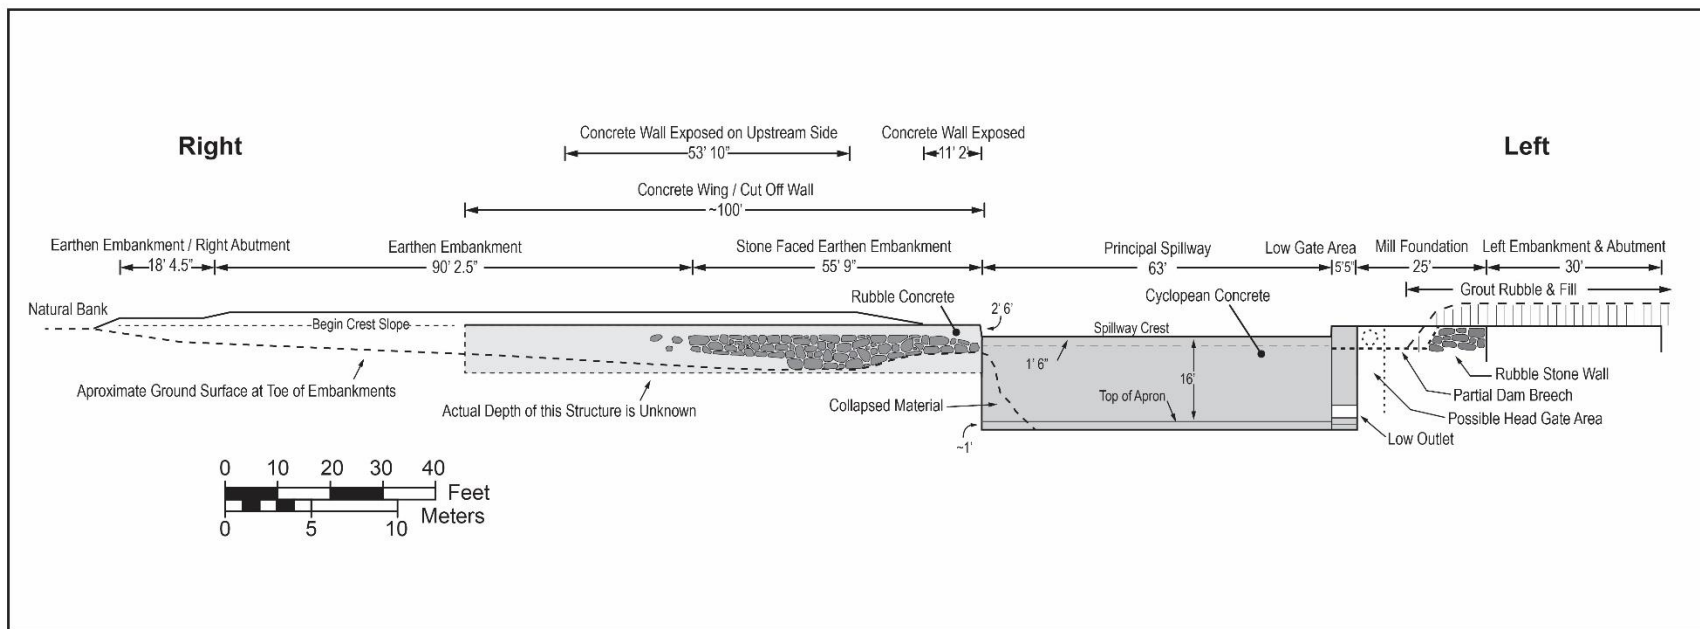
Figure 17. Elevation plan of the Hands Mill Dam (VT State ID #225.01), Washington, Orange County, Vermont (Base map from <https://vcgi.vermont.gov>).

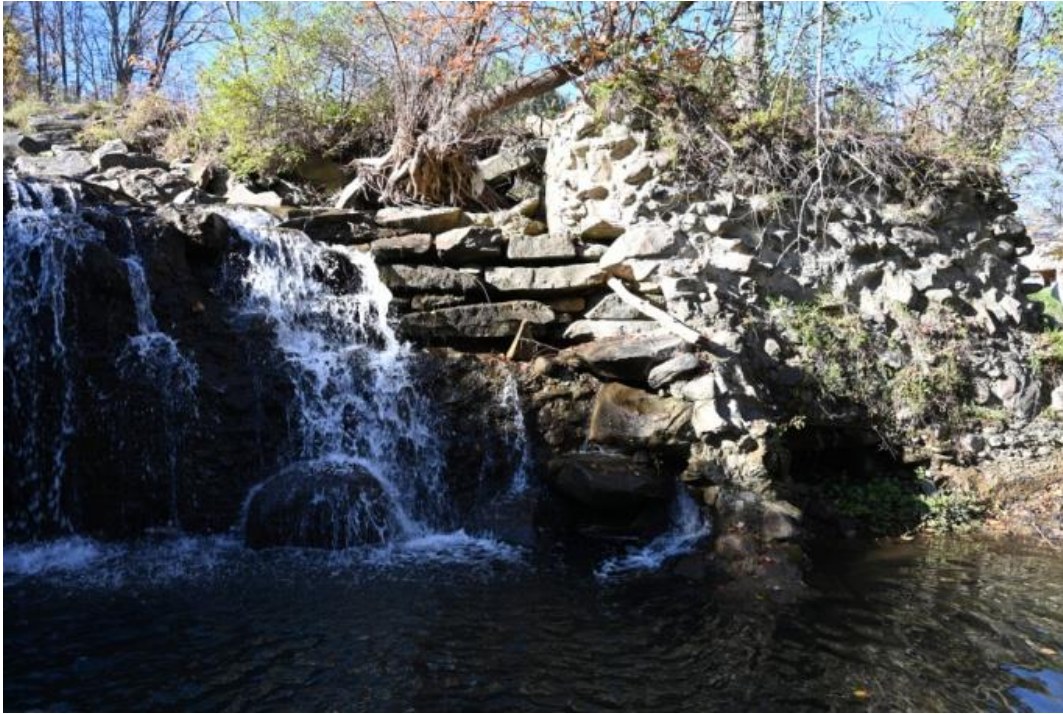
Figure 27. View of a turbine pit structure (at right), looking west northwest.

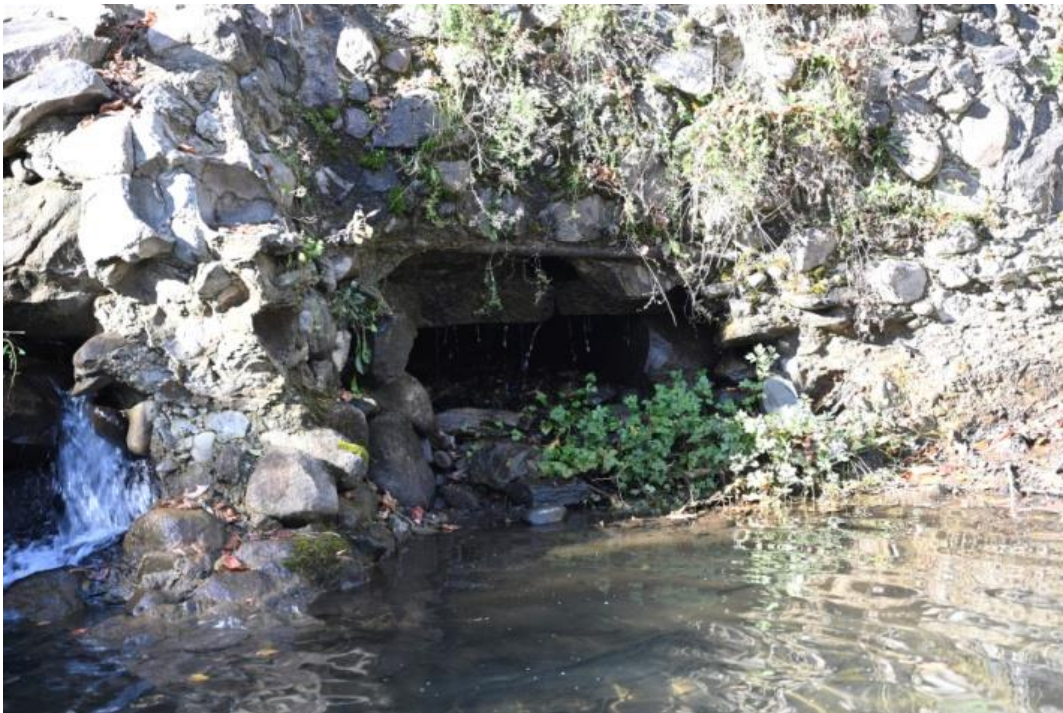
Figure 28. View of the tailrace outlet built into the turbine pit structure, looking west.

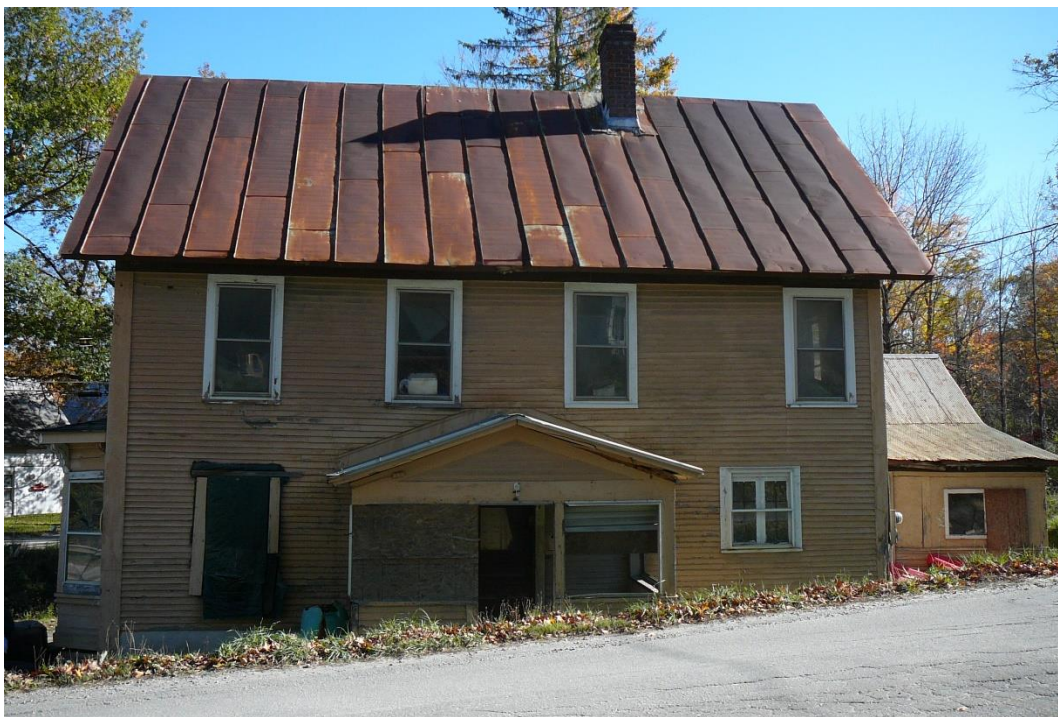
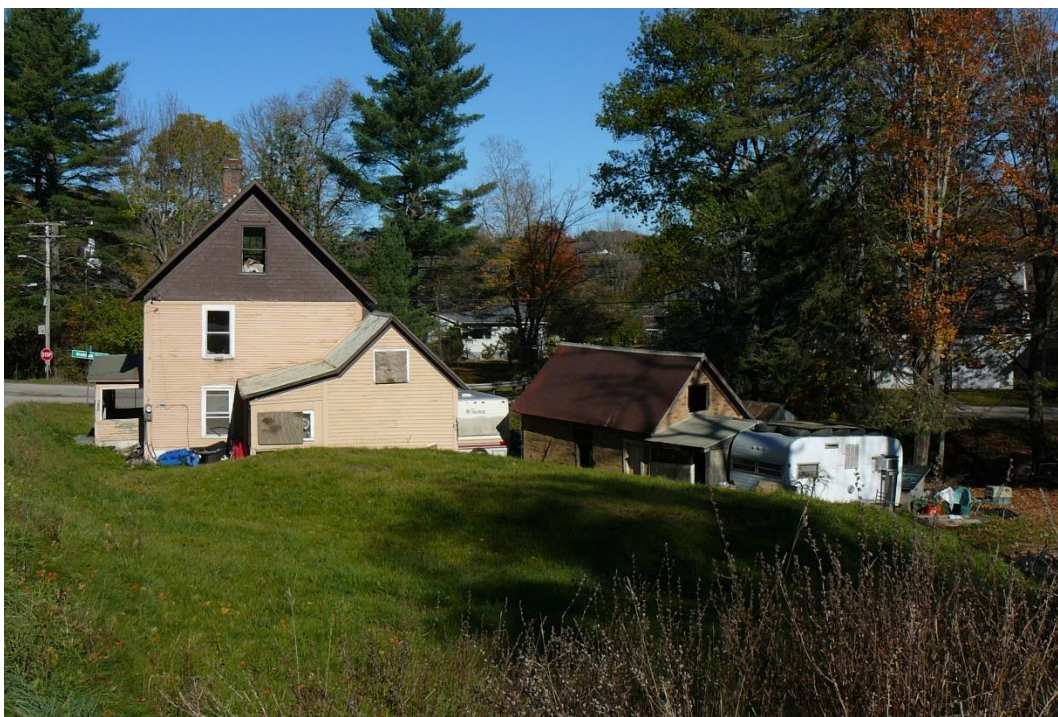
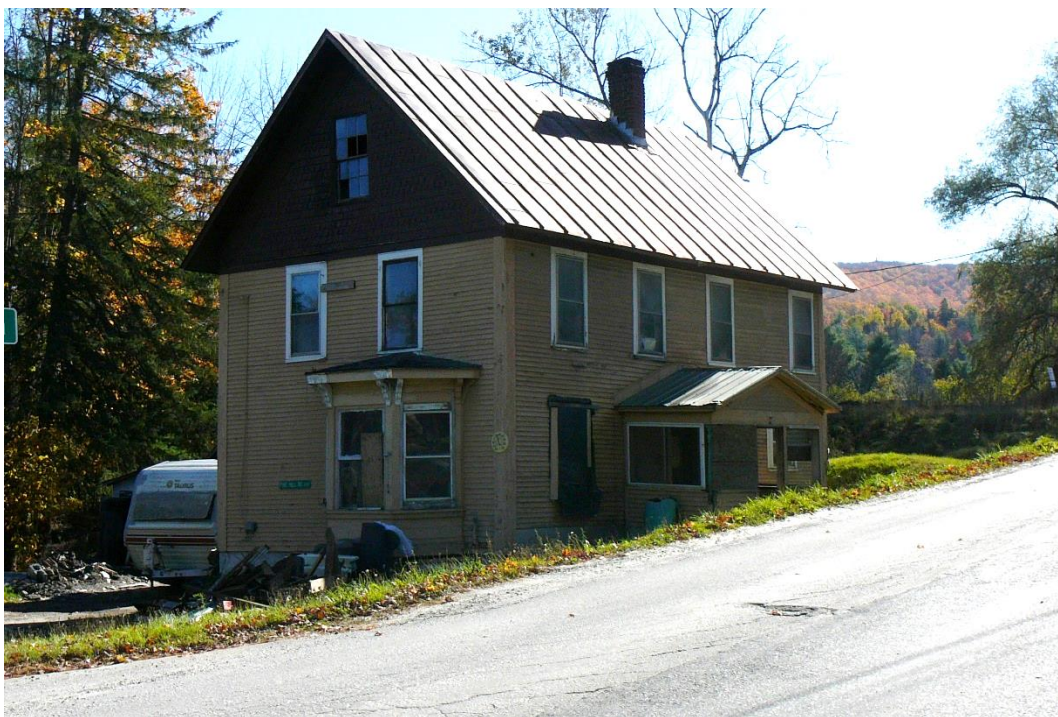
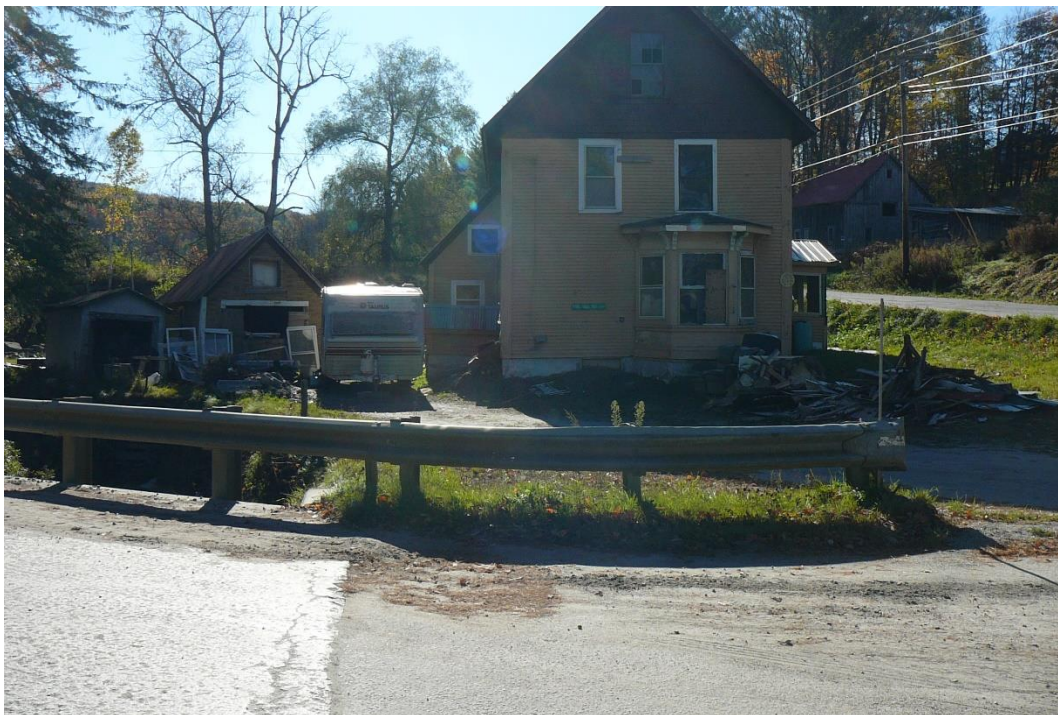
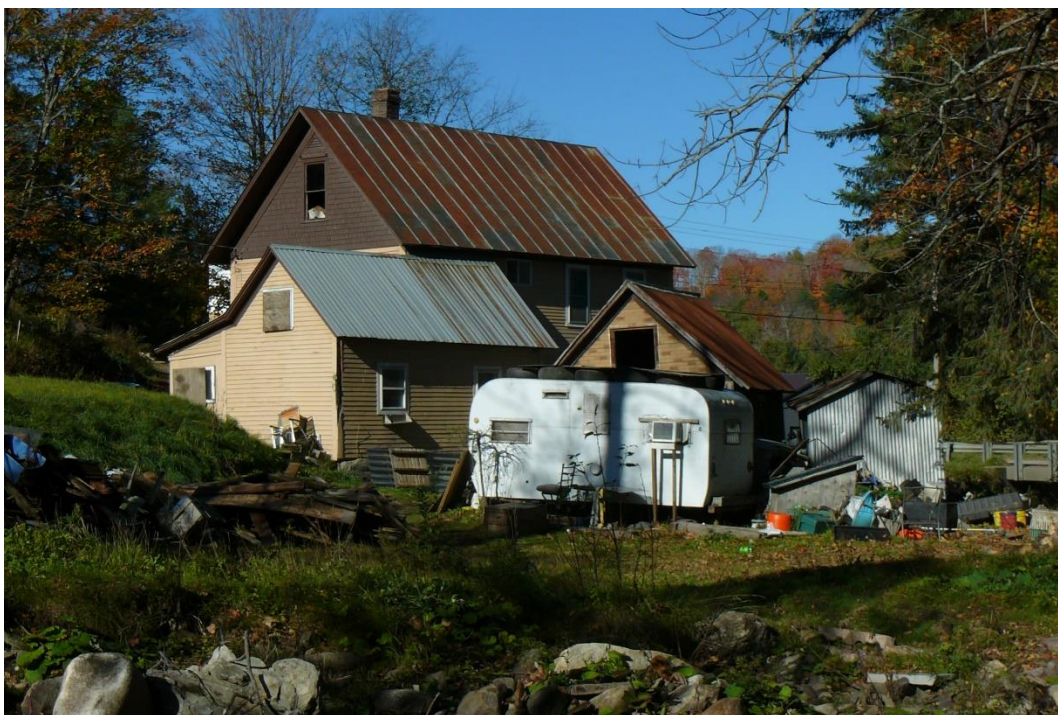
16 Woodchuck Hollow Road: House, Garage & Shed
(Figures 33 – 38)

The house at 16 Woodchuck Hollow Road is a 2 ½ story, wood frame, gable roof building with an eaves front that faces West Corinth Road. The house has a granite slab foundation, metal roof and clapboard siding. Queen Anne style details include a bracketed bay window on its west end, and patterned wood shingles in its gable ends. A single story gable roof wing with shed roof extension is attached to its northeast corner. A detached c. 1950 one bay garage and later shed are constructed behind (north of) the house, and there are two trailers behind the house. Numerous windows on the house are broken or missing completely, and it appears to be used for the storage of various types of debris. Additional piles of debris are scattered outside of the buildings on the property.

The house at 16 Woodchuck Hollow Road was added to the State Register on September 14, 1989 (VDHP 1979a; SR #0195-26), however, due to its current condition, this review recommends that it is no longer eligible for inclusion on the State Register. Due to its condition, this Historic Resources Review also recommends that the resource does not meet criteria for significance and recommends that it is not eligible for inclusion on the National Register of Historic Places. It is therefore recommended that project work will have No Effect on the property. The Vermont State Historic Preservation Office (SHPO) will have the opportunity of review and comment prior to project work.

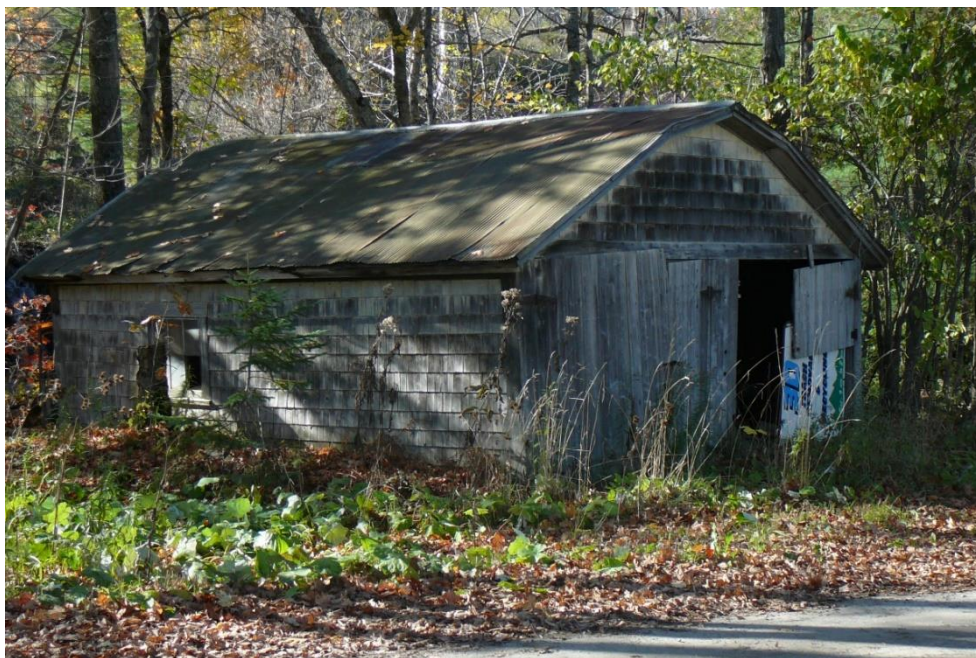
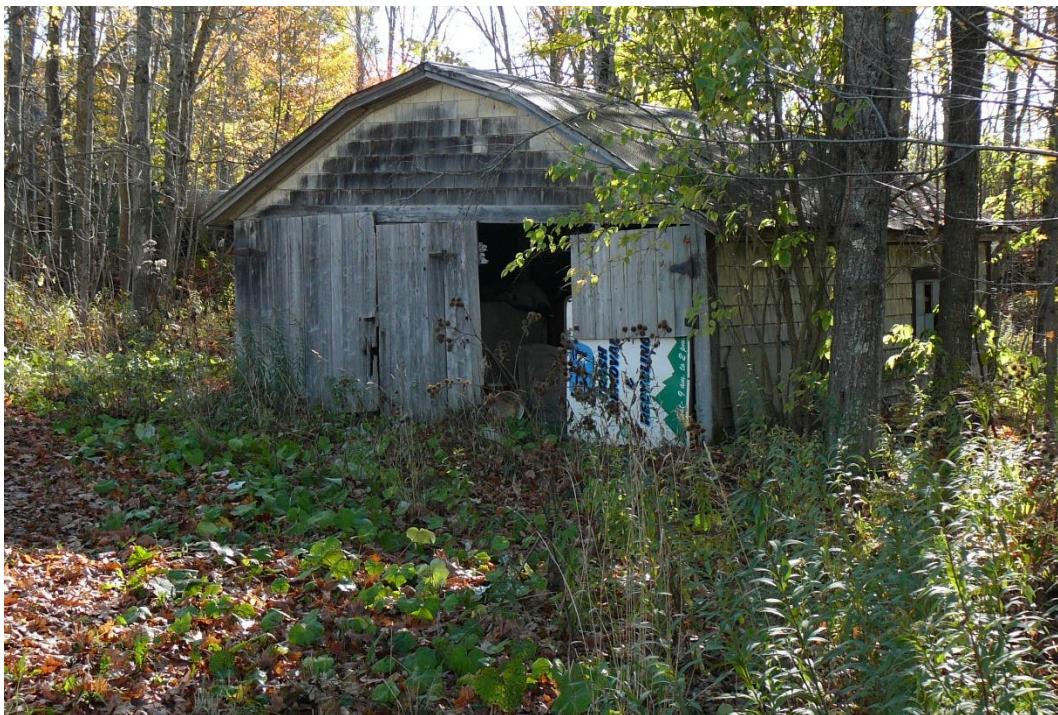
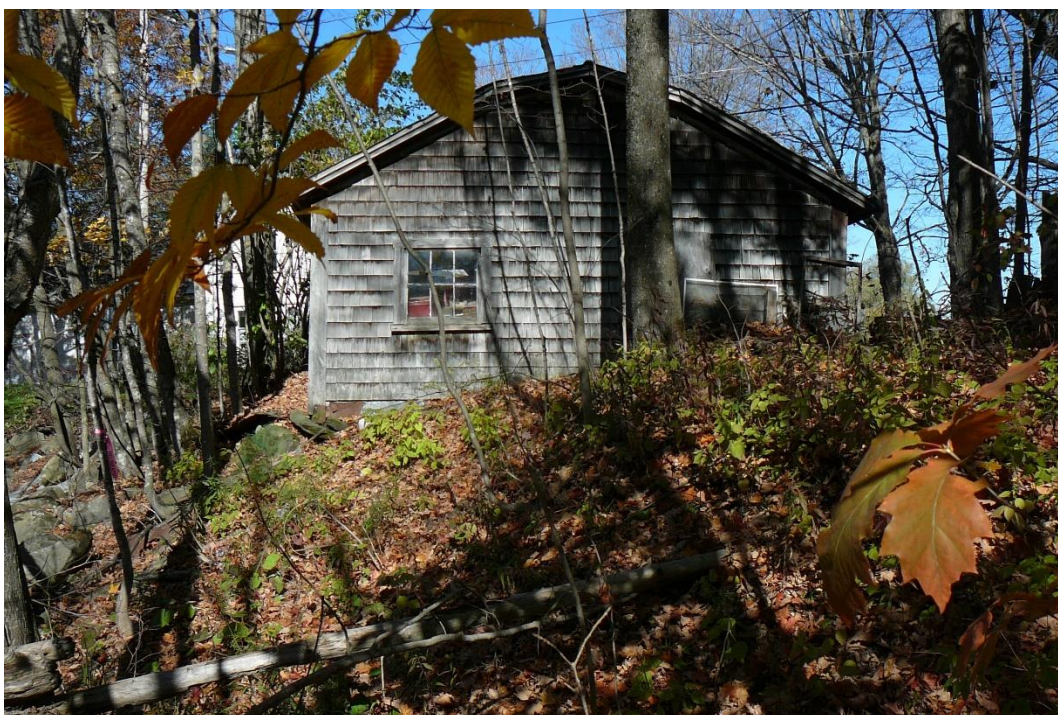
39 Woodchuck Hollow Road: Shed
(Figures 39 – 43)

The single story shed located just north and downstream of the dam on the north side of Jail Branch, is now part of 39 Woodchuck Hollow Road, most of which is on the opposite (north) side of the road. In 1947, the shed was part of the 16 Woodchuck Hollow Road property, then owned by Armand Vermette (see Figure 12). A definitive date of construction was not determined for the structure; it appears to date to the late 1800s or first decades of the 1900s. The building is wood frame with a low gambrel roof with metal covering and it has wood shingle siding. It does not appear to have a foundation but seems to rest directly on the ground, possibly on rocks. The front (north) gable end that faces Woodchuck Hollow Road has two sets of plank, side hinged doors. There are two window openings on the south gable end, one is boarded and one is a fixed 6-pane window, and the east and west elevations have a single 6-pane window toward the back (south) end of the building. The structure is possibly an outbuilding for small machinery.

The c. 1900 house with attached barn at 39 Woodchuck Hollow Road was added to the state register on September 15, 1989; the shed is not listed as part of the property at that time (VDHP 1979b; SR #0195-63). Additional land records research would be needed to determine when the shed property was joined with the house property. Initial research did not determine if the shed was built by an owner of 16 Woodchuck Hollow Road property. This Historic Resources Review recommends that the shed does not meet criteria for significance and recommends that it is not eligible for inclusion on the National Register of Historic Places. The house does not appear to exemplify distinctive characteristics of period and is also recommended as not eligible for inclusion on the National Register of Historic Places. It is therefore recommended that project work will have No Effect on the resource. The Vermont State Historic Preservation Office (SHPO) will have the opportunity of review and comment prior to project work.

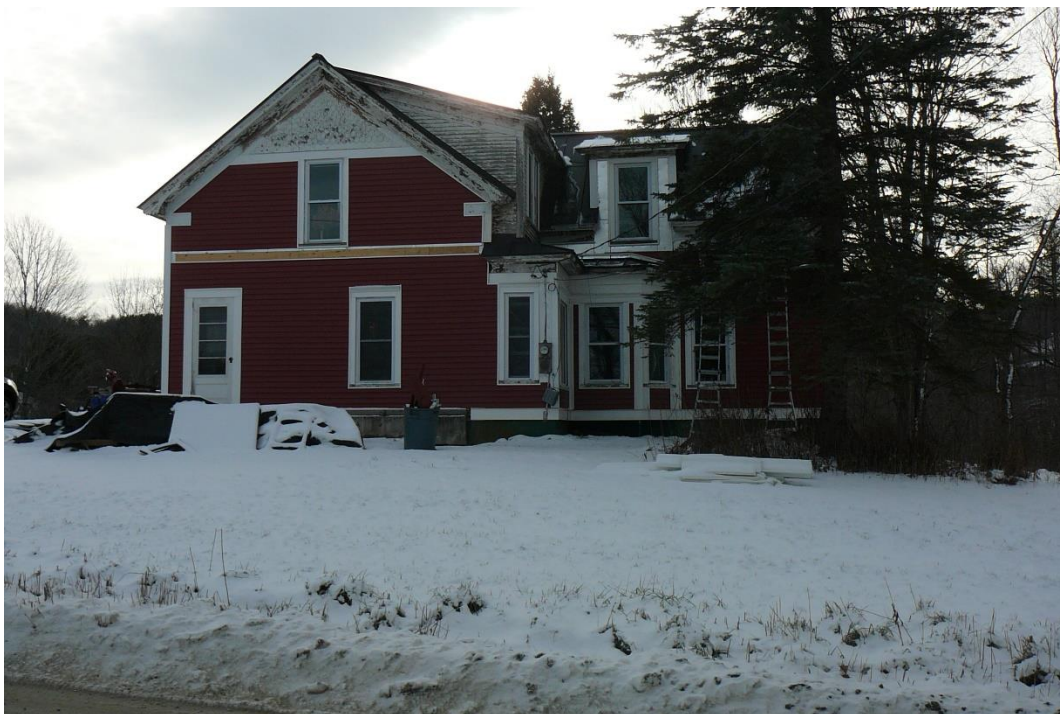
The house at 110 Woodchuck Hollow Road dates to after 1877, and probably to the last decades of the 19th century (Beers 1877). It is a 1 ½ story wood frame, gable front building with a cross gable ell on its west side; both the main block and the ell have newer metal roofs. The main block has a large shed dormer added to its west roof slope, and the ell has a smaller shed roof dormer added to its north roof slope. A shed roof porch is built onto the southeast corner of the main block. The building is currently under renovation and has recent windows and siding and may have had a front porch removed. Decorative wood shingles currently remain in gable peaks.

Due to alteration, this Historic Resources Review recommends that the resource does not meet criteria for significance and recommends that it is not eligible for inclusion on the National Register of Historic Places. It is therefore recommended that project work will have No Effect on the property. The Vermont State Historic Preservation Office (SHPO) will have the opportunity of review and comment prior to project work.

Figure 44. View southeast of the house at 110 Woodchuck Hollow Road.
