Stone Project No. 20-007 Subject: Hands Mill Dam Removal – Geotechnical Report

Stone Environmental, Inc. (Stone) has completed desktop, field, and laboratory geotechnical investigations at the Hands Mill Dam as part of the overall 30% design effort. This memo provides a summary of these investigations including field and laboratory methods, data logs, and the implications of the data for site design and construction processes.

Hands Mill Dam Removal in Washington, Vermont

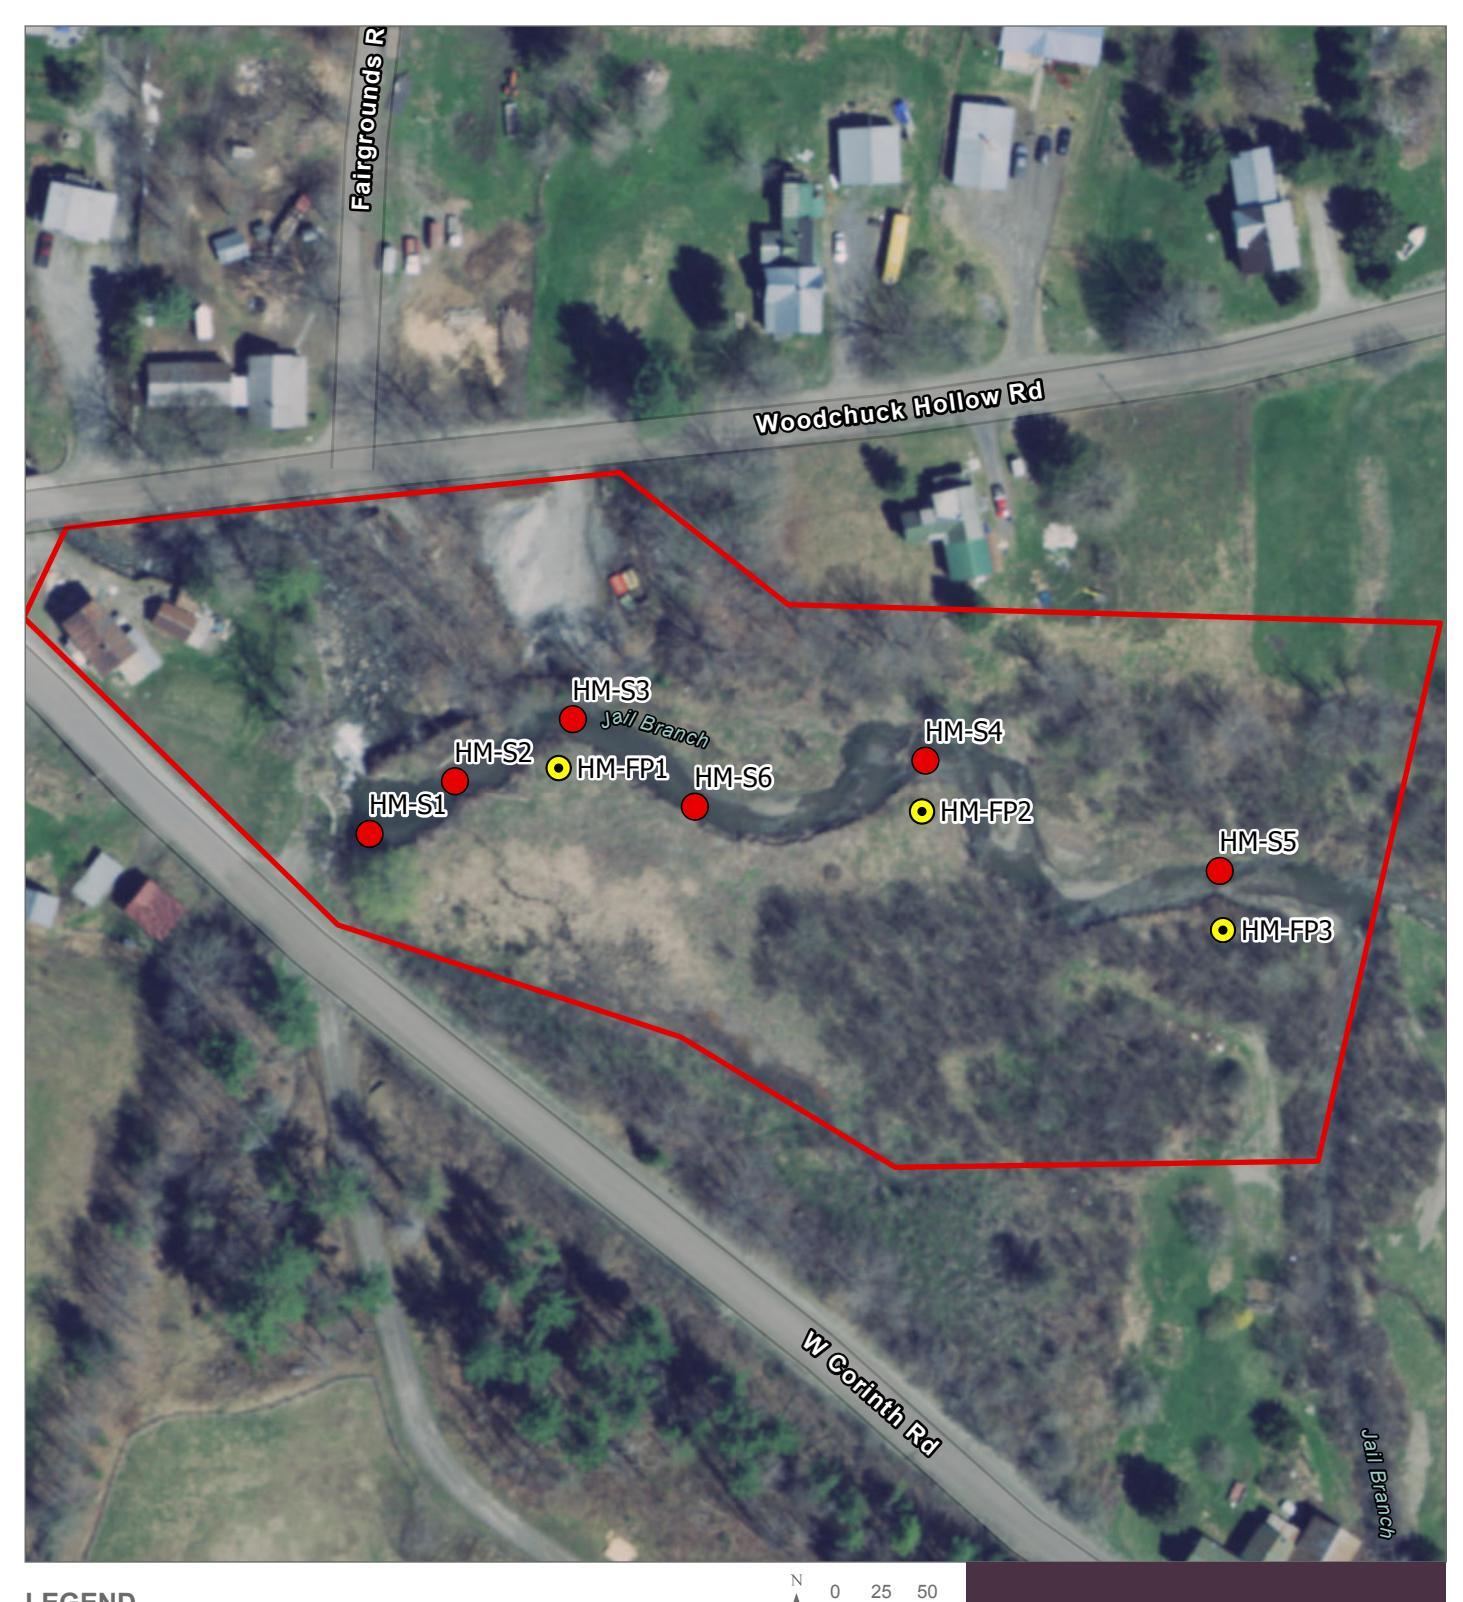
Figure 1: Site Map

A preliminary desktop evaluation was performed to determine the potential extents of sampling. Aerial imagery of the Hands Mill Dam location (44.10569, -72.43000) from Google Earth shows aggradation of sediment, likely coarse grained, for approximately 750 linear feet upstream of the Hands Mill Dam (See Figure 1 on the following page for approximate project extents). This area was further investigated in the field to confirm sampling locations. The number of channel samples to be collected (six in total) was predetermined and was to include a combination of pebble counts and laboratory grain size analyses (methodologies defined below). The number of floodplain samples to be collected (three in total) was also predetermined to represent the spatial extent of the left-bank floodplain.

An initial site evaluation was utilized to confirm the extents of sampling. Though Google Earth aerial imagery showed aggraded sediments for approximately 750 linear feet upstream of Hands Mill Dam, visible changes in bed slope and material indicated that the direct impact of the dam on sediment impoundment was likely limited to approximately 600 linear feet upstream. Channel sediment sampling was therefore focused within this extent. Exact sampling locations were selected to maximize the range of outcomes of the grain size analyses in order to assess the variability of grain size distribution throughout the channel. One sample, HM-S6, was excluded from further analysis and was sent to archive due to extensive similarity to sample HM-S4. Floodplain samples were spaced at equidistant intervals (approximately 150 - 200 feet apart) throughout the left bank floodplain.

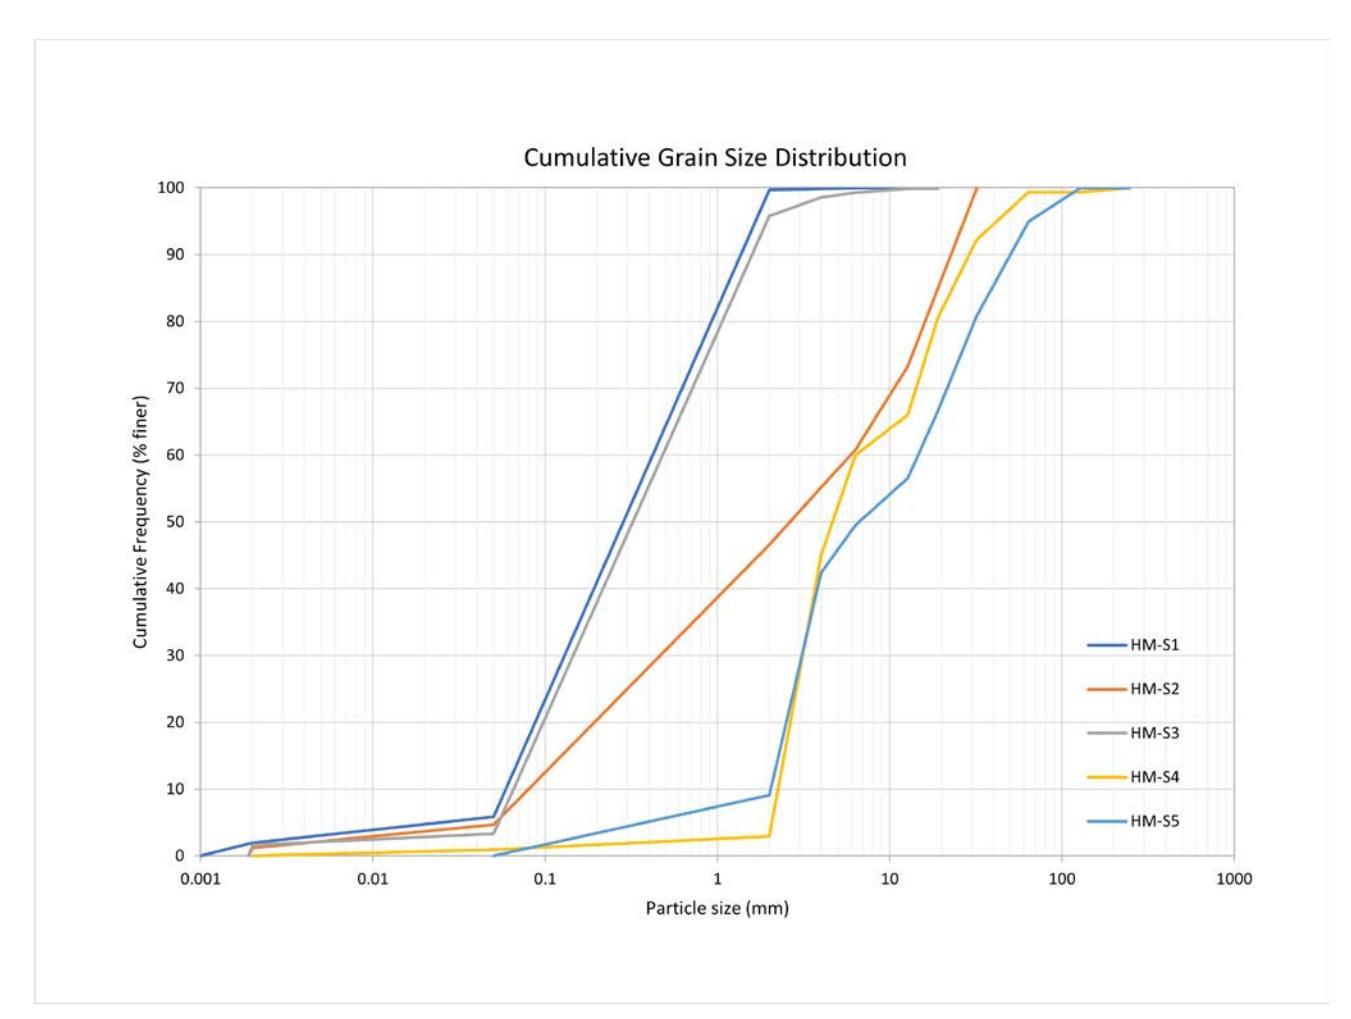
The results of the channel and floodplain investigations are shown in Tables 1 through 3. Pebble count data were aligned with the size classes tested via hydrometer and sieve analyses at the UVM Lab for direct comparison. Figure 2 shows the cumulative grain size distribution at each of the channel sampling sites (note that the curves for HM-S4 and HM-S5 were generated from pebble count data).

Figure 2 – Cumulative grain size distribution curves for channel samples HM-S1 through HM-S5. HM-S4 and HM-S5 curves were generated using pebble count data.

As is common with pebble counts, the sampling data show that the pebble count samples tended towards the coarser fraction of the impounded bed sediment material than the Lab tested bulk samples. However, both the Lab samples and pebble counts indicate that the median grain size (d_{50}) of the channel material is less than 10 mm (1 cm) in diameter. Particles of this size are highly mobile via both rolling and entrainment during common storm events. Both sample types also indicate that approximately 75% or more of the impounded bed sediment is finer than 25 mm (approximately 1 inch) in diameter. Coarse gravel in this size class is still likely to mobilize during storm flow events based on a simple incipient motion approximation using the critical Shields Number.
