Hands Mill Dam Removal Preliminary Engineering Report

HANDS MILL DAM REMOVAL **AT JAIL BRANCH** TOWN OF WASHINGTON, VERMONT

30% DESIGN **ISSUED: JANUARY, 2021**

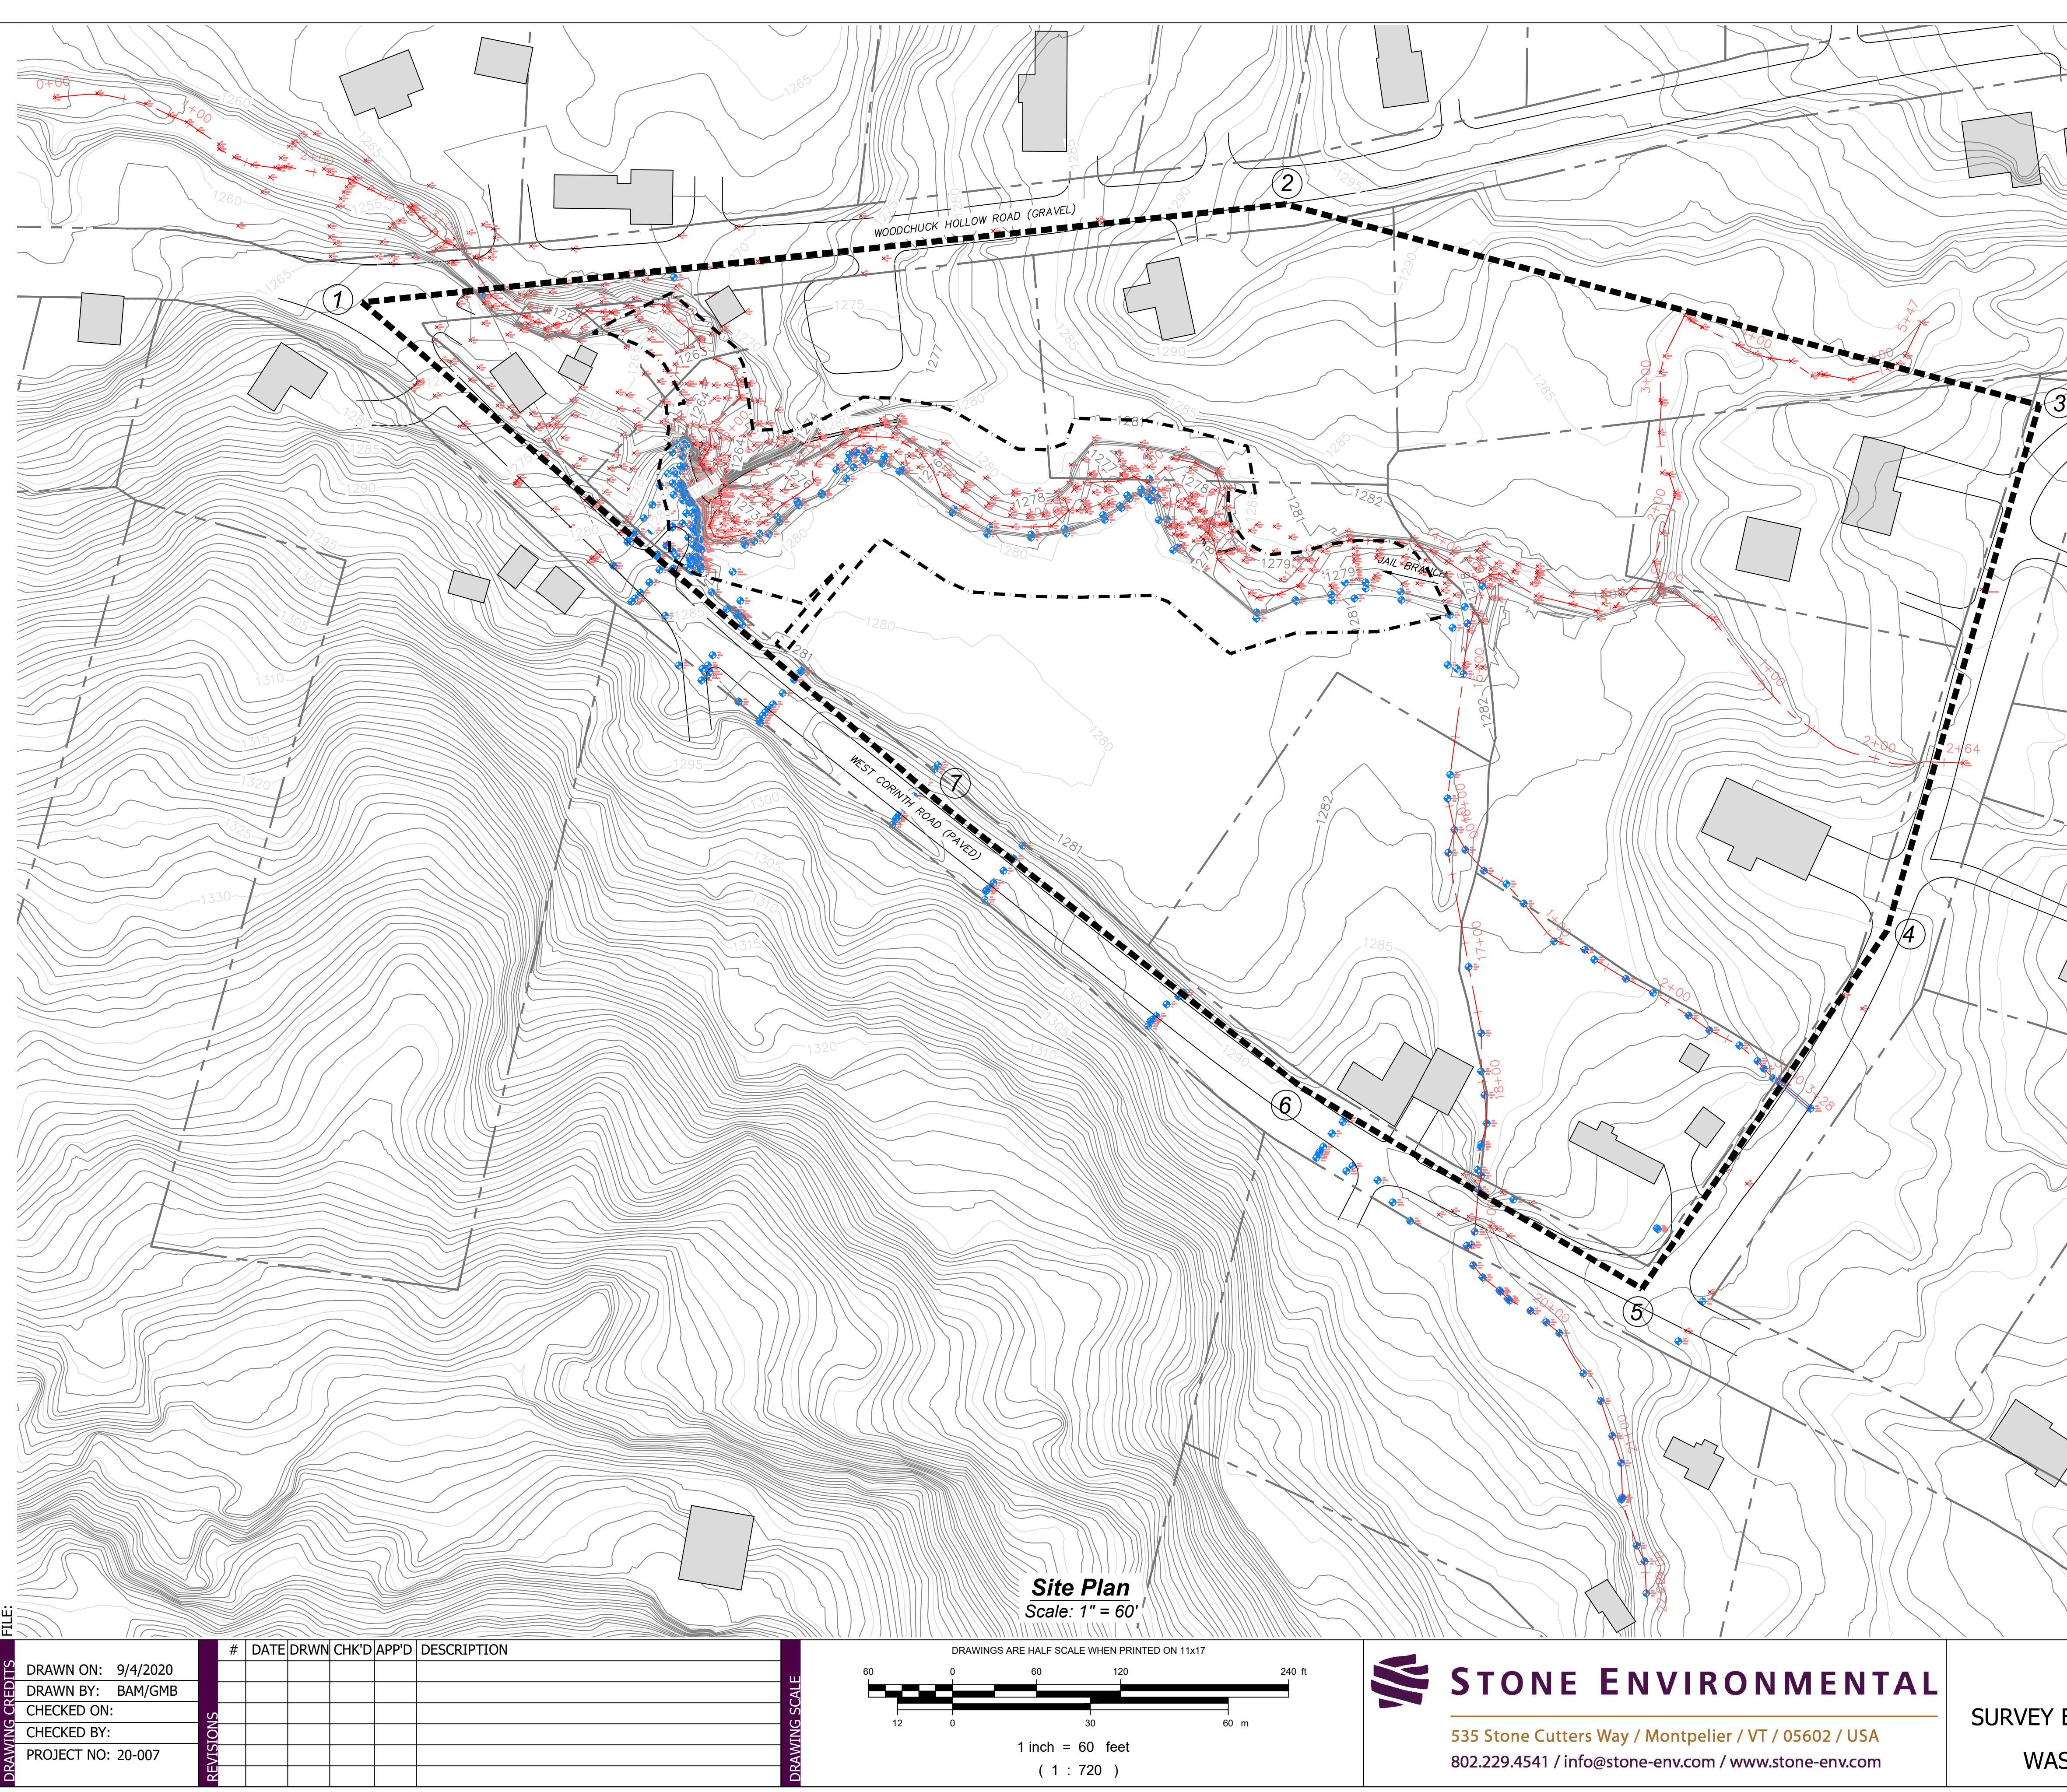
HANDS MILL DAM REMOVAL AT JAIL BRANCH SURVEY EXTENTS PLAN AND LIMITS OF DISTURBANCE WASHINGTON VERMONT

Limits of Disturbance							
Point Ta	able						
Latitude	Longitude						
44.105868	-72.430835						
44.106068	-72.428349						
44.105635	-72.426226						
44.104637	-72.426656						
44.103929	-72.427335						
44.104311	-72.428325						
44.104845	-72.429264						
	its of Dist Point Ta Latitude 44.105868 44.105635 44.104637 44.103929 44.104311 44.104845

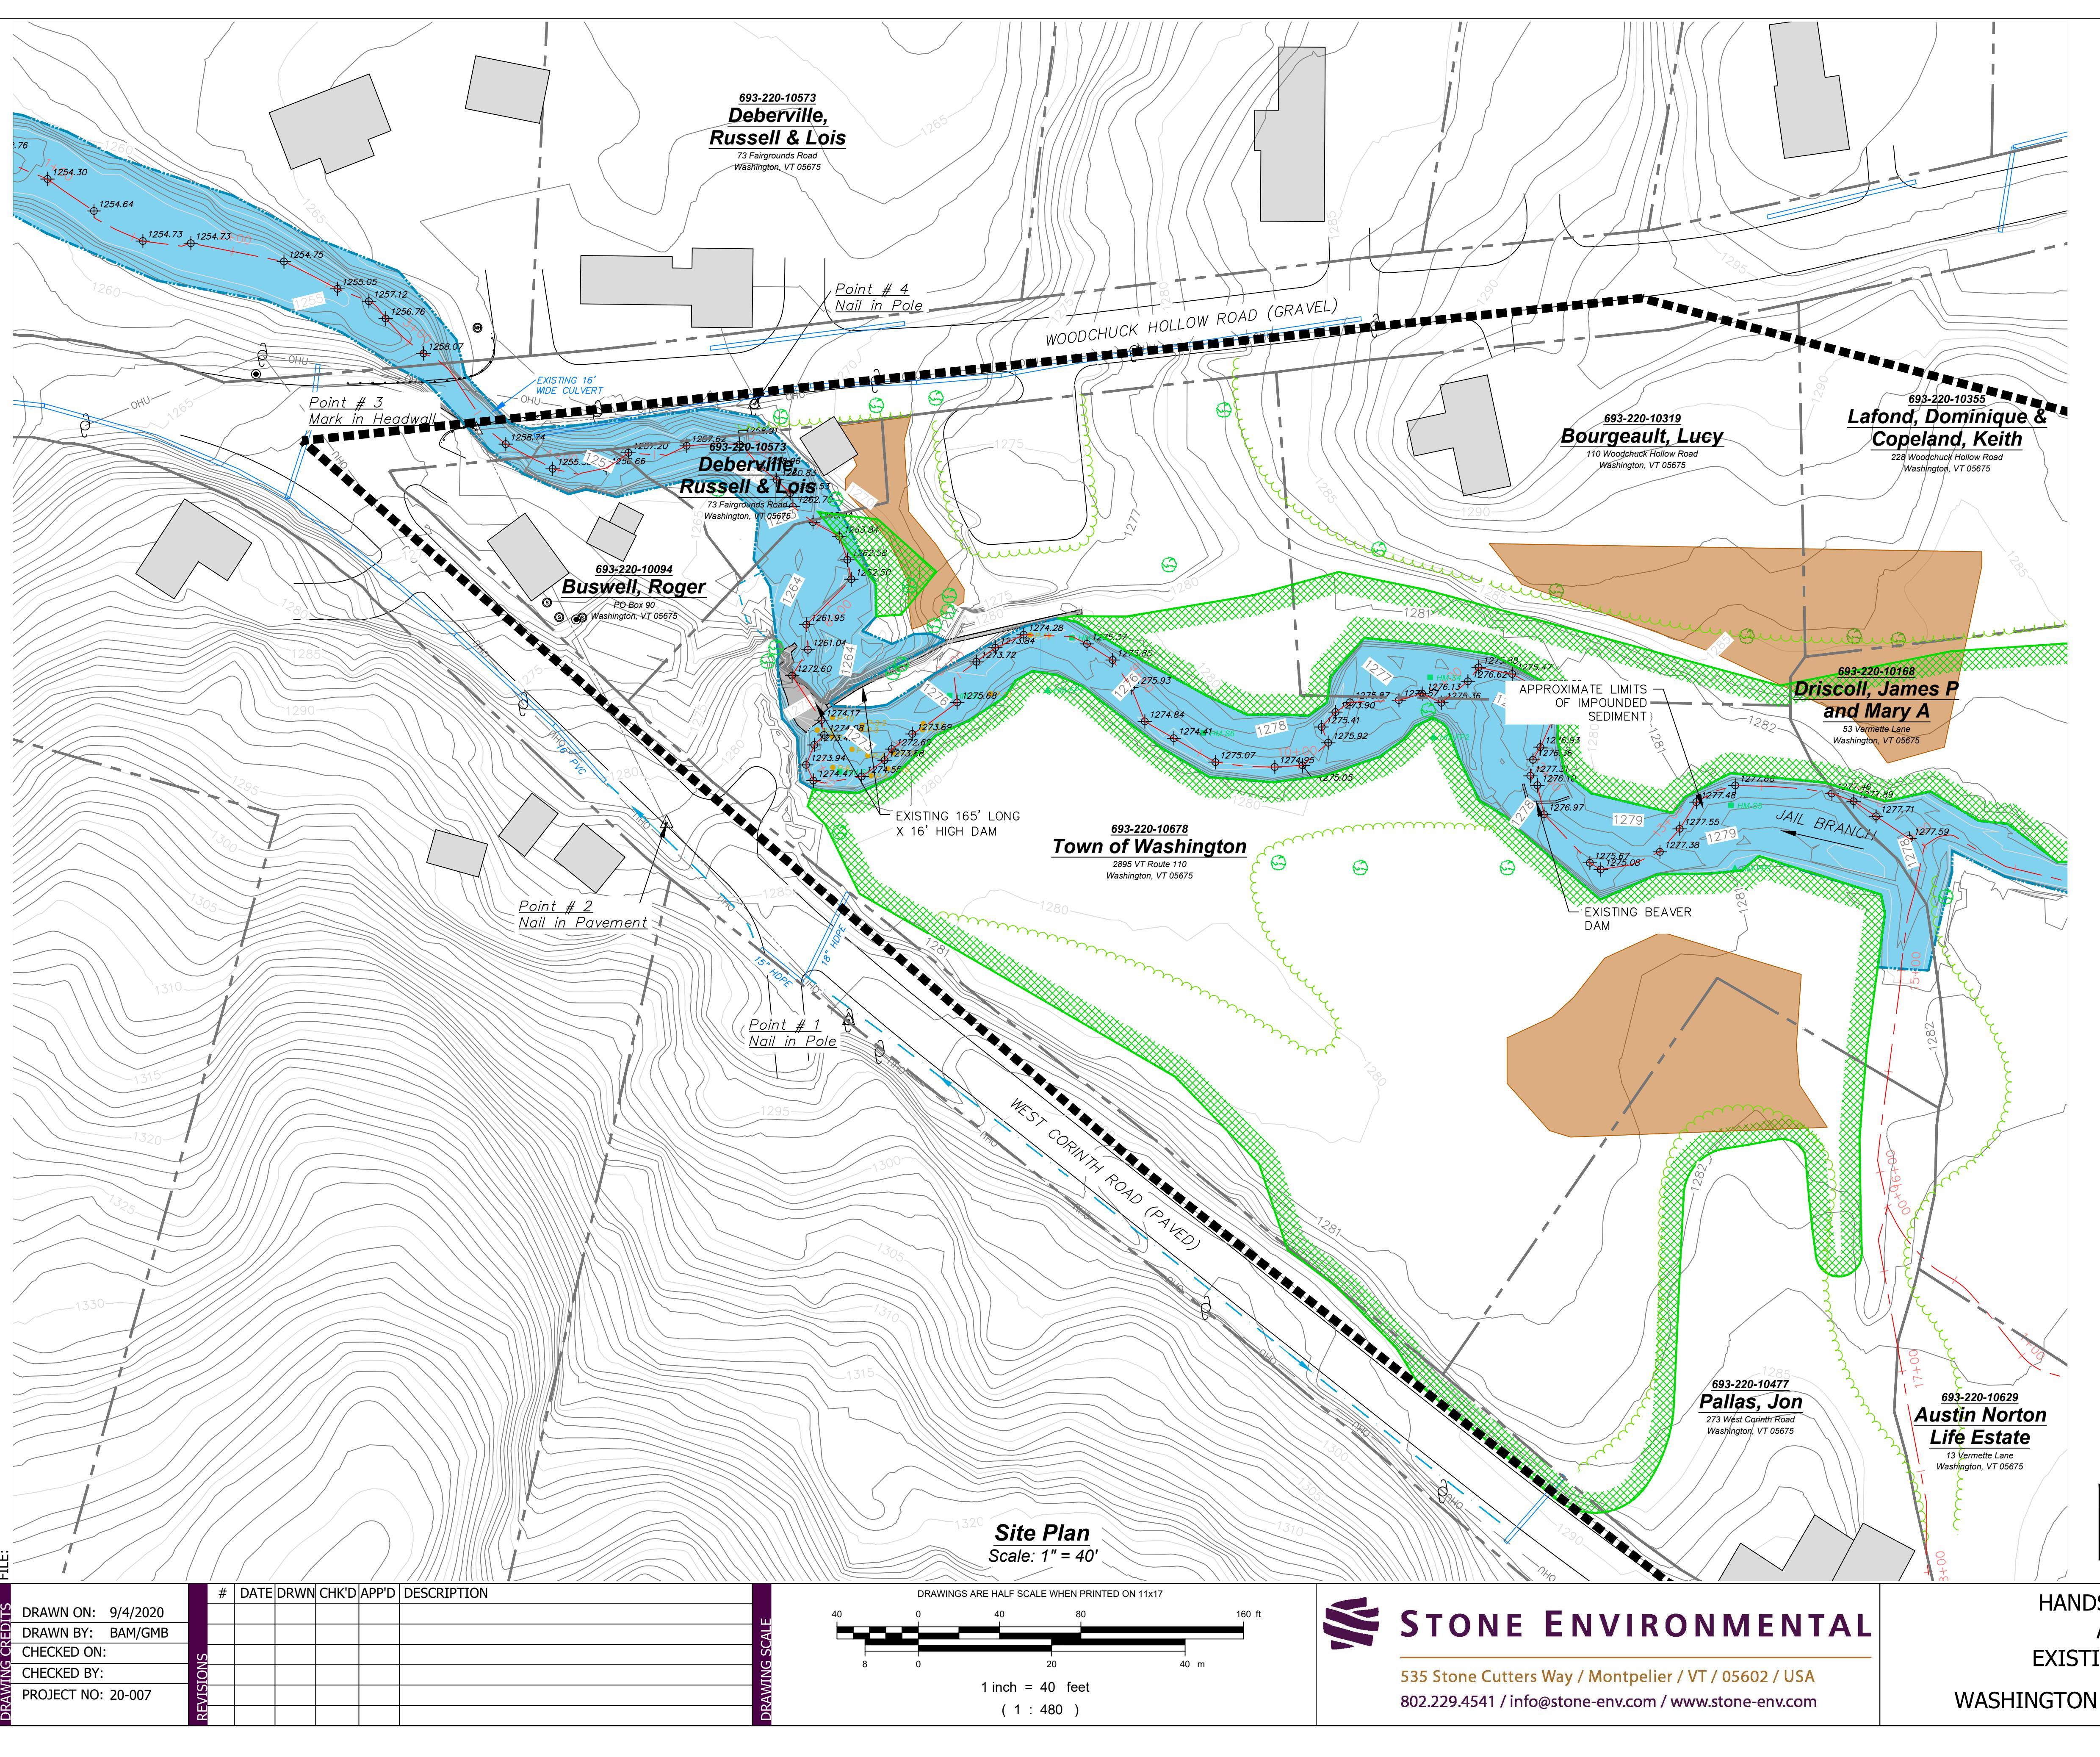
HANDS MILL DAM REMOVAL AT JAIL BRANCH EXISTING CONDITIONS PLAN

- 5. Utility locations shown on this plan should be considered approximate. Contractor is required to verify utility locations prior to work.
- 6. Wetland boundaries shown on this plan were delineated by Karina Dailey of the Vermont Natural Resources Council (VNRC) on October 8, 2020. The wetland delineation was performed in accordance with the U.S. Army Corps of Engineers Wetland Delineation Manual, Technical Report Y-87-1, January 1987, Regional Supplement to the Corps of Engineers Wetland Delineation Manual: Northcentral and Northeast Region (Version 2.0), January 2012, and Section 3.2 of the Vermont Wetland Rules.

- Archaeological sensitive areas identified by the University of Vermont Consulting Archaeology Program, October, 2020.

A map of the Hands Mill Dam and surrounding properties, as surveyed during the topographic survey is provided in Sheet 3 of Appendix A. A photograph of the existing dam structure is provided in Figure 1. The existing conditions at the project site are described below.

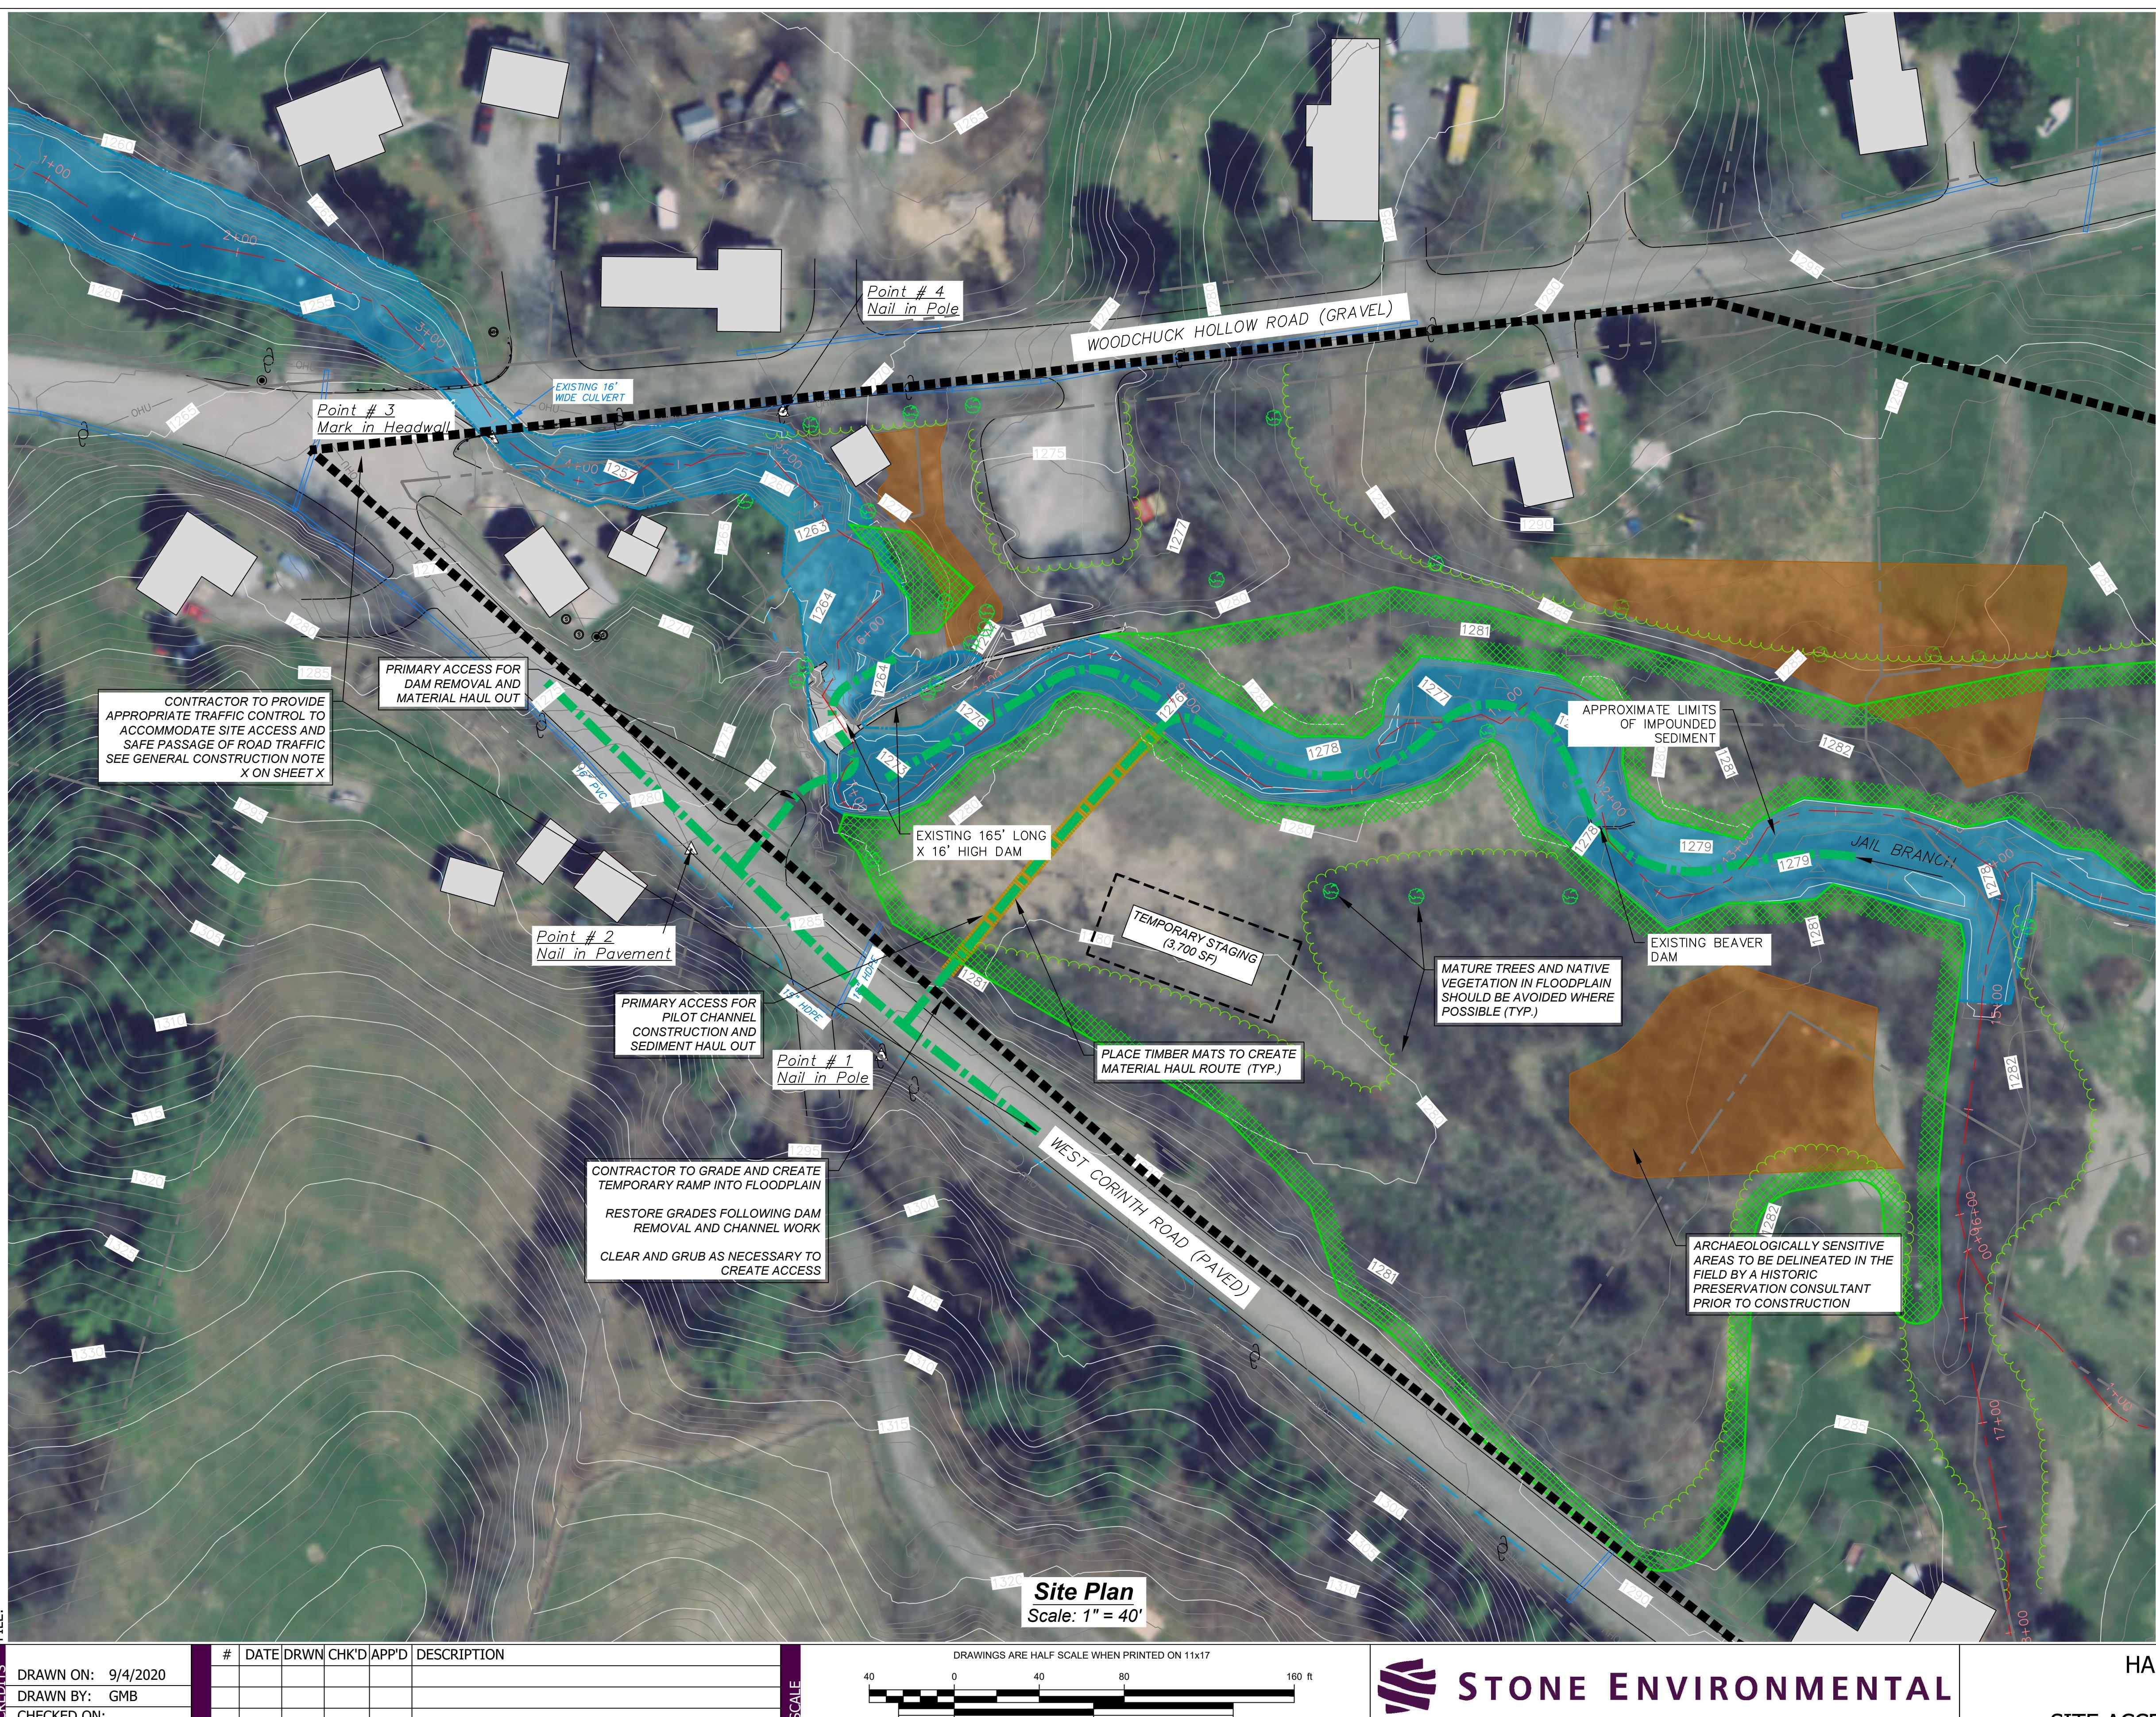
HANDS MILL DAM REMOVAL AT JAIL BRANCH SITE ACCESS & MATERIAL REMOVAL PLAN

Site Access & Material Removal Notes:

- 1. Utility locations shown on this plan should be considered approximate. Contractor is required to verify utility locations prior to work.
- 2. The suggested site access shown on this sheet is an example and for the purposes of project bidding.
- 3. The Contractor shall submit an Access and Material Removal Plan for approval by the Engineer prior to mobilization. The plan can follow the suggested route, or vary based on revised project sequencing. Overall, the Plan will be the Contractor's plan that meets all permit requirements and is subject to approval by the Engineer. See specifications.

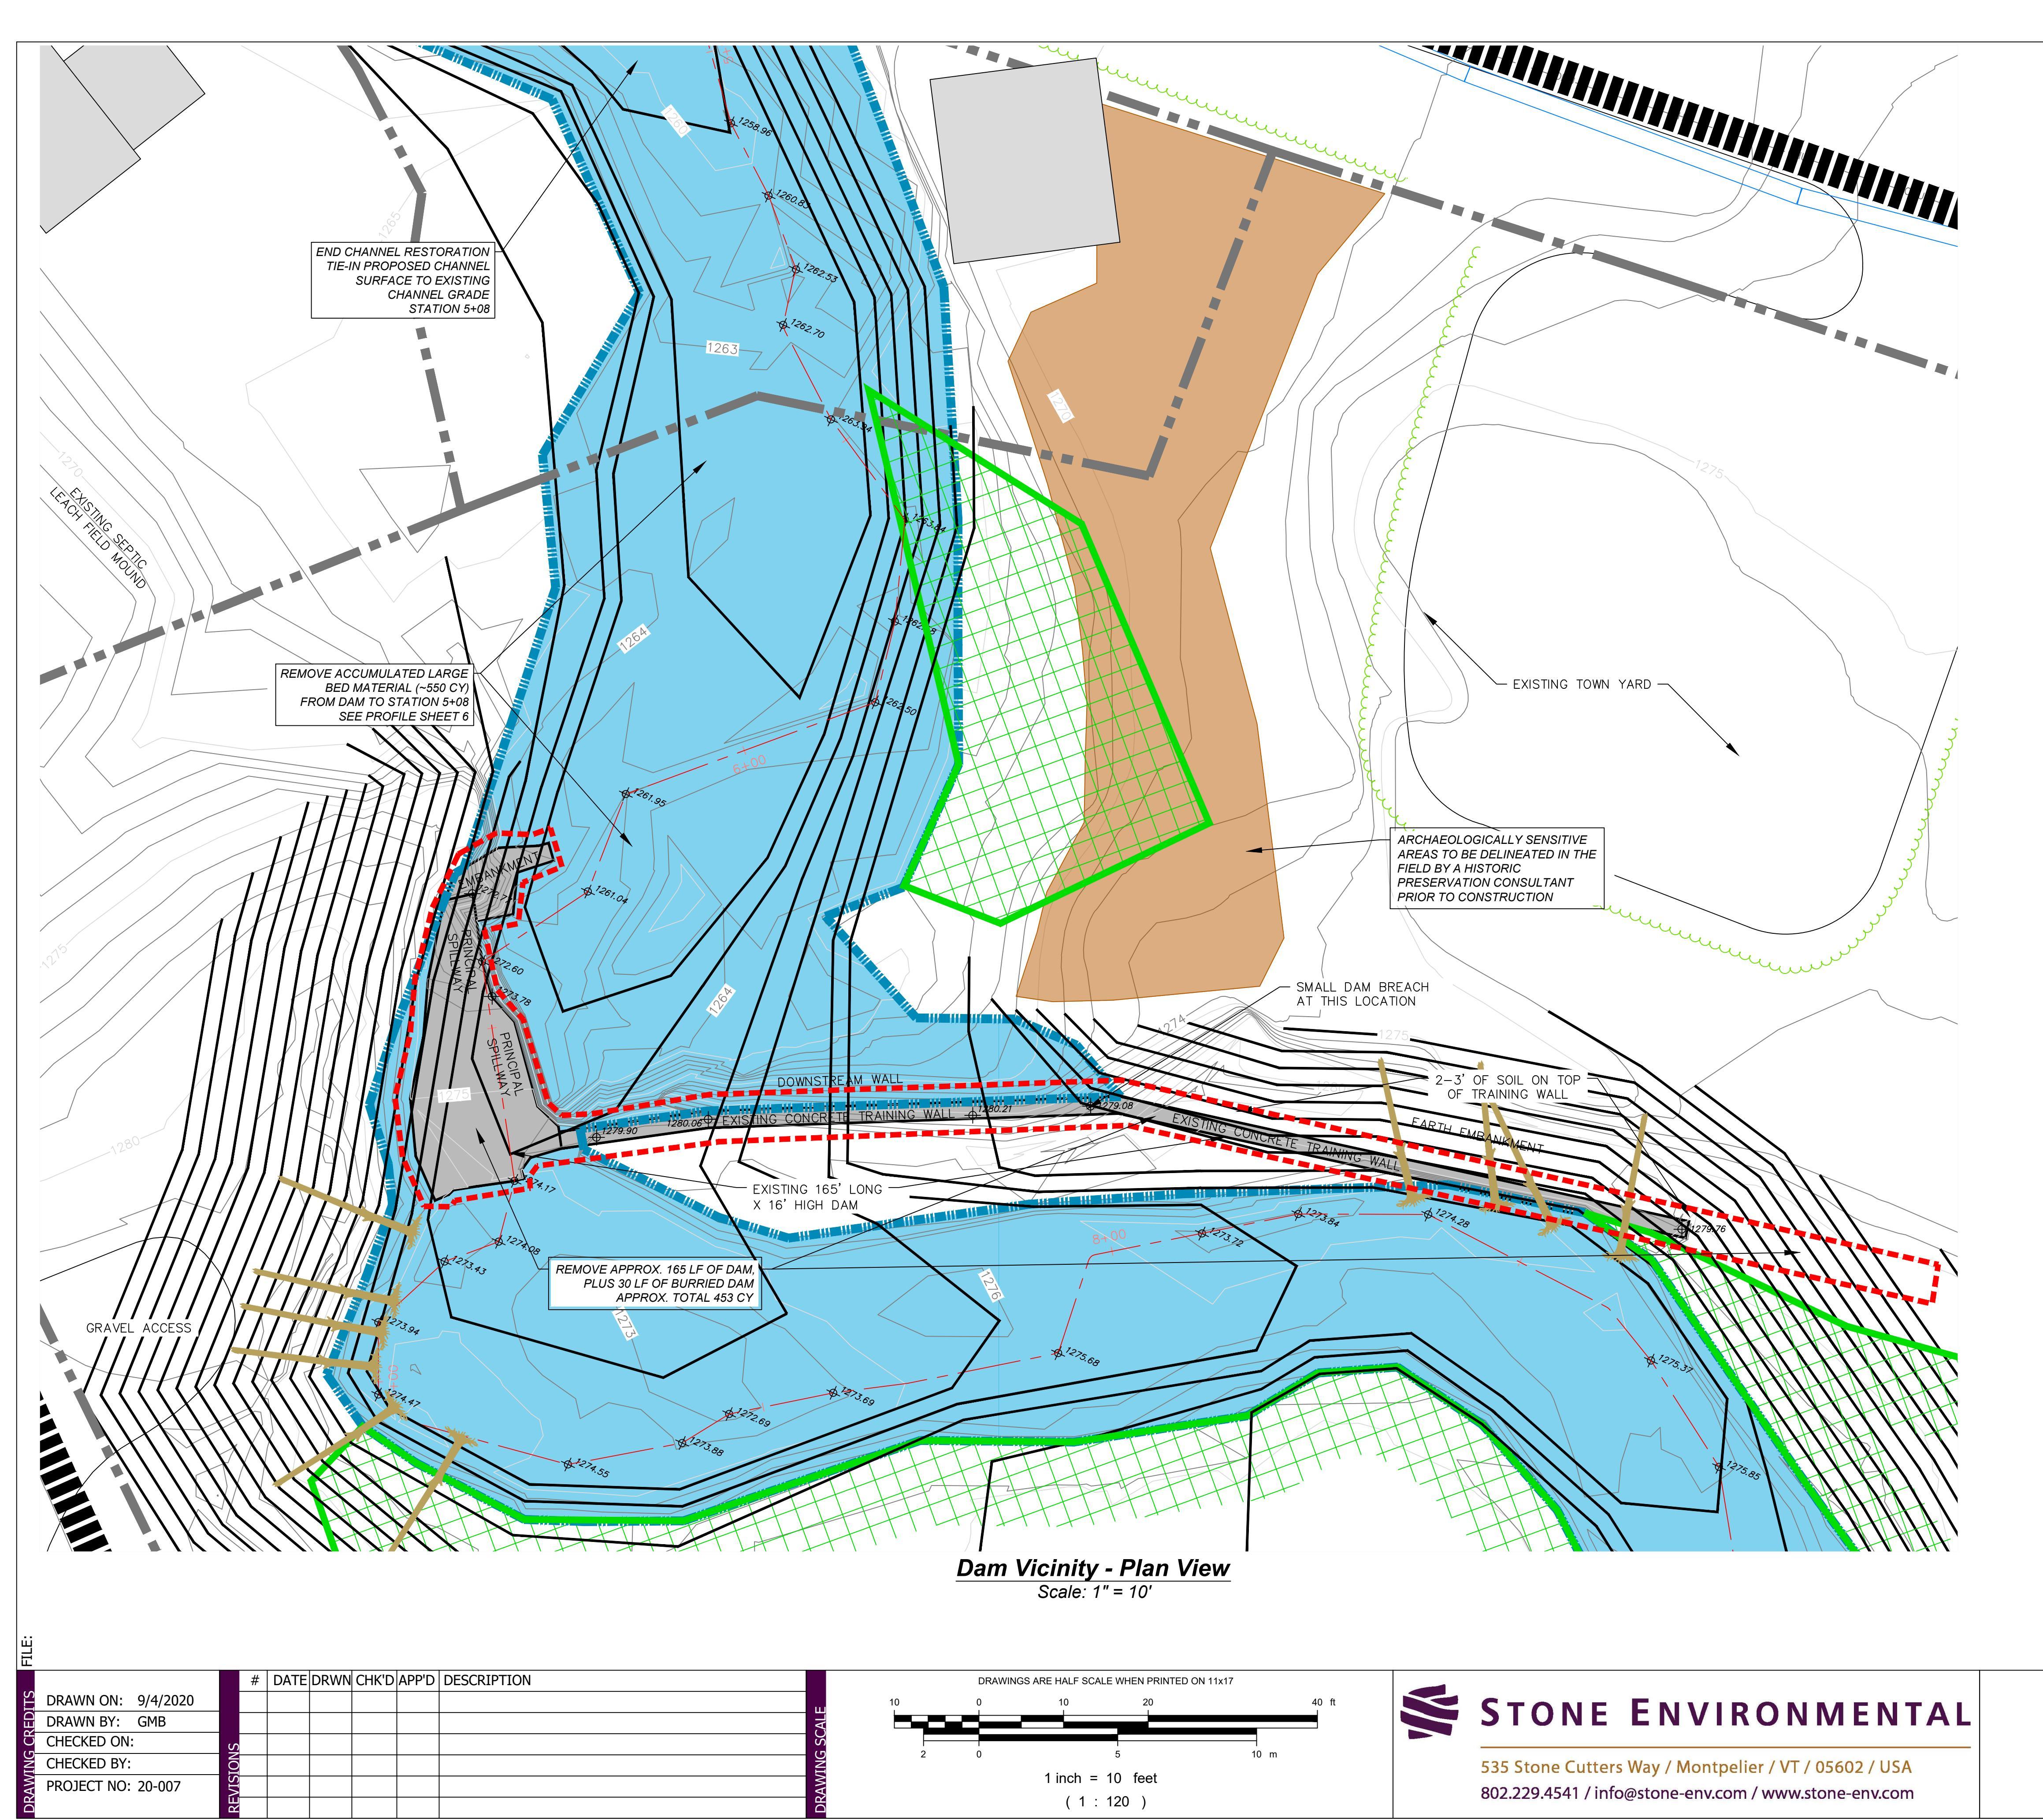
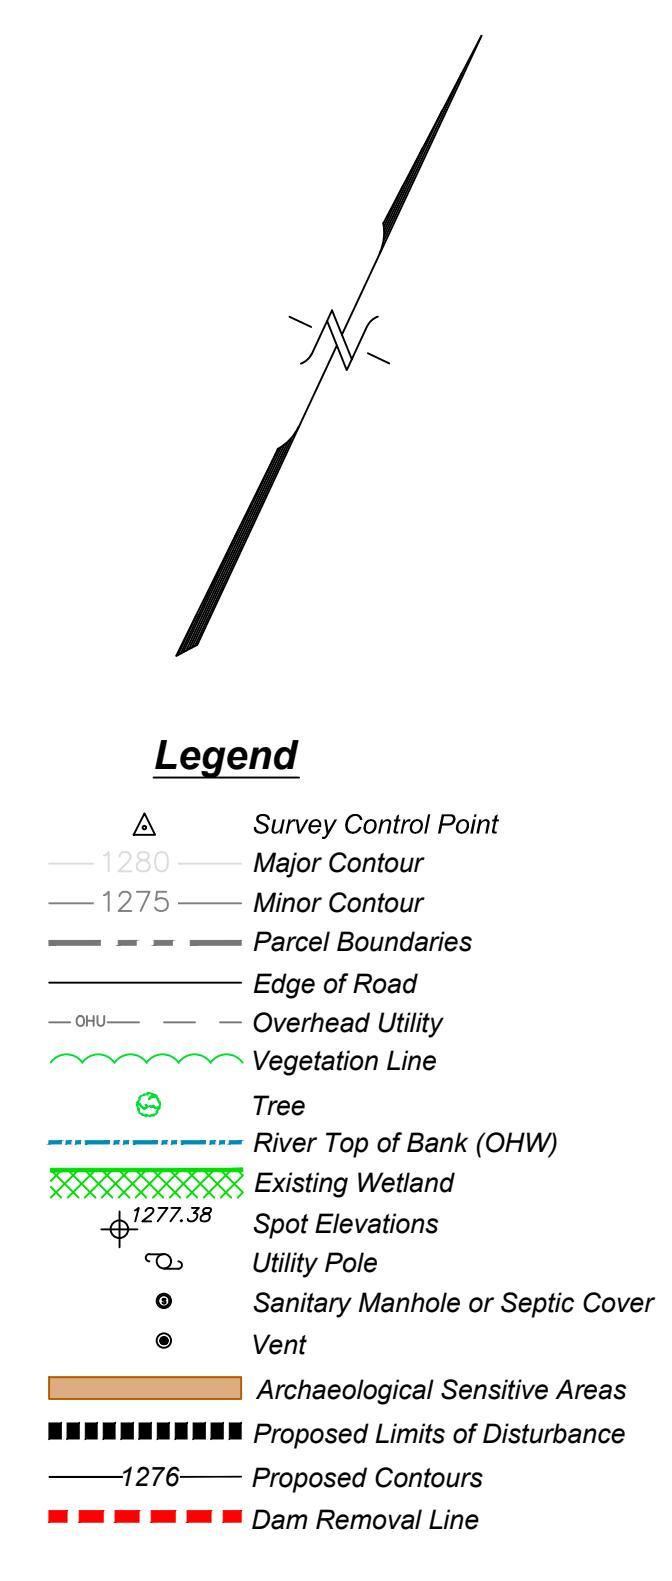
HANDS MILL DAM REMOVAL AT JAIL BRANCH EXISITNG DAM & DEMOLITION PLAN

Dam Demolition Plan Notes:

- 1. Potential limits of structures, as indicated on this sheet are based on surveys, probing data and assumed geometry of structures, and are therefore unconfirmed and should be verified by the contractor.
- 2. Note that there will be no removal of bedrock at the dam and throughout the extent of the project.

Due to the degraded and fragile nature of the dam walls river right of the spillway, removal efforts will need to be focused and performed with care. The construction bid advertisement and specifications will clearly state that the dam is in a degraded condition and a construction sequence that will ensure a controlled removal of the dam will be required.

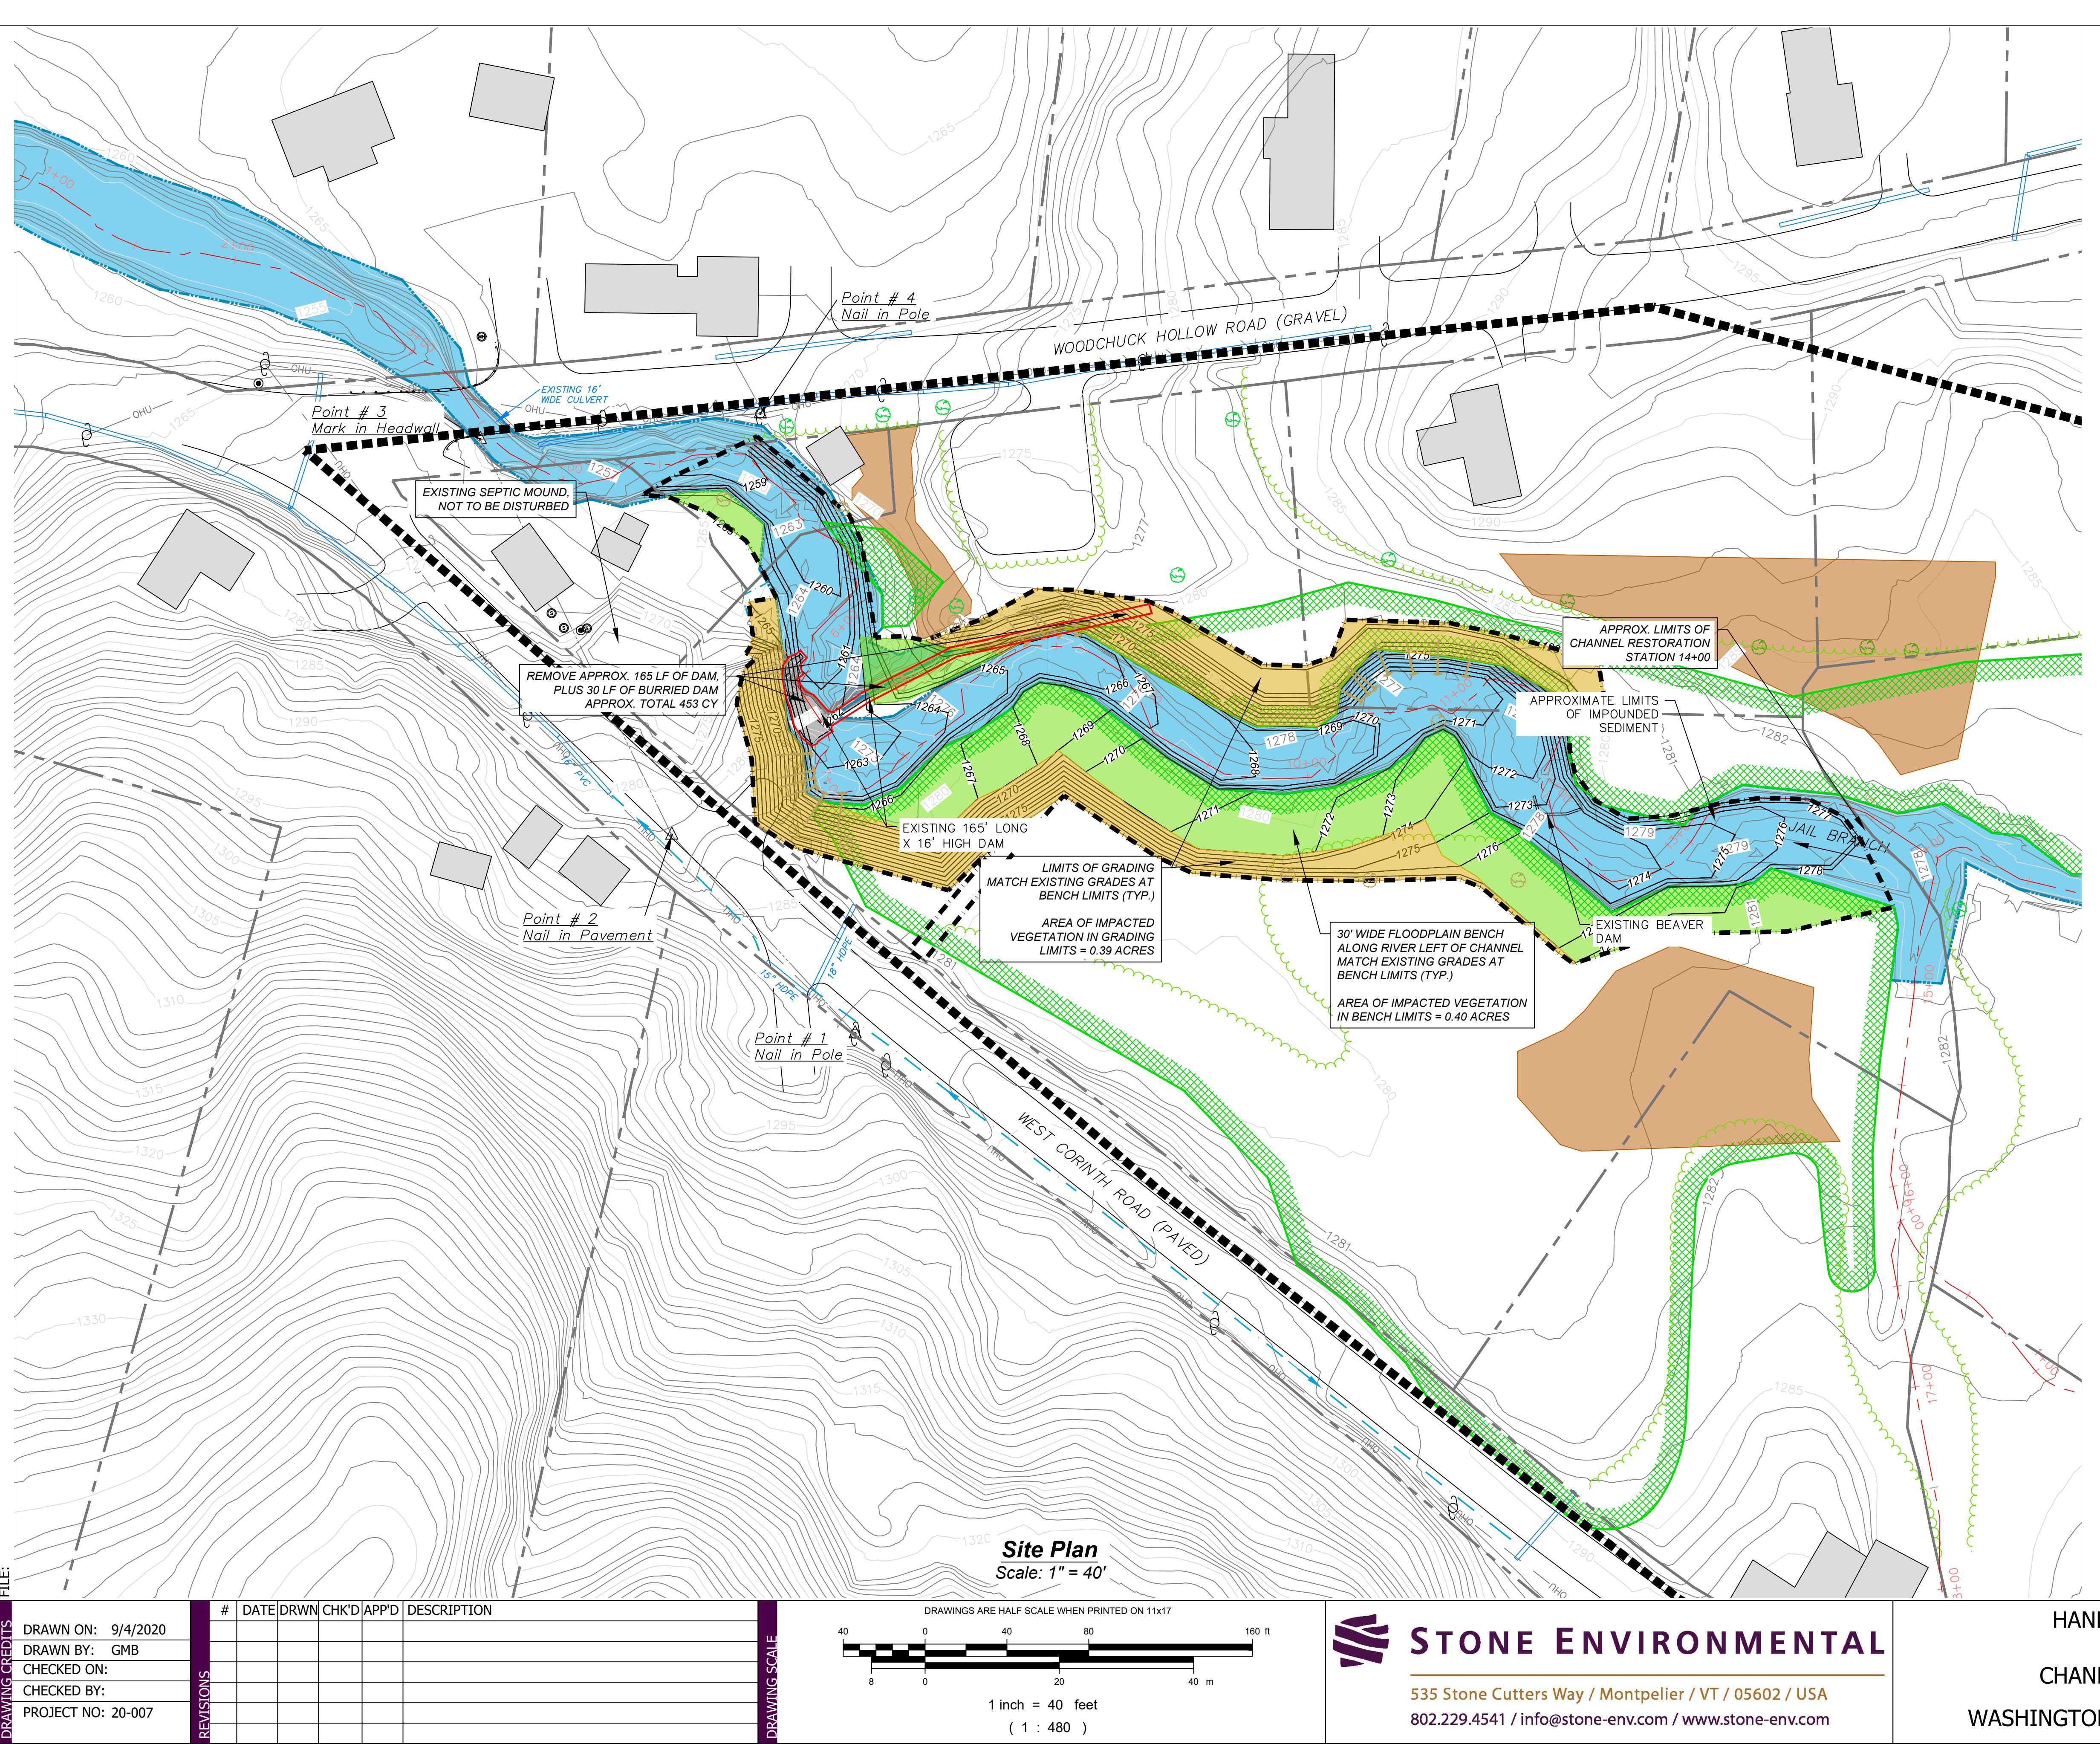
HANDS MILL DAM REMOVAL AT JAIL BRANCH CHANNEL RESTORATION PLAN

# Channel Restoration Plan Notes:

- Contractor to clear and grub as necessary to provide access, remove dam and construct bank stabilizations (Item 201.10).
- 2. Contractor to install topsoil and seed along disturbed floodplains and other areas of disturbance per the direction of the Engineer.
- 3. See the 'Typical Channel Cross Section' on Sheet 6 for a depiction of the pilot channel cross section to be constructed per the extents shown on this sheet
- Final channel and floodplain grading associated with the limits of pilot channel construction and bank stabilizations shown on this plan may be further revised in 100% design plans.

Schematic layouts for existing conditions and the selected alternative A4 are provided in Appendix A. Site plans were not developed for A2 and A3.
