Hands Mill Dam Removal Preliminary Engineering Report

HANDS MILL DAM REMOVAL **AT JAIL BRANCH** TOWN OF WASHINGTON, VERMONT

30% DESIGN **ISSUED: JANUARY, 2021**

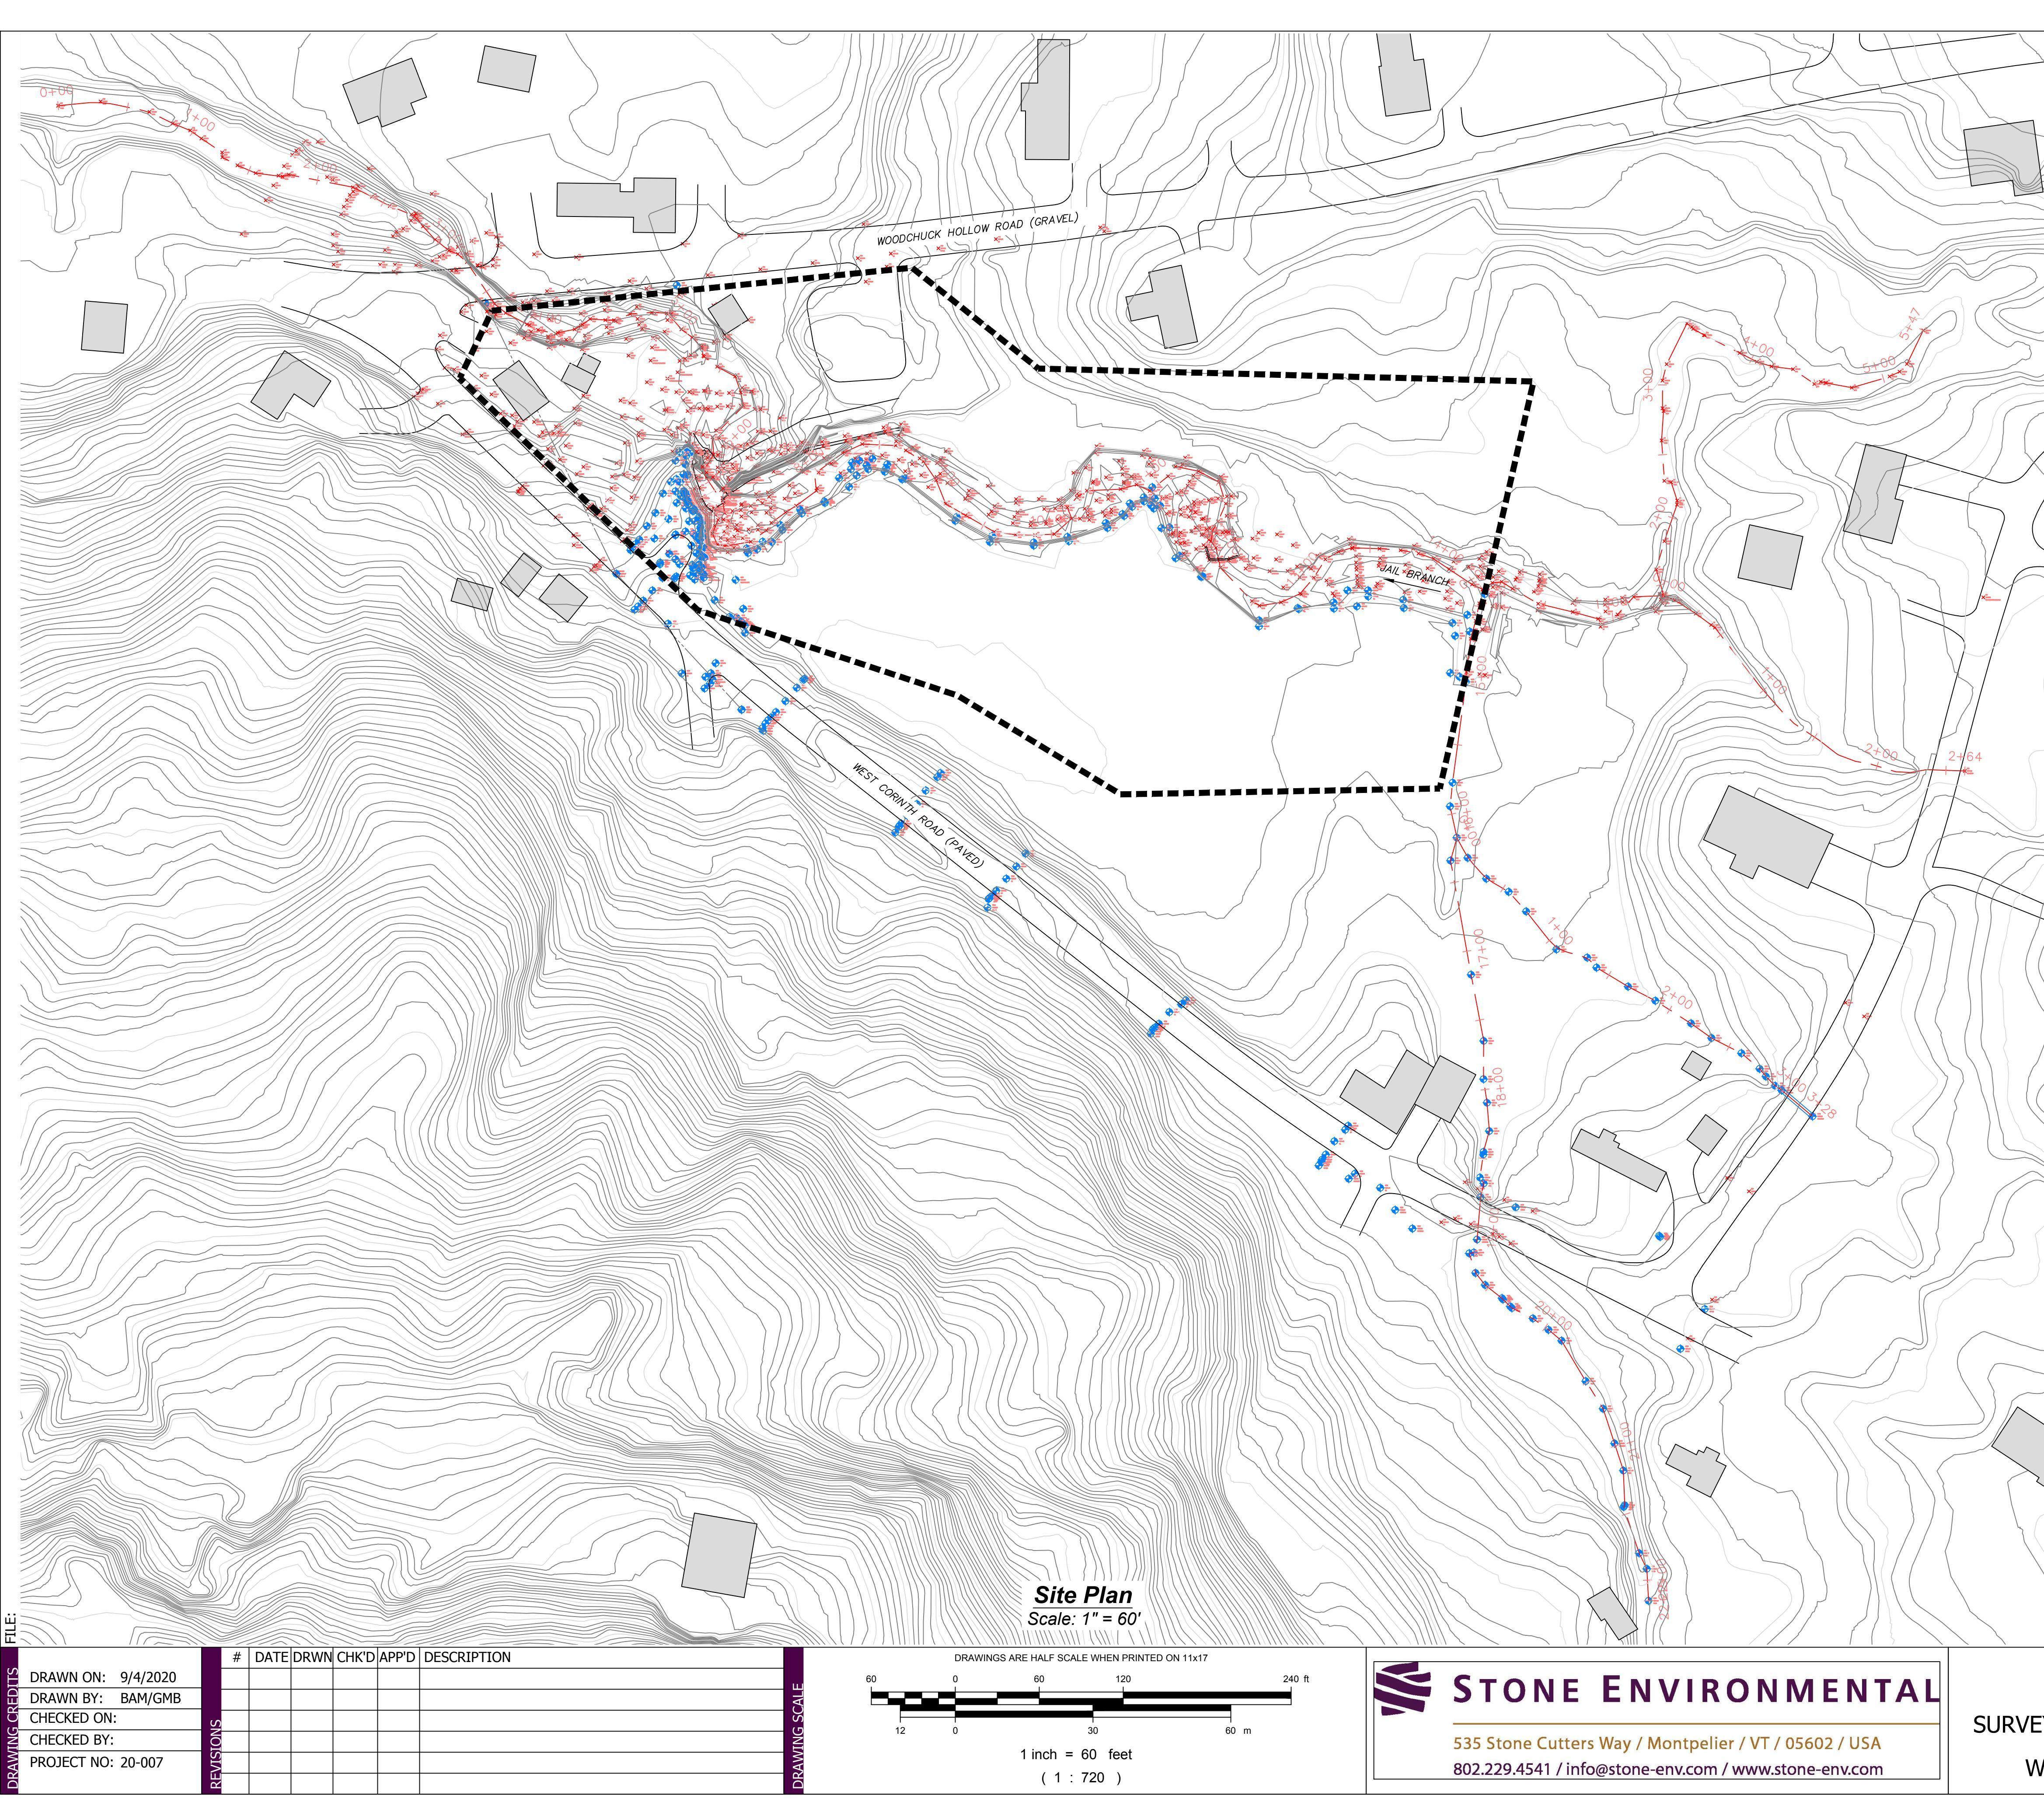
HANDS MILL DAM REMOVAL AT JAIL BRANCH SURVEY EXTENTS PLAN AND LIMITS OF DISTURBANCE

**EXAMPLE 1** Proposed Limits of Disturbance
