30% Design Report: Hands Mill Dam Removal

PROJECT NO.

20-007

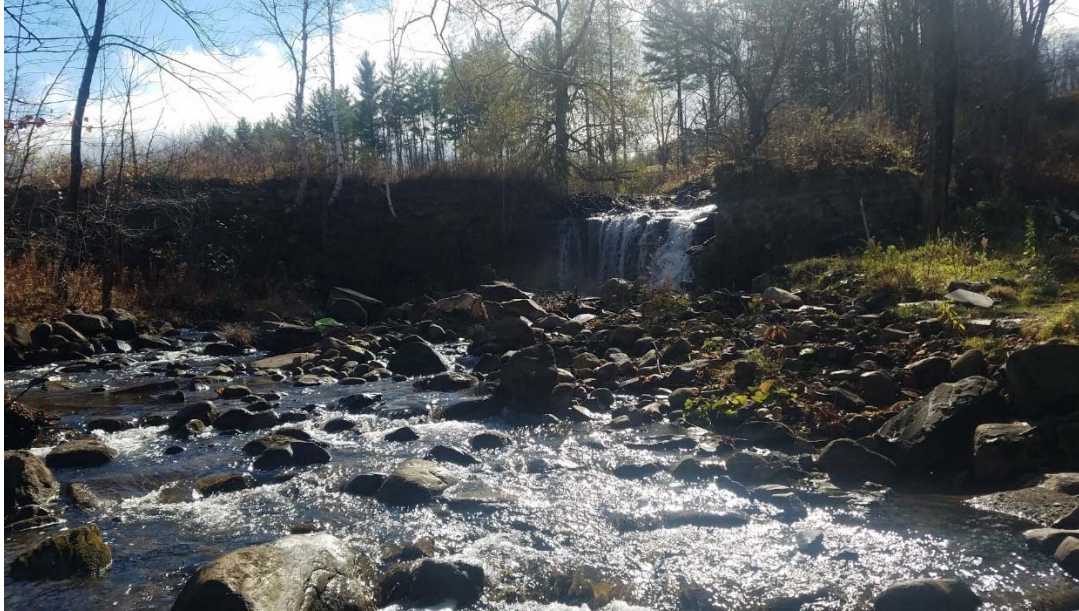
Stone completed a photographic simulation of post dam removal conditions at the site. The photo simulation was completed using a photo taken downstream of the dam and looking upstream, with the assumption that approximately 195 linear feet of the dam is removed. A photo of the existing conditions at the site is provided in Figure 1 and a photo simulation of the site following dam removal is provided in Figure 2.

Figure 1. Photo of existing conditions at Hands Mill looking upstream.

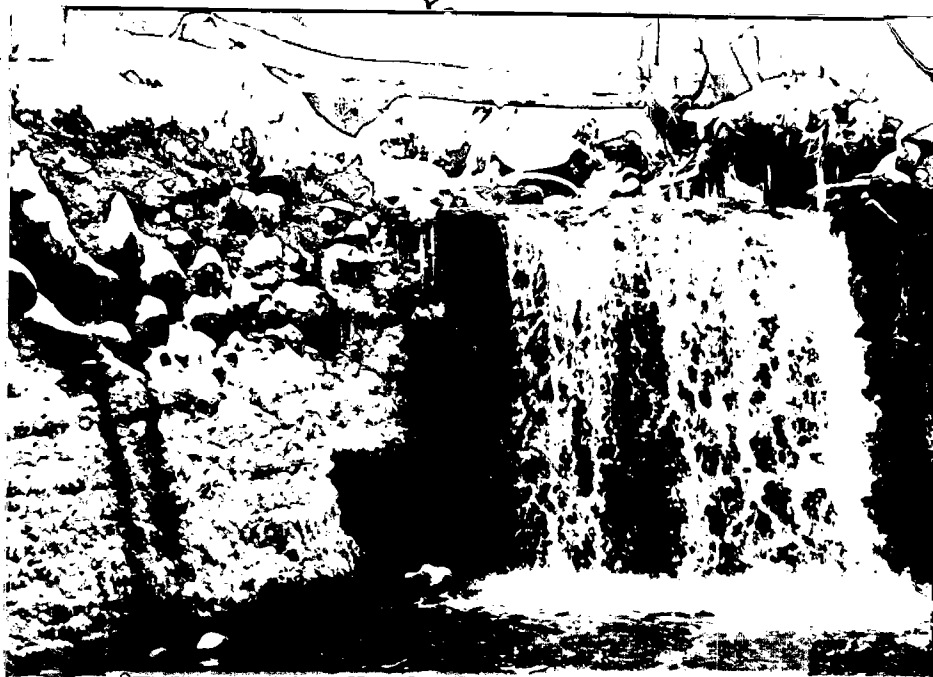
CT-51-32

Left end
breed

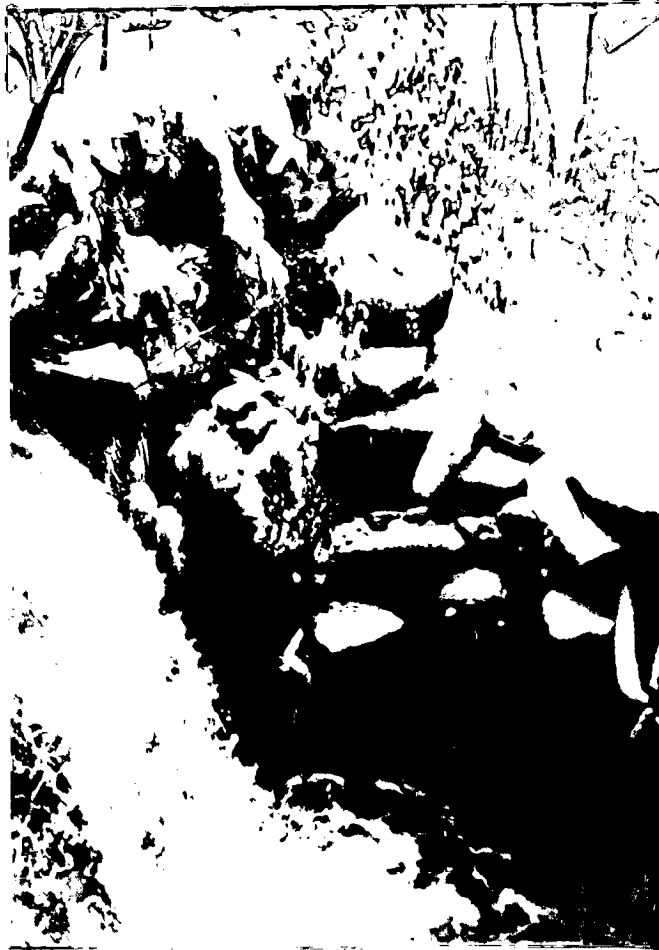
84-51-23

Looking d/c along
right side mill wall
and wheel pit structure.

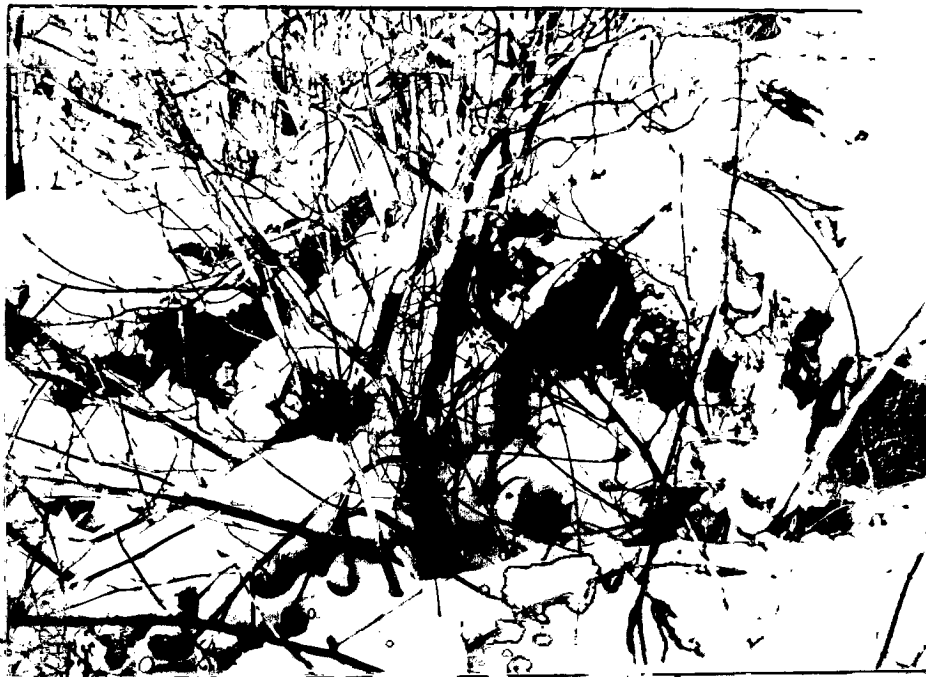
84-51-24

Collapsed and eroded area at
right end spillway at embankment (w/isth).

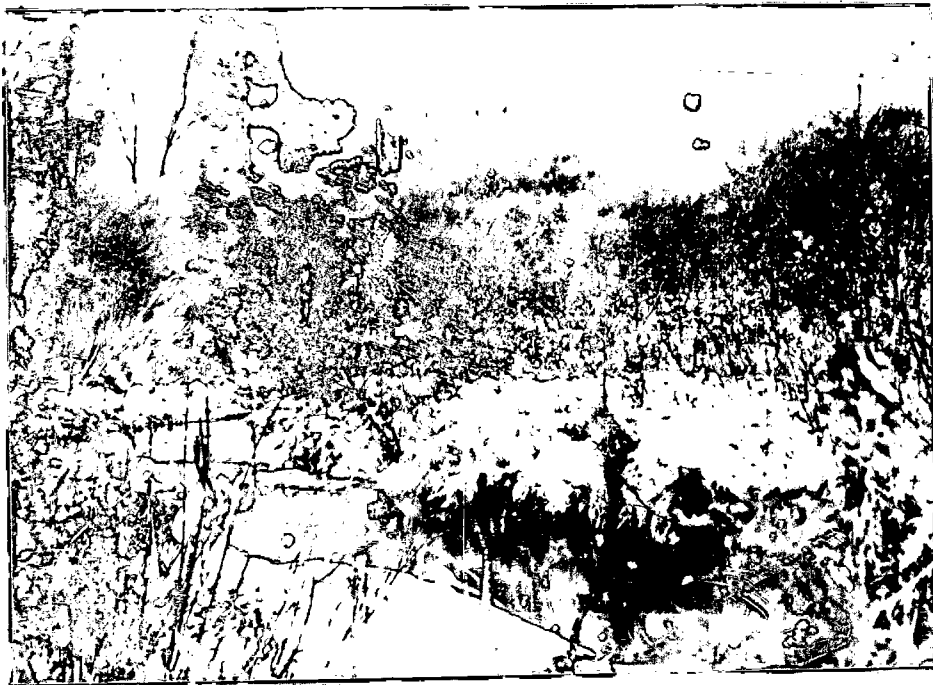
8:51-20

"Reservoir" as viewed from
crest of dam on R/S spillway near breach
- looking U/S.

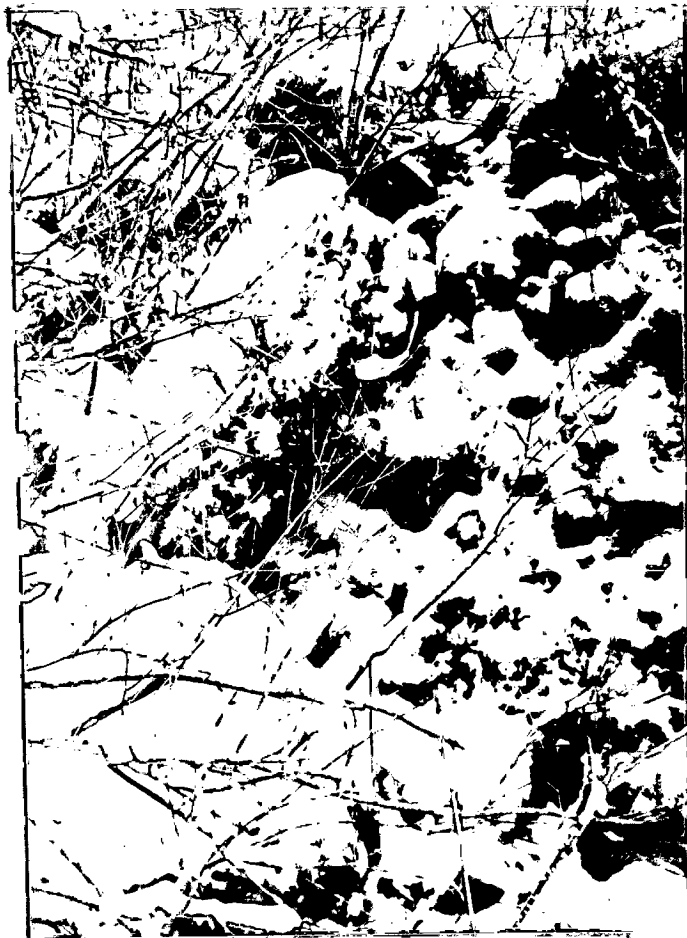
84-51-31 Remnants of well at
right end spillway and
embankment

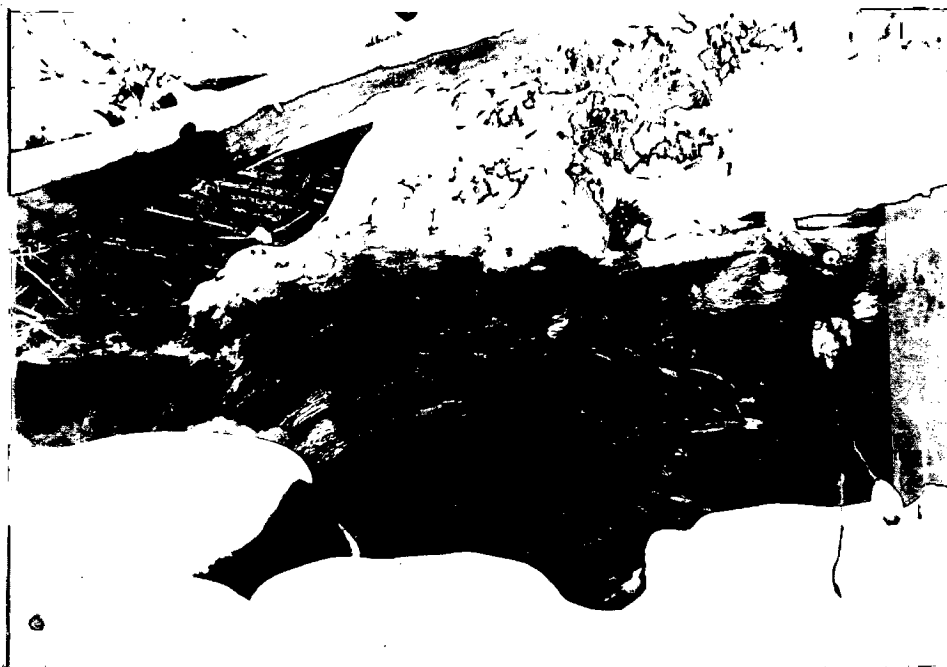
84-51-36 Breach at left end of spillway.
